VEHICLE INSPECTION REPORT

Mercedes-Benz E Class E 200 AMG Line Premium 5dr 9G-Tronic

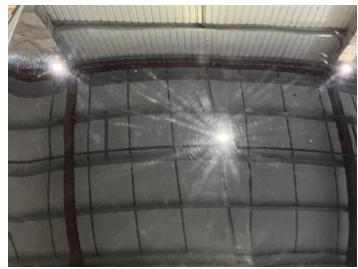
1: Bonnet Chipped 1 To 5

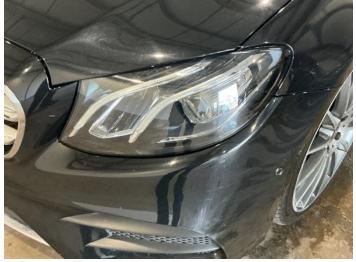
2: Bumper Front Scratched Over 100mm Thru Paint

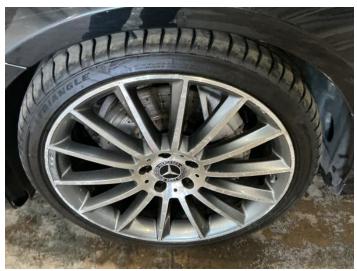
3: Wheel nsf Scratched Over 50mm

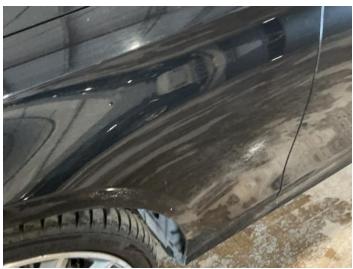
4: Wing nsf Chipped 1 To 5

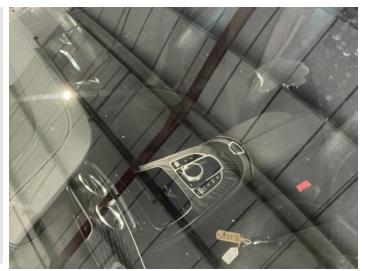
6: Screen Front Chipped UpTo 10mm

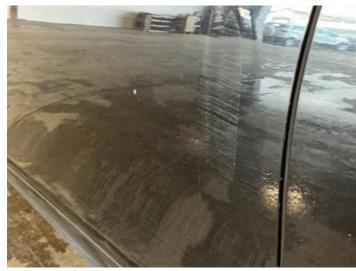
7: Door nsf Dented With Paint Damage

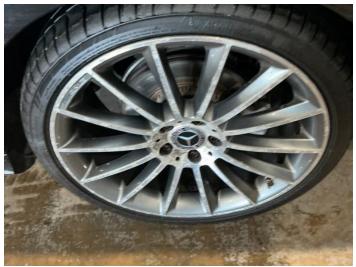
9: Wheel nsr Scratched Over 50mm

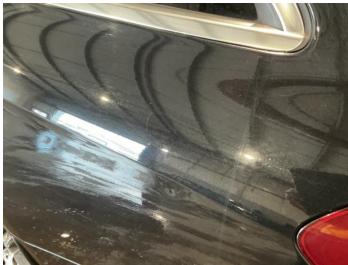
10: Qtr Panel nsr Dented Over 2 UpTo 10mm

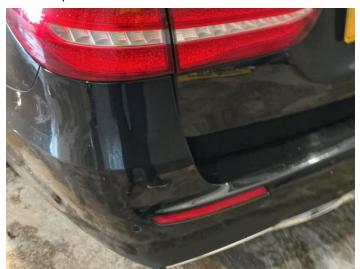
12: Bumper Rear Scratched Over 100mm Thru Paint

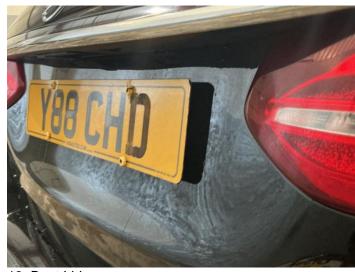
13: Boot Lid Chipped 1 To 5

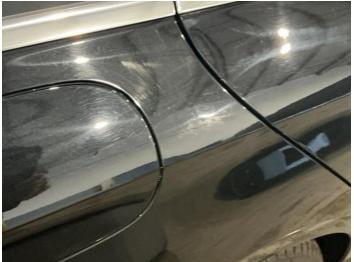
15: Qtr Panel osr Poor Previous Repair Poor Paint

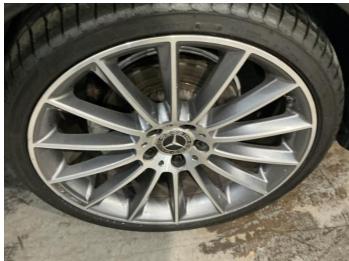
16: Wheel osr Scratched Over 50mm

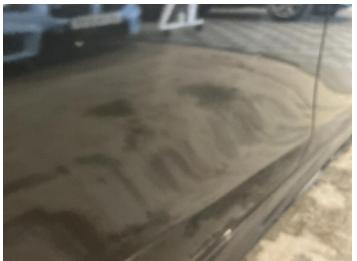
17: Door osr Poor Previous Repair Poor Paint

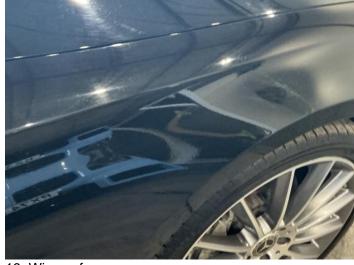
19: Wing osf Chipped 1 To 5

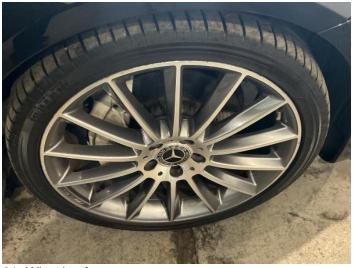
21: Wheel osf Scratched Over 50mm

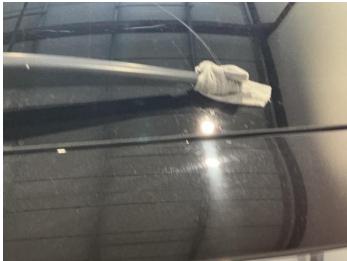
22: Wiper Rear Broken Replace
