# VEHICLE INSPECTION REPORT

**GY71JWO**

## MG Mg 5 EXCLUSIVE

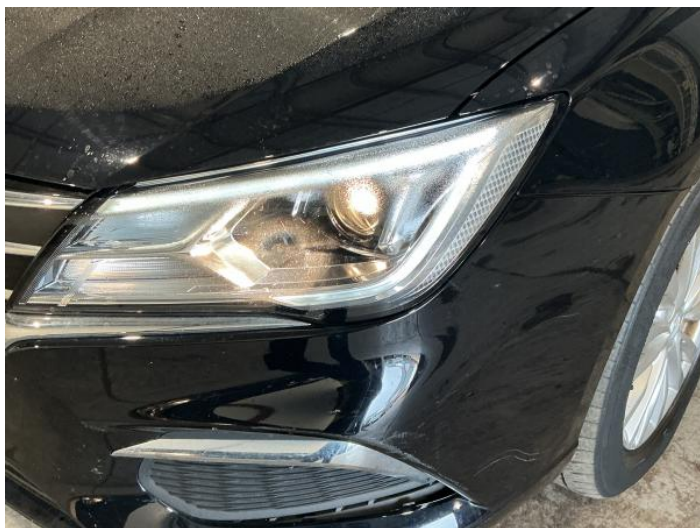
1: Bumper Front  
Scratched  
Over 100mm Thru Paint

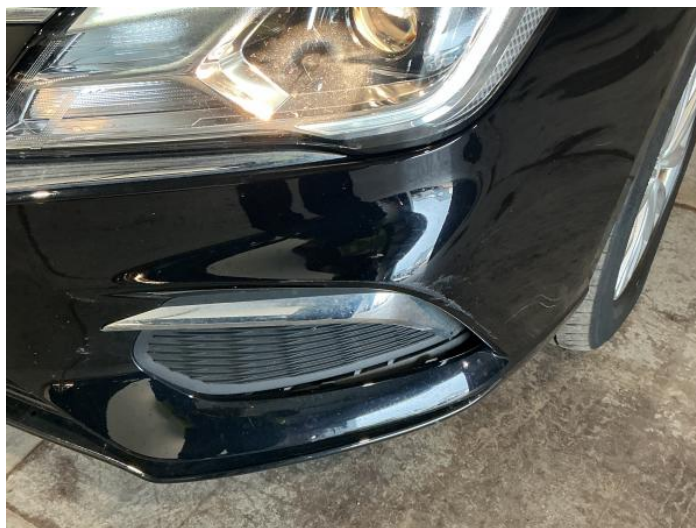
2: Fog Lamp Surrounds  
Broken  
Replace

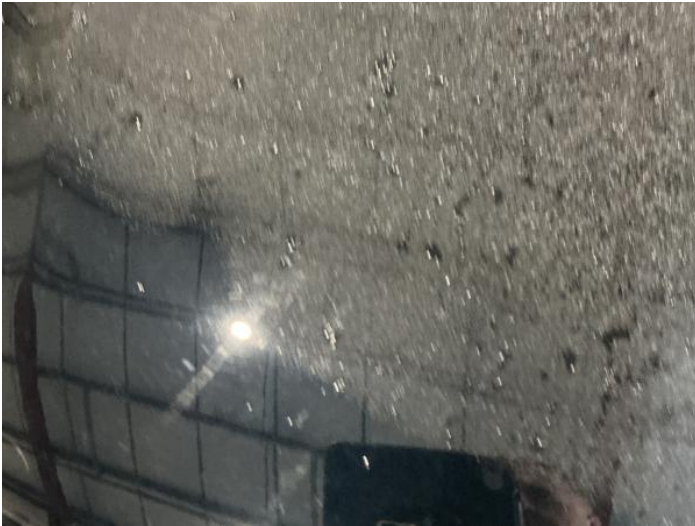
3: Bonnet  
Chipped  
Multiple Chips

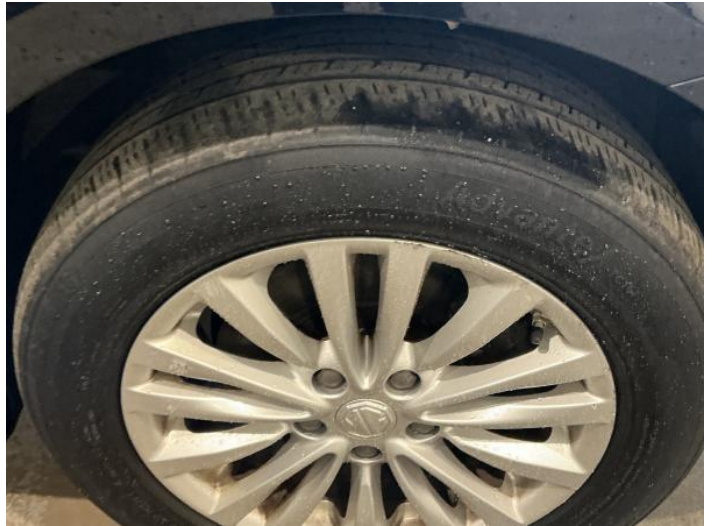
4: Wheel osf  
Scratched  
Over 50mm

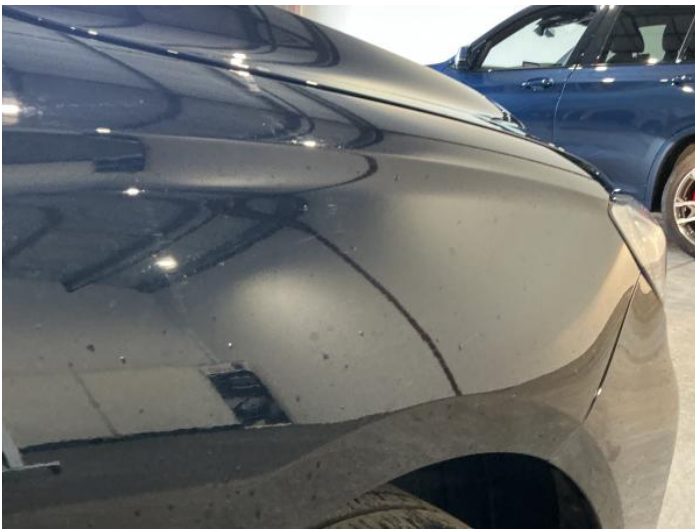
5: Wing osf  
Chipped  
1 To 5

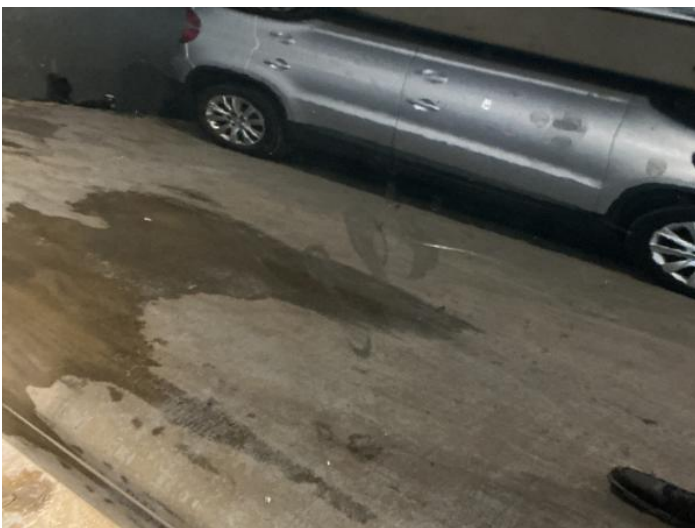
7: Door osf  
Scratched  
Over 25mm Thru Paint

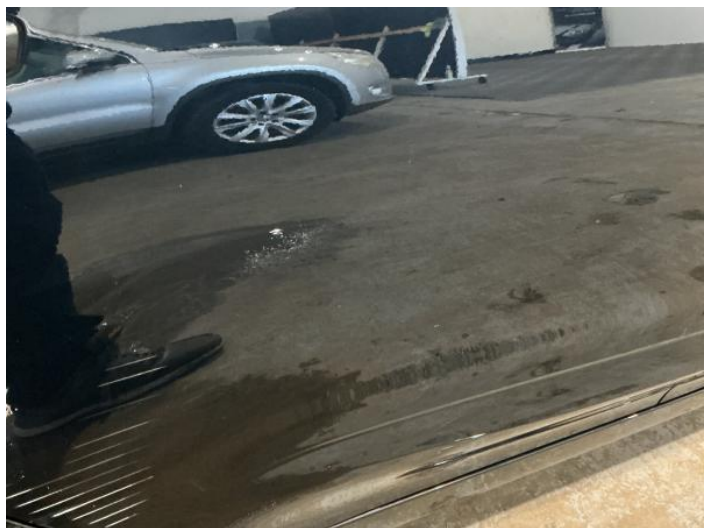
8: Door osr  
Dented  
With Paint Damage

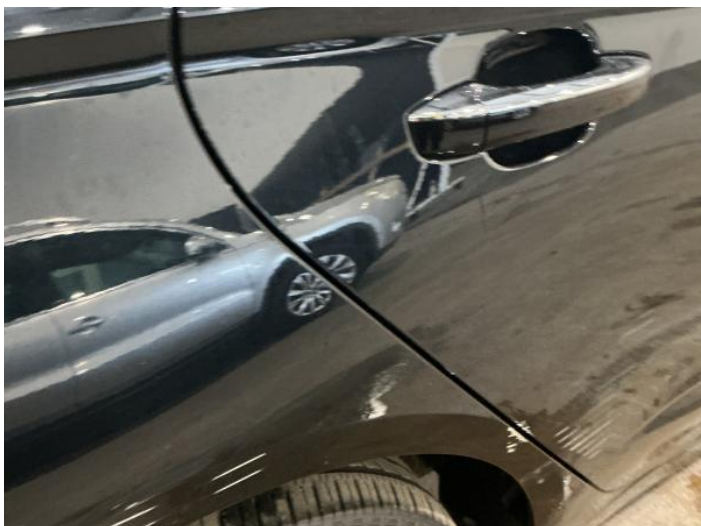
9: Qtr Panel osr  
Dented  
With Paint Damage

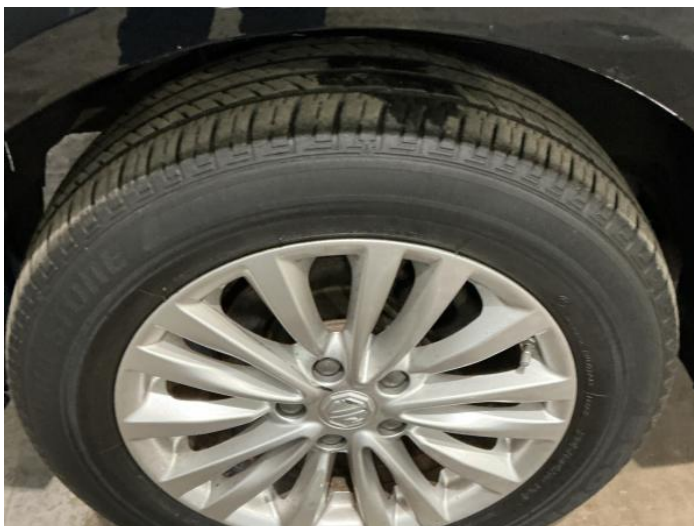
10: Wheel osr  
Scratched  
Up To 50mm

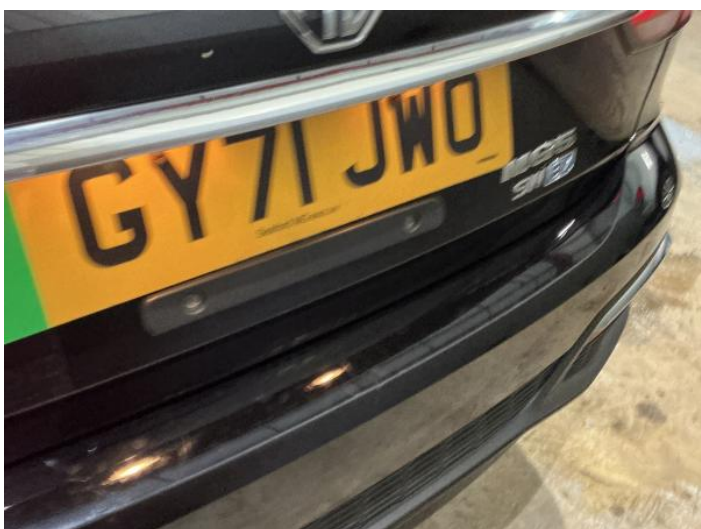
11: Bumper Rear  
Scratched  
25 to 100mm Thru Paint

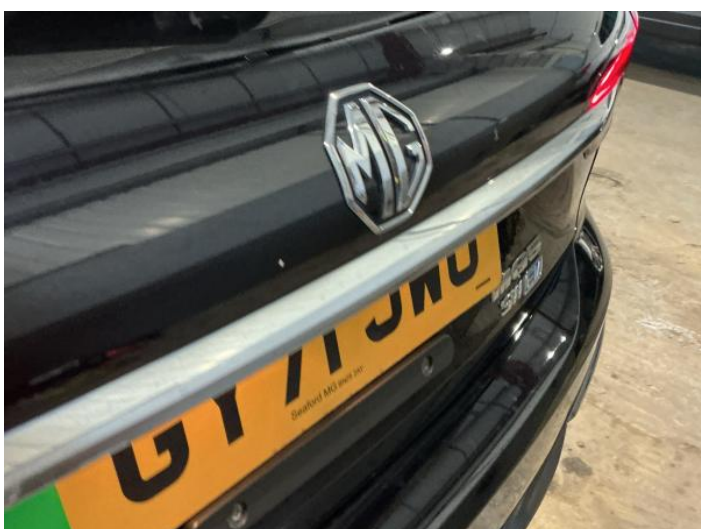
13: Boot Lid  
Chipped  
1 To 5

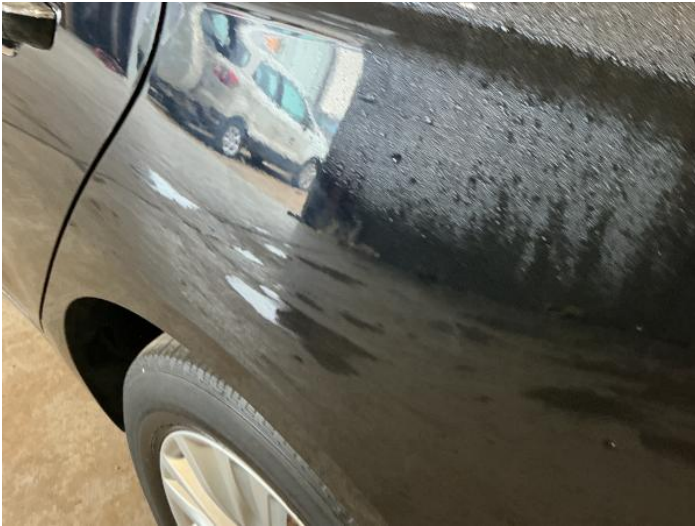
15: Qtr Panel nsr  
Dented  
Over 30mm

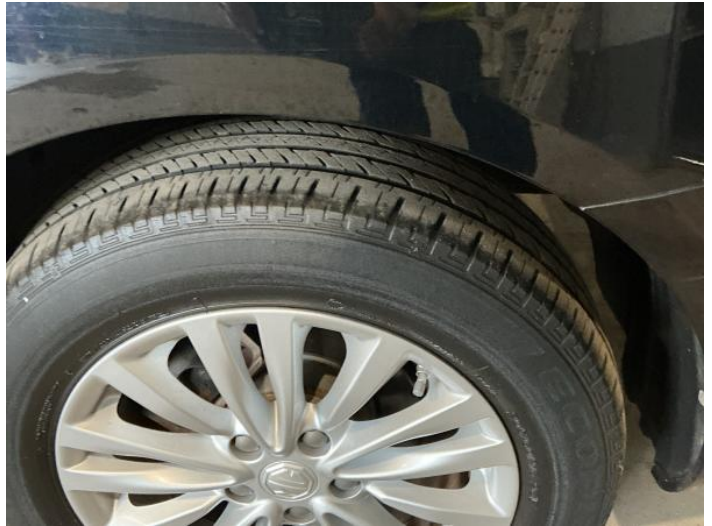
16: Wheel nsr  
Scratched  
Up To 50mm

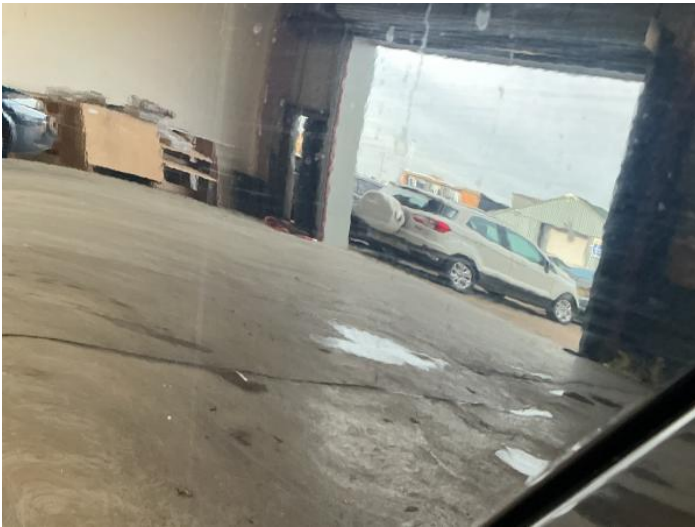
17: Door nsr  
Dented  
With Paint Damage

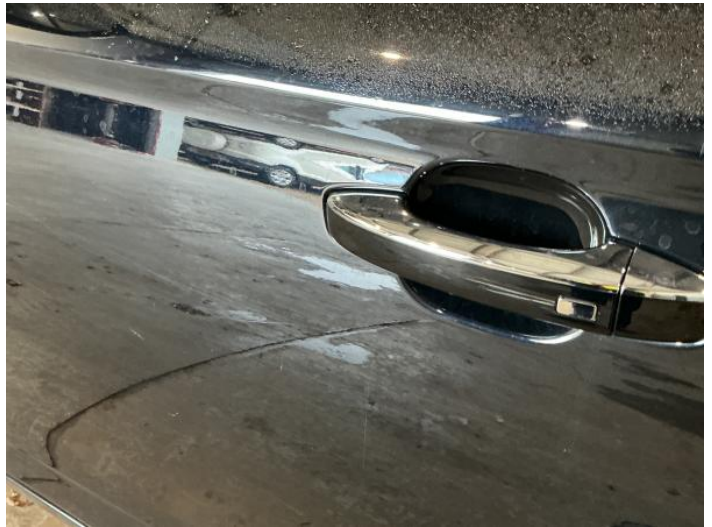
18: Door nsf  
Chipped  
Multiple Chips

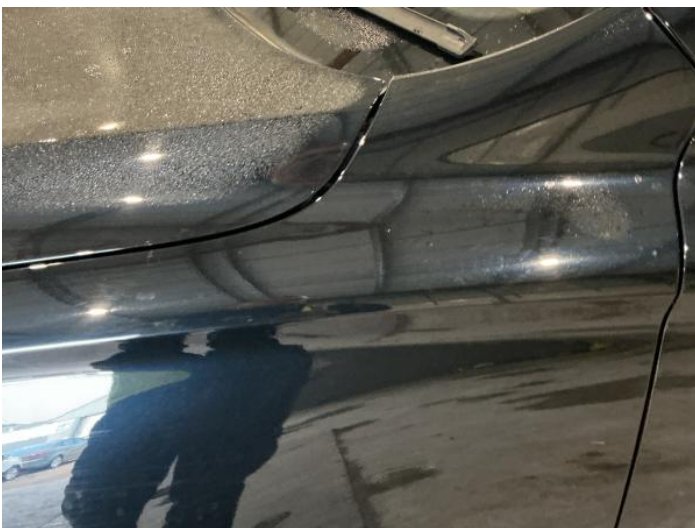
19: Wing nsf  
Chipped  
1 To 5

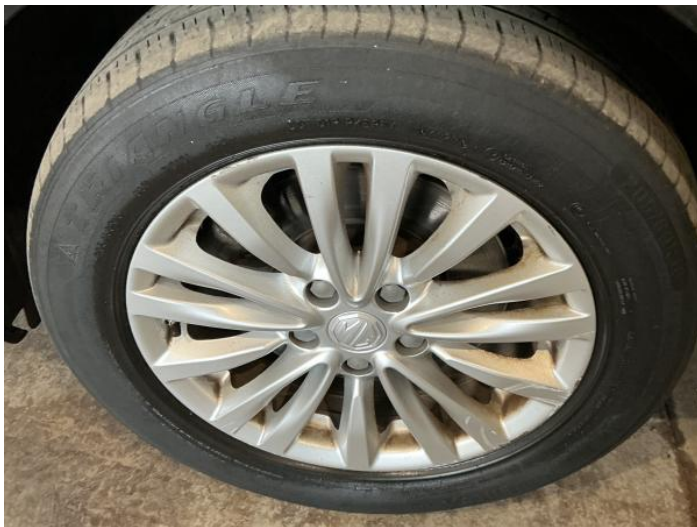
21: Wheel nsf  
Scratched  
Over 50mm

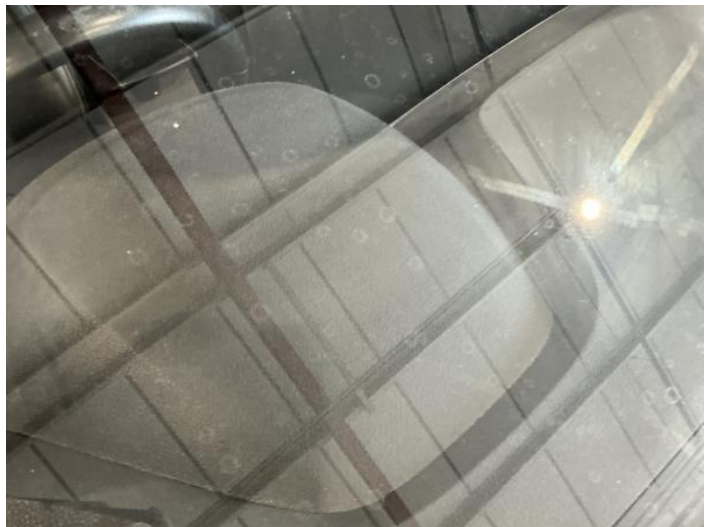
22: Screen Front  
Chipped  
UpTo 10mm
