VEHICLE INSPECTION REPORT

GJ12YCB

Audi A1 1.4 TFSI Sport 3dr

nama
 GRADE
3

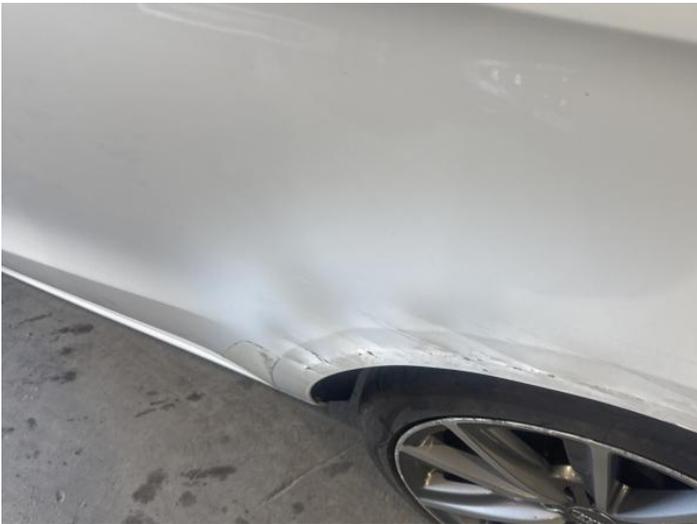
1: Qtr Panel nsr
Dented
With Paint Damage

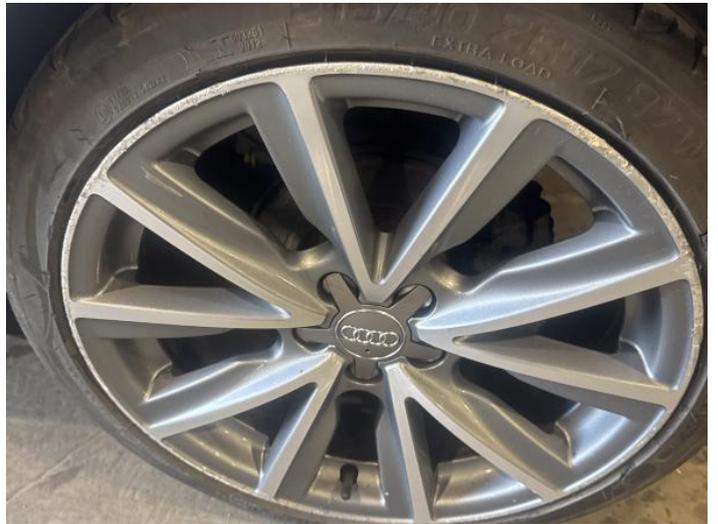
2: Wheel nsr
Scratched
Over 50mm

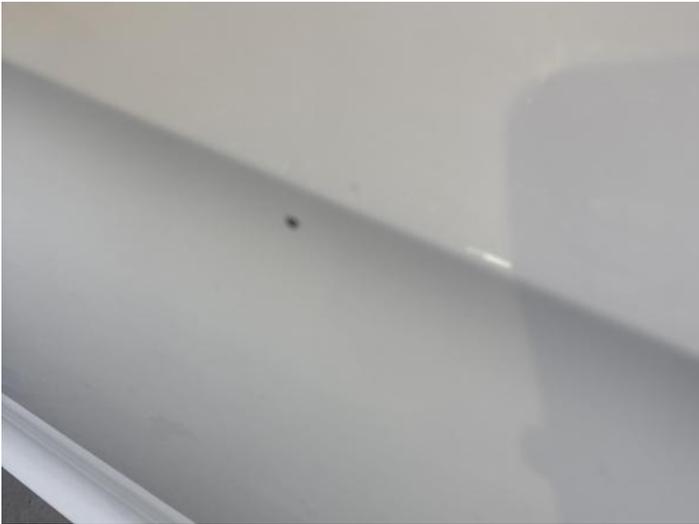
3: Door nsf
Chipped
1 To 5

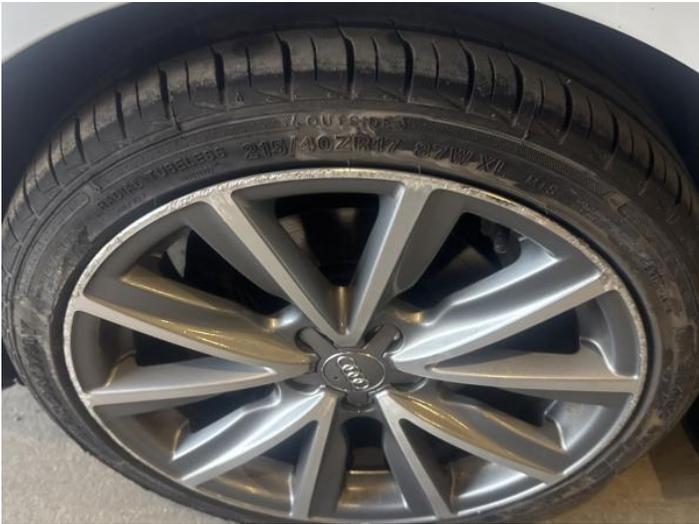
5: Wheel nsf
Scratched
Over 50mm

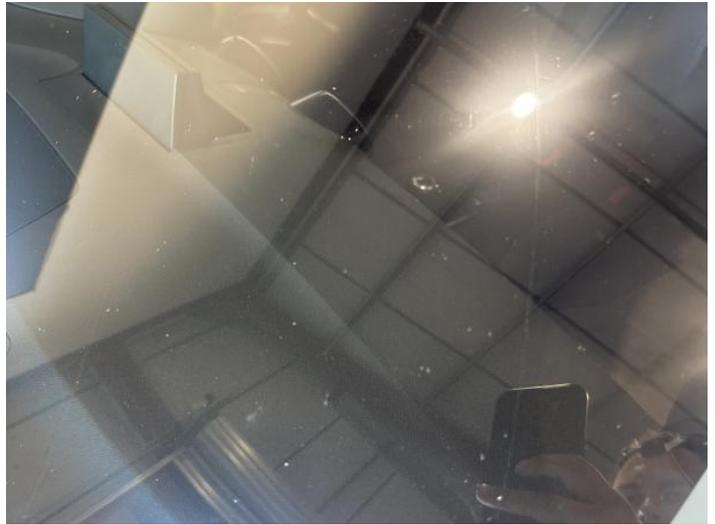
6: Screen Front
Chipped
UpTo 10mm

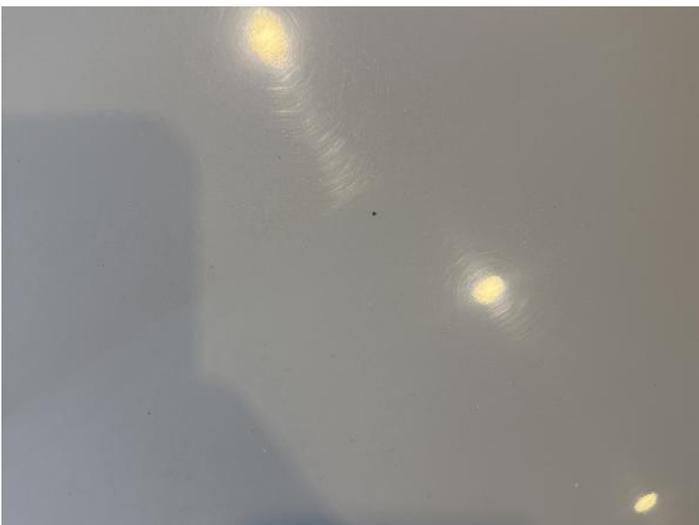
7: Bonnet
Chipped
1 To 5

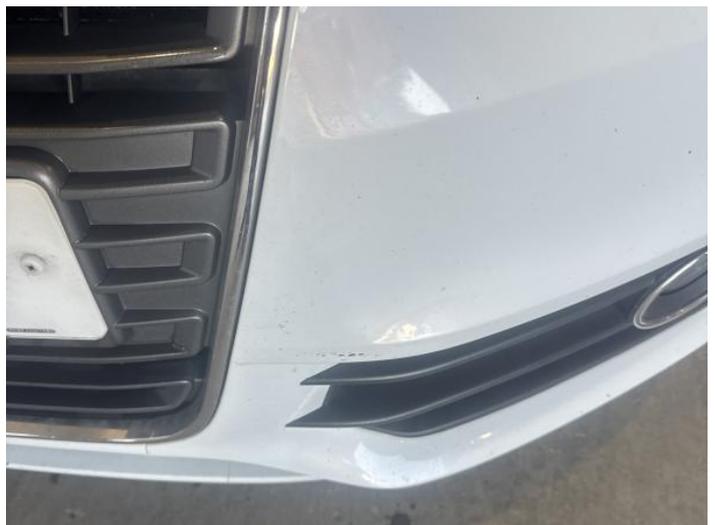
8: Bumper Front
Scratched
Over 100mm Thru Paint

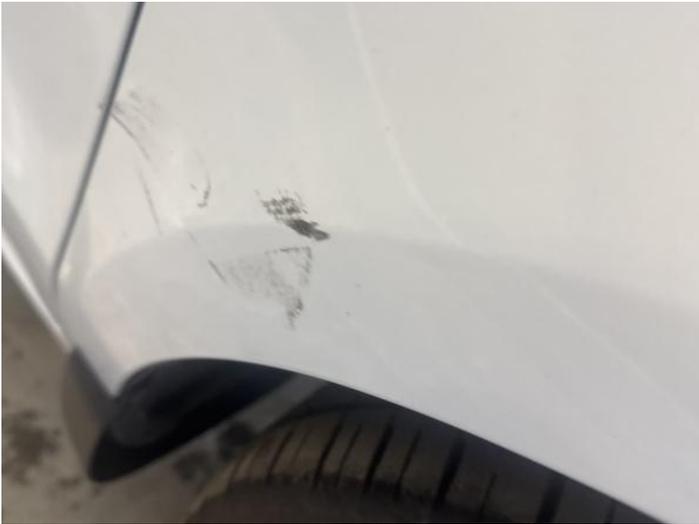
9: Wing osf
Scratched
Over 25mm Thru Paint

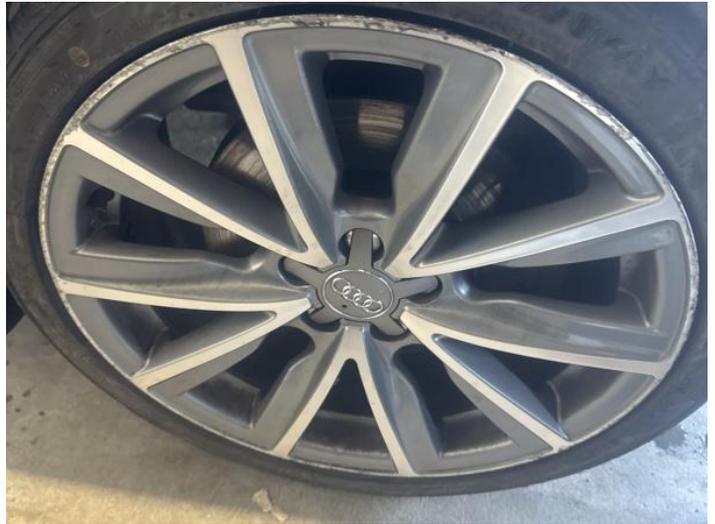
10: Wheel osf
Scratched
Over 50mm

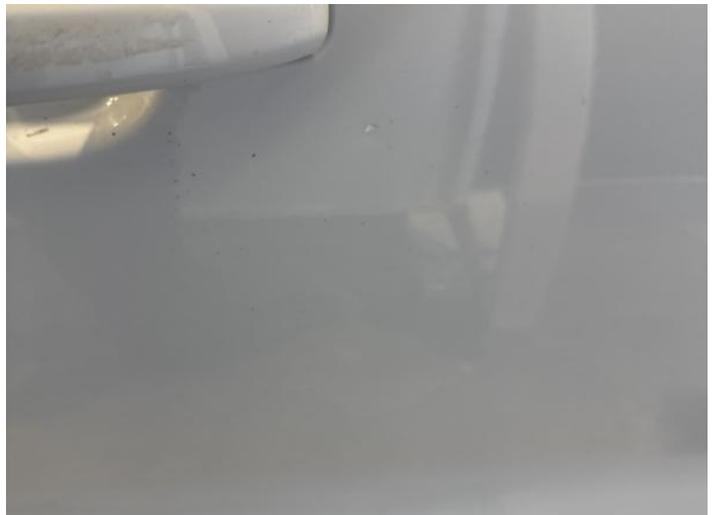
12: Door osf
Chipped
1 To 5

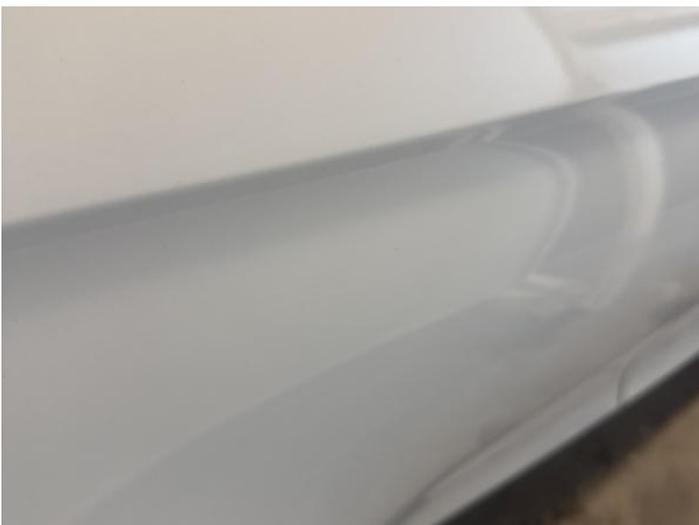
13: Qtr Panel osr
Dented
2 Or Less UpTo 10mm

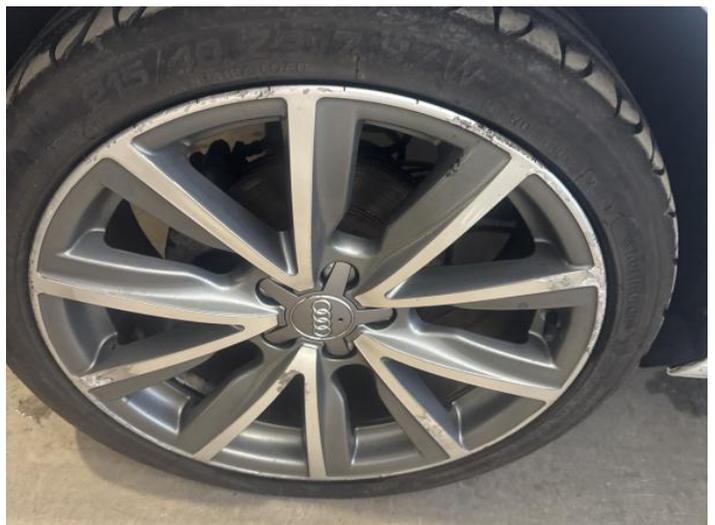
14: Wheel osr
Scratched
Over 50mm

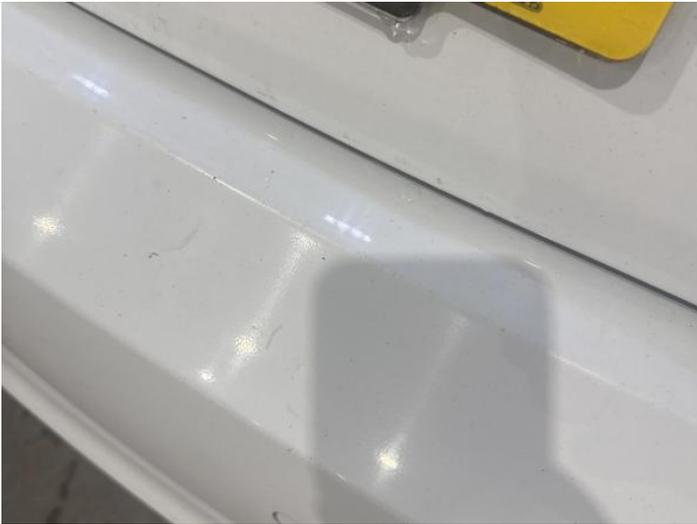
15: Bumper Rear
Chipped
Multiple Chips

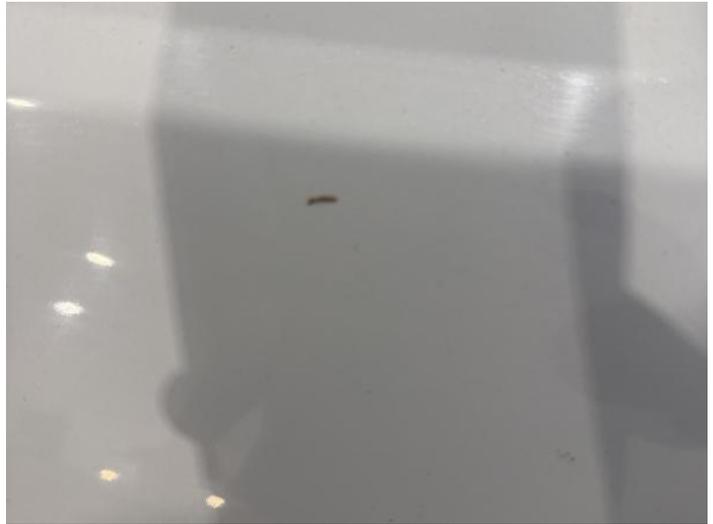
16: Boot Lid
Chipped
1 To 5

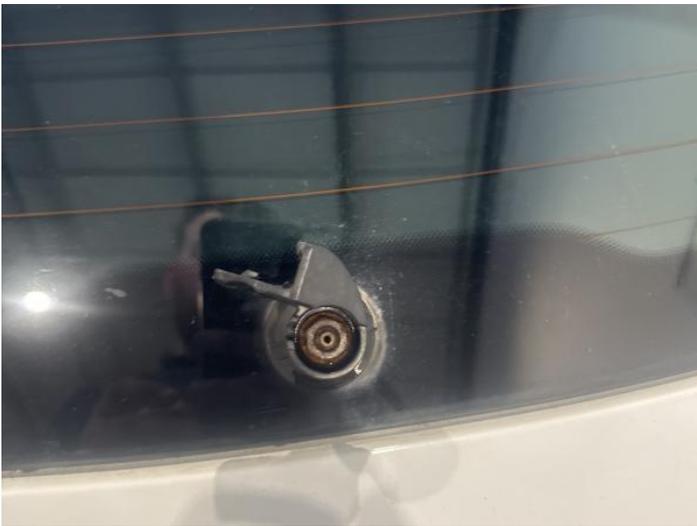
17: Wiper Rear
Broken
Replace
