# VEHICLE INSPECTION REPORT

**KN12UBW**

## Kia Sportage 2.0 CRDi KX-2 5dr

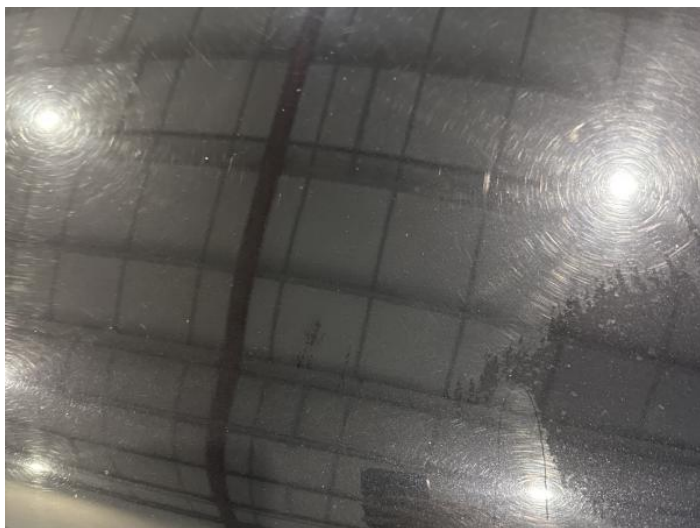
1: Bonnet  
Chipped  
Multiple Chips

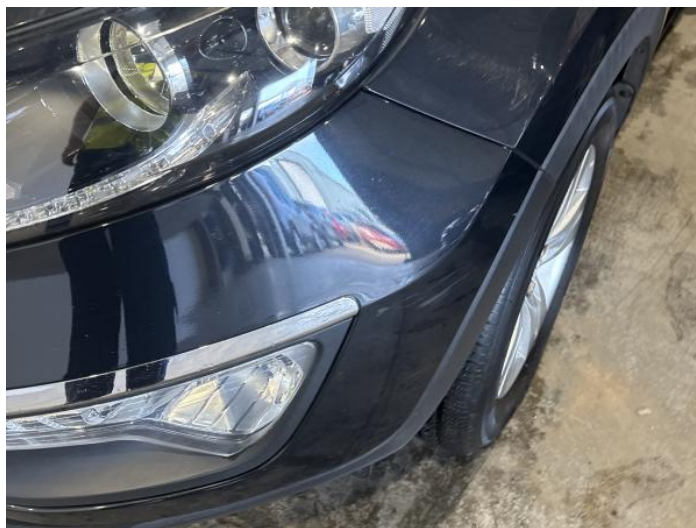
2: Bumper Front  
Scratched  
Over 100mm Thru Paint

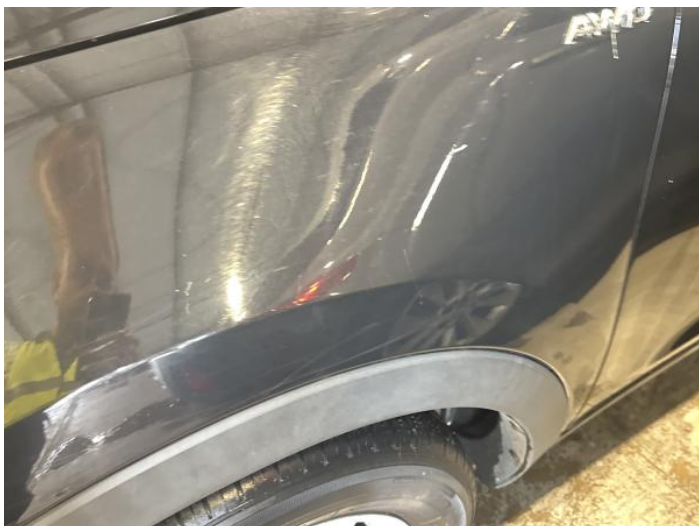
3: Wing nsf  
Scratched  
Over 25mm Thru Paint

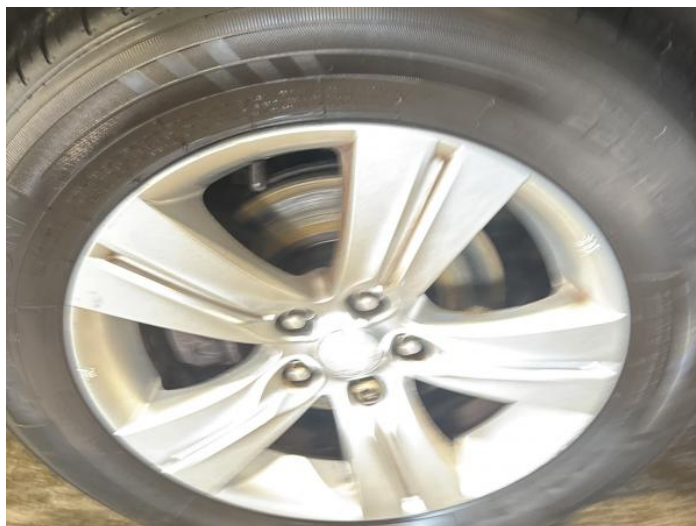
4: Wheel nsf  
Scratched  
Over 50mm

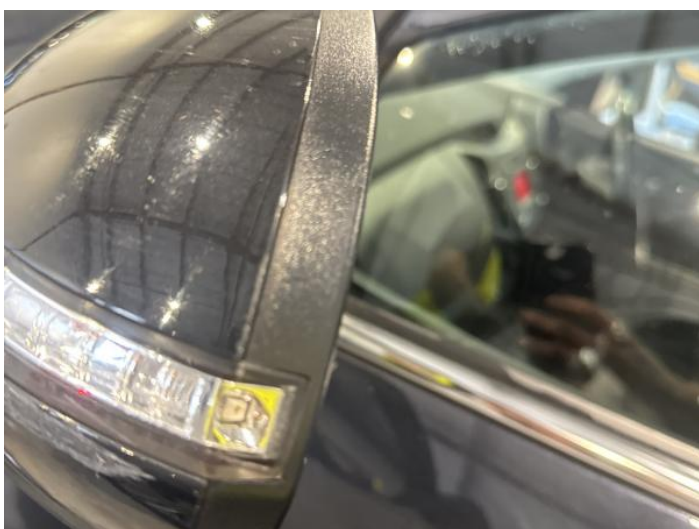
5: Door Mirror Assy nsf  
Scratched (Painted)  
Over 25mm Thru Paint

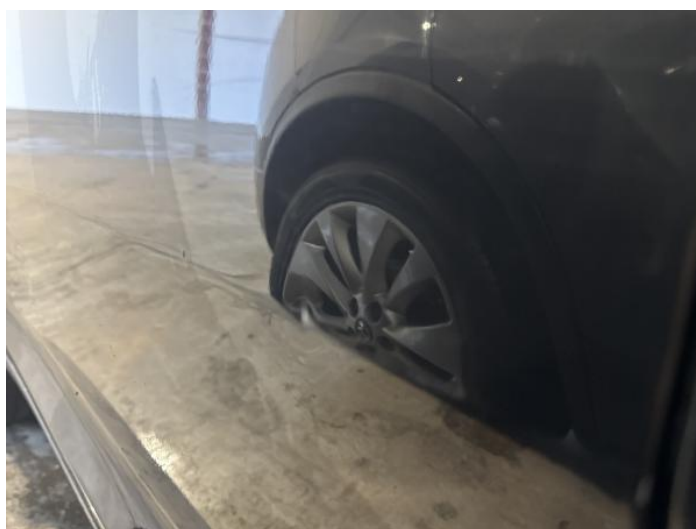
6: Door nsf  
Dented  
With Paint Damage

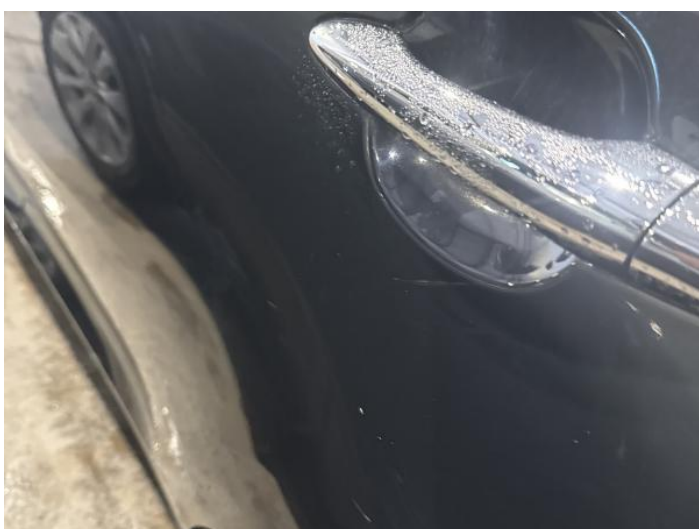
7: Door nsr  
Chipped  
1 To 5

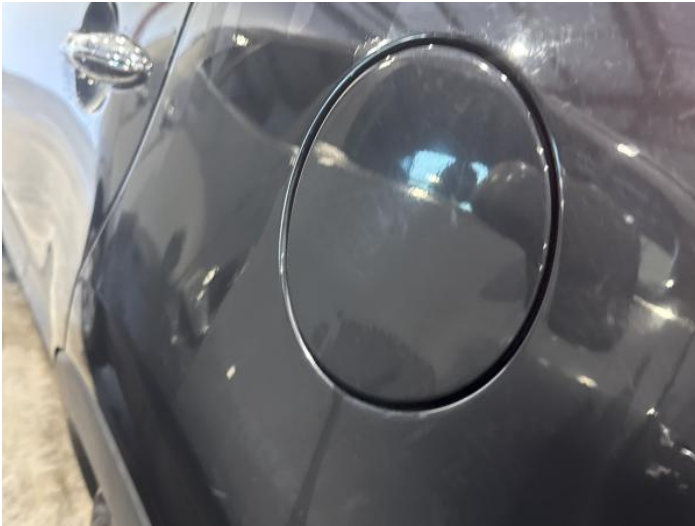
9: Qtr Panel nsr  
Chipped  
1 To 5

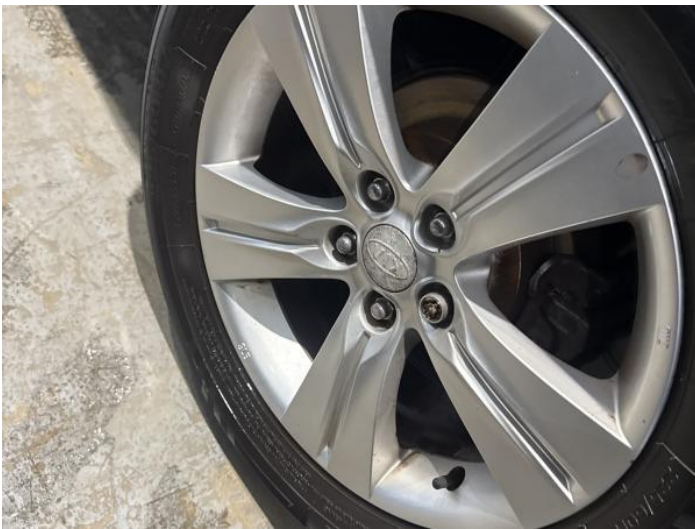
11: Wheel nsr  
Scratched  
Up To 50mm

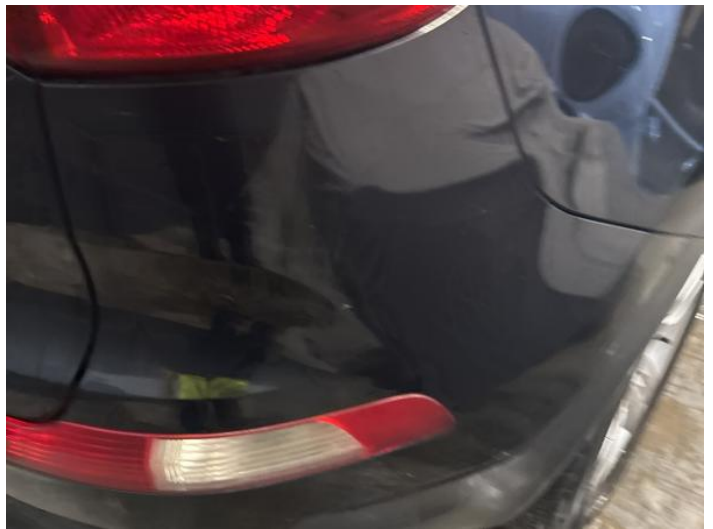
12: Bumper Rear  
Scratched  
25 to 100mm Thru Paint

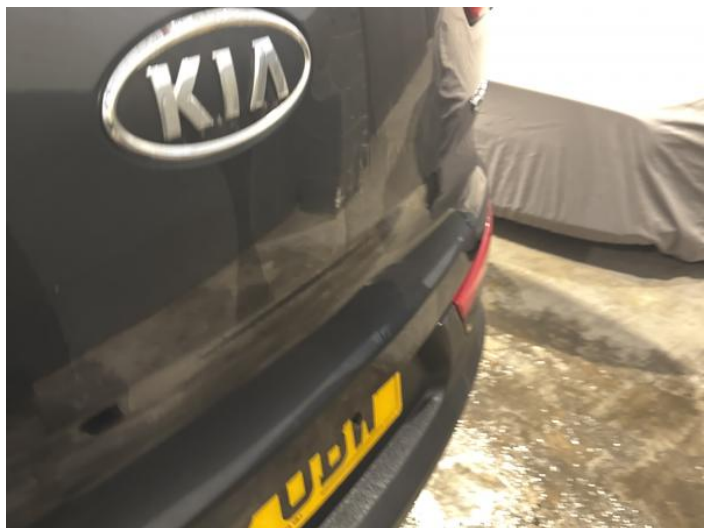
14: Boot Lid  
Dented  
Over 2 UpTo 10mm

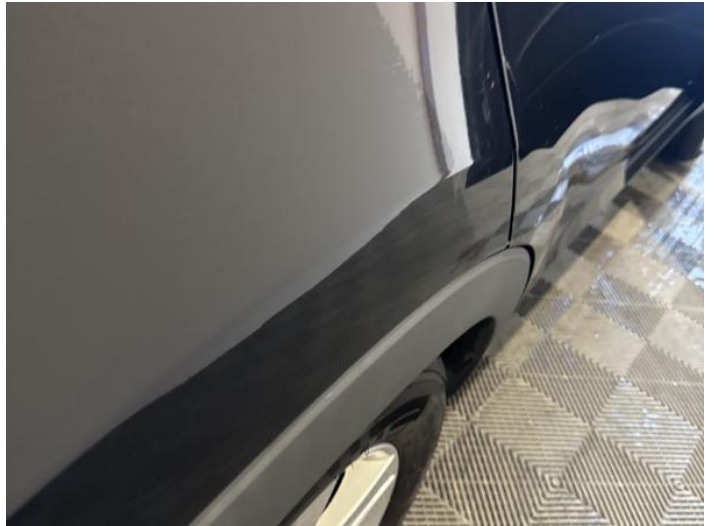
16: Qtr Panel osr  
Chipped  
1 To 5

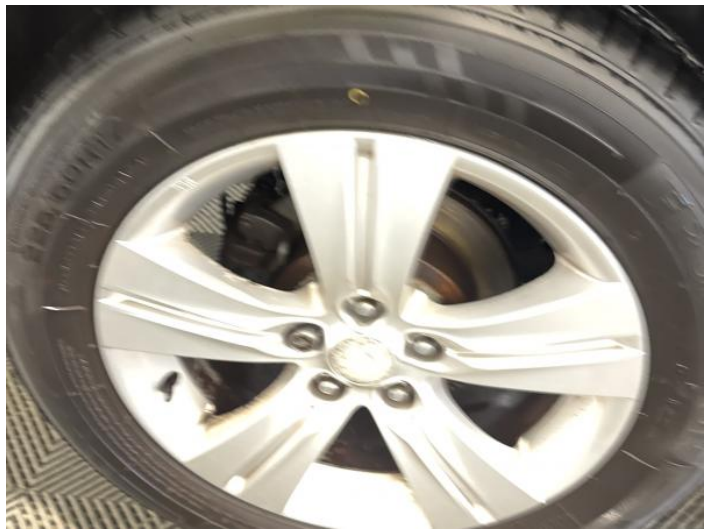
18: Wheel osr  
Scratched  
Over 50mm

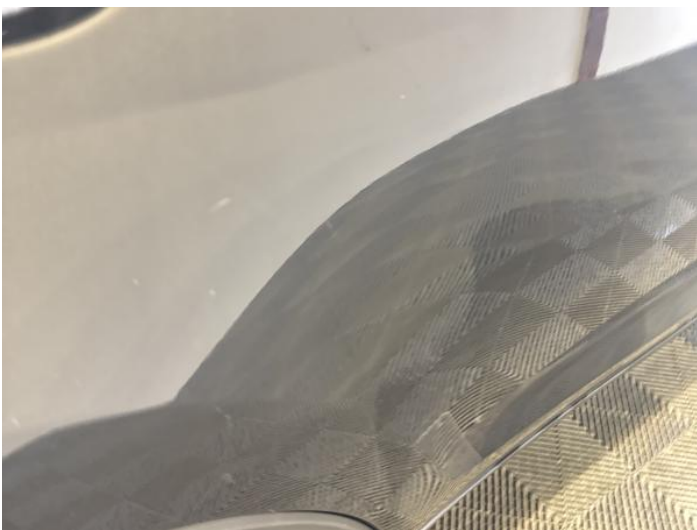
19: Door osr  
Dented  
With Paint Damage

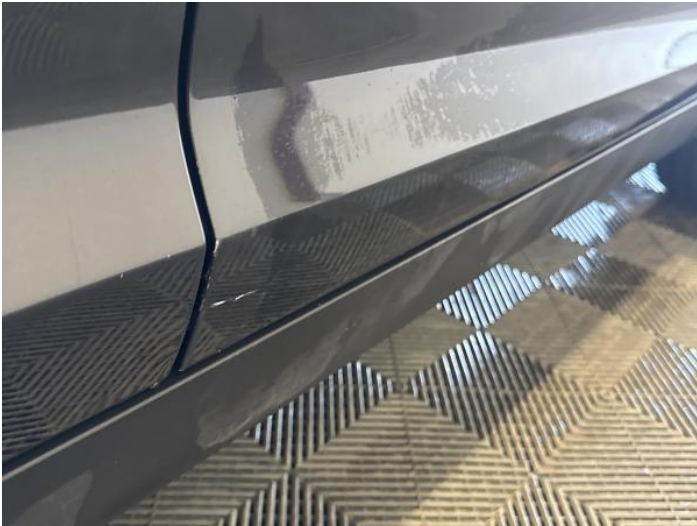
21: Door osf  
Chipped  
1 To 5

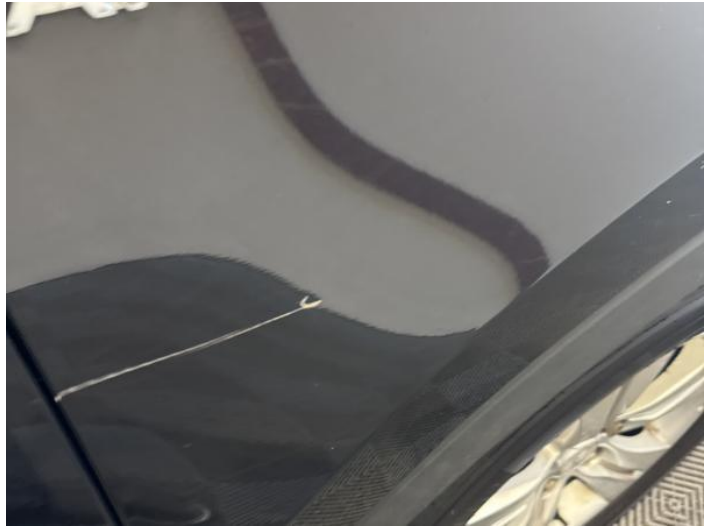
22: Wing osf  
Dented  
With Paint Damage

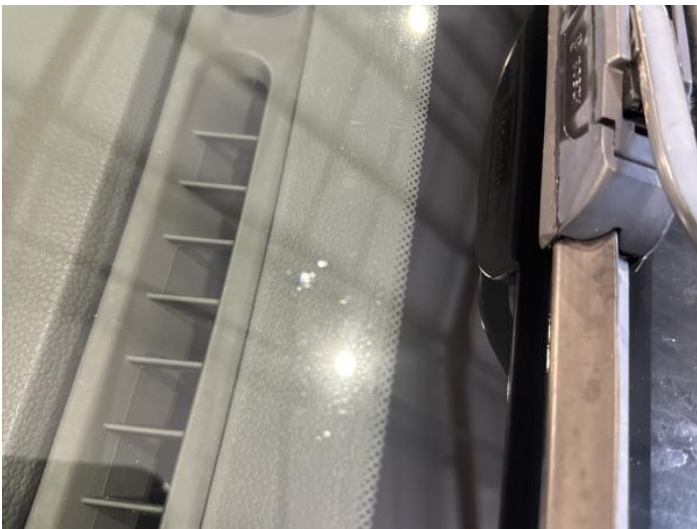
23: Screen Front  
Chipped  
UpTo 10mm

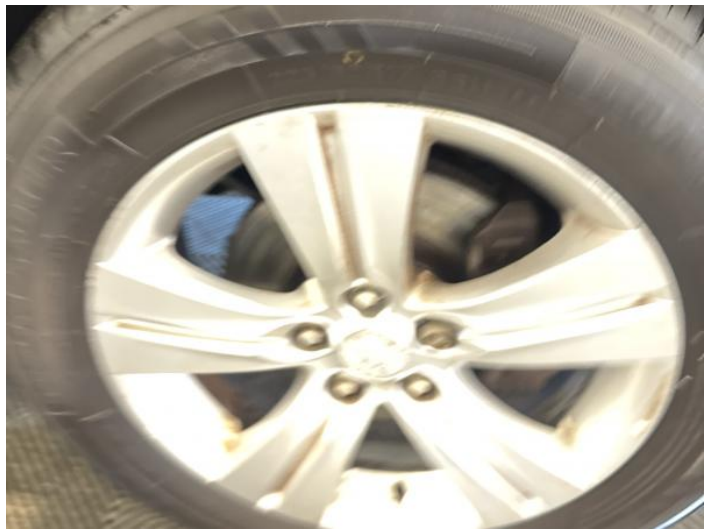
24: Wheel osf  
Scratched  
Over 50mm

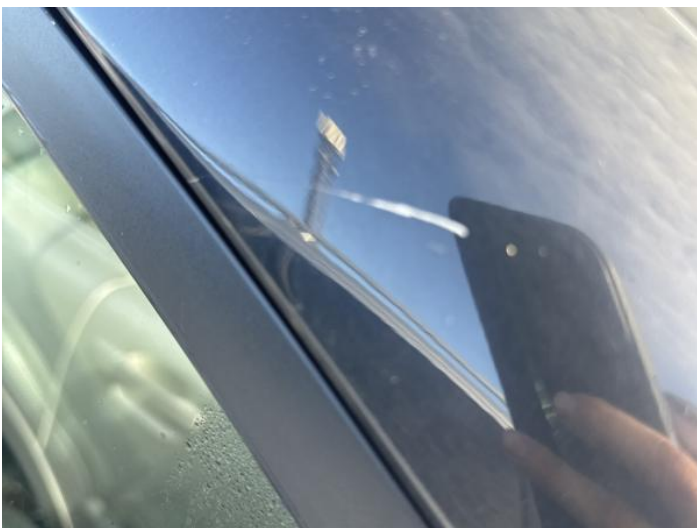
25: A Post os  
Scratched  
UpTo 25mm Thru Paint
