VEHICLE INSPECTION REPORT

GJ71MKF

BMW X5 xDrive30d MHT xLine 5dr Auto

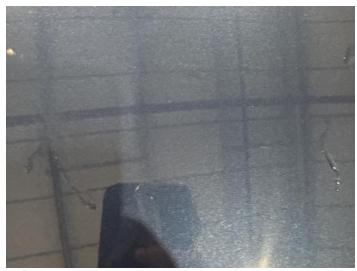
2: Bumper Front Scratched Over 25mm Not Thru Paint

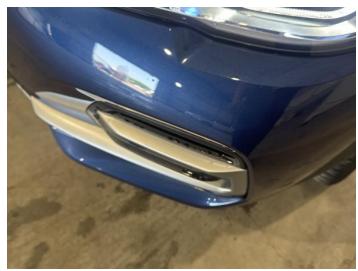
3: Bumper Front Chipped Multiple Chips

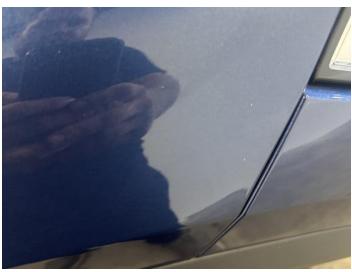
4: Wing osf Chipped 1 To 5

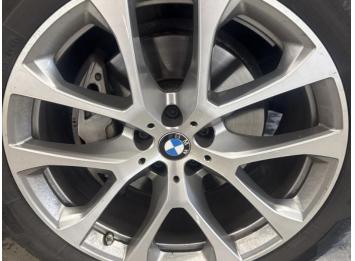
5: Wheel osf Scratched Up To 50mm

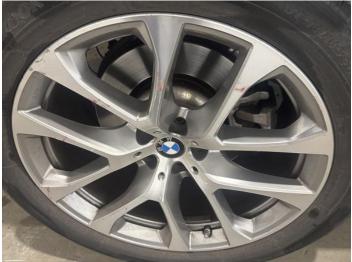
8: Wheel osr Scratched Over 50mm

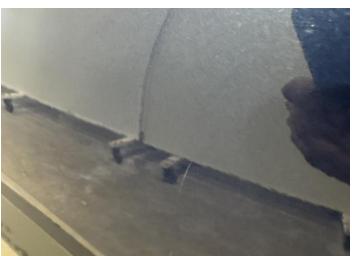
11: Qtr Panel nsr Scratched Over 25mm Thru Paint

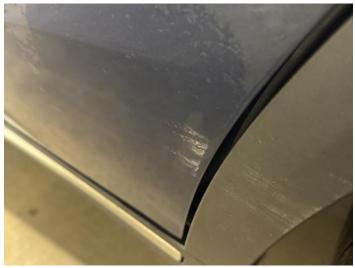
13: Door nsr Scratched Over 25mm Thru Paint

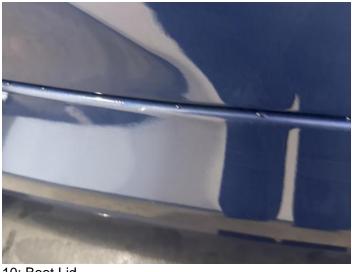
10: Boot Lid Chipped 1 To 5

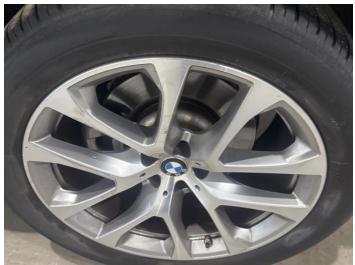
12: Wheel nsr Scratched Over 50mm

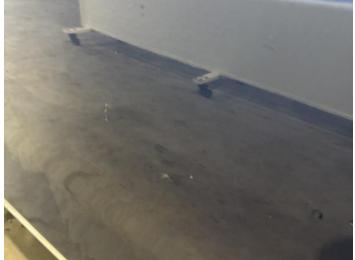
14: Door nsf Chipped 1 To 5

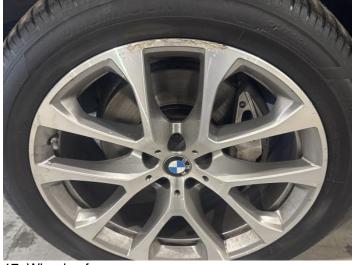
17: Wheel nsf Scratched Over 50mm
