# VEHICLE INSPECTION REPORT

**NU12SWO**

## Mini Countryman 2.0 Cooper S D 5dr

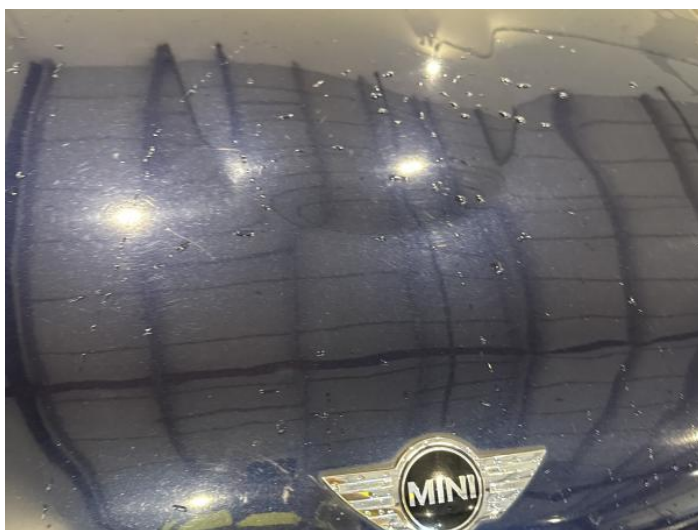
1: Bonnet  
Chipped  
Multiple Chips

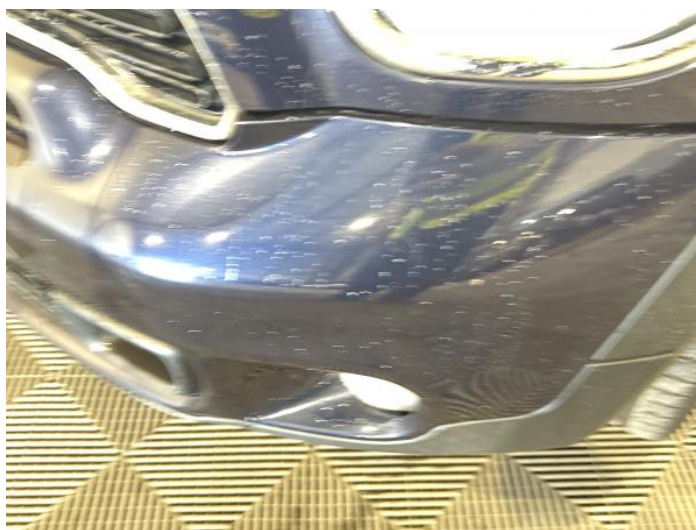
2: Bumper Front  
Scratched  
25 to 100mm Thru Paint

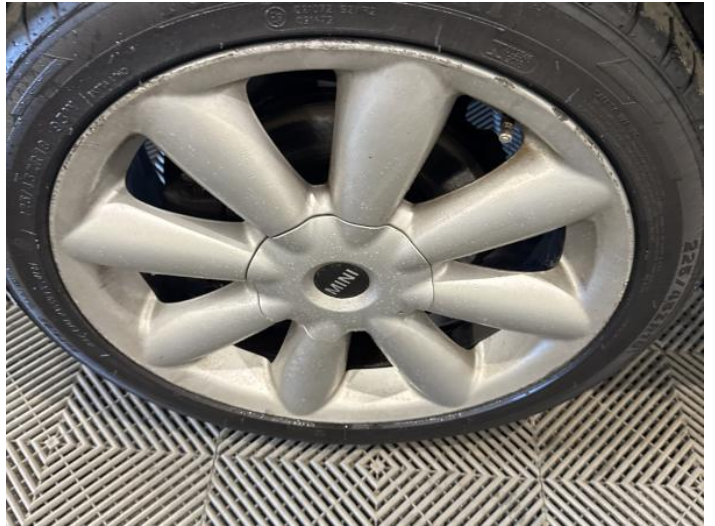
4: Wheel nsf  
Scratched  
Over 50mm

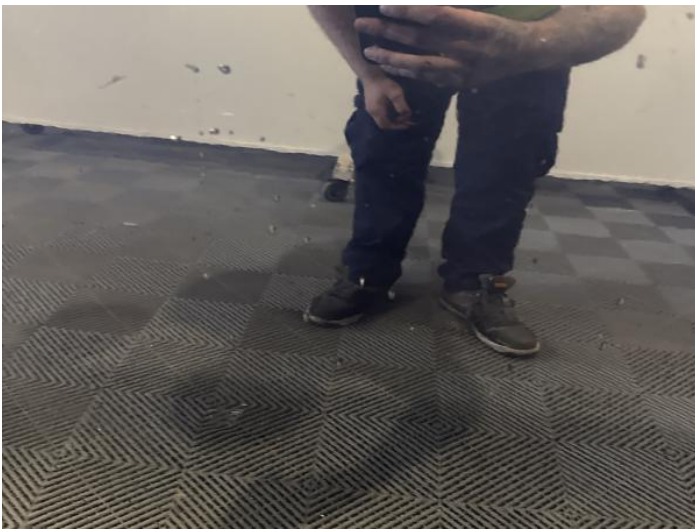
5: Door nsf  
Chipped  
1 To 5

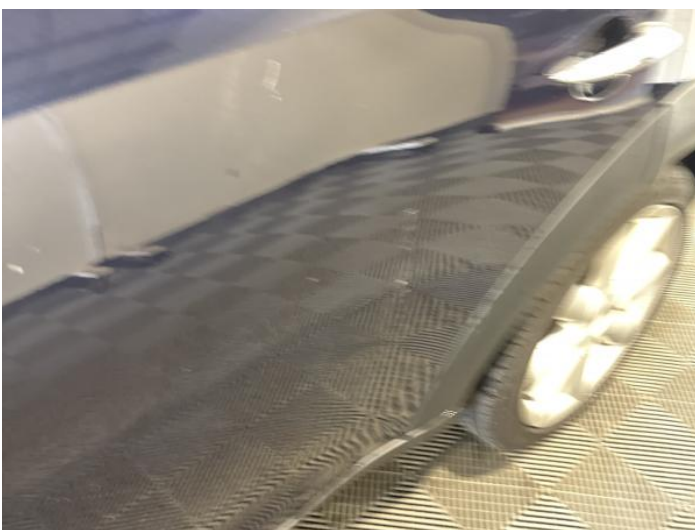
7: Door nsr  
Dented  
With Paint Damage

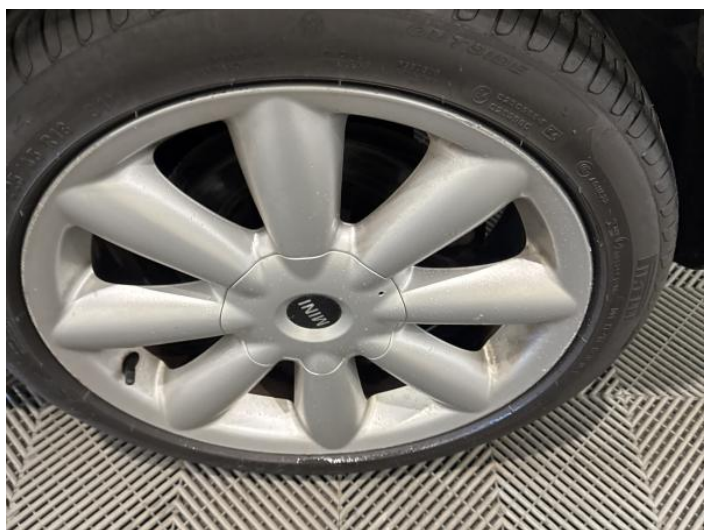
8: Wheel nsr  
Scratched  
Over 50mm

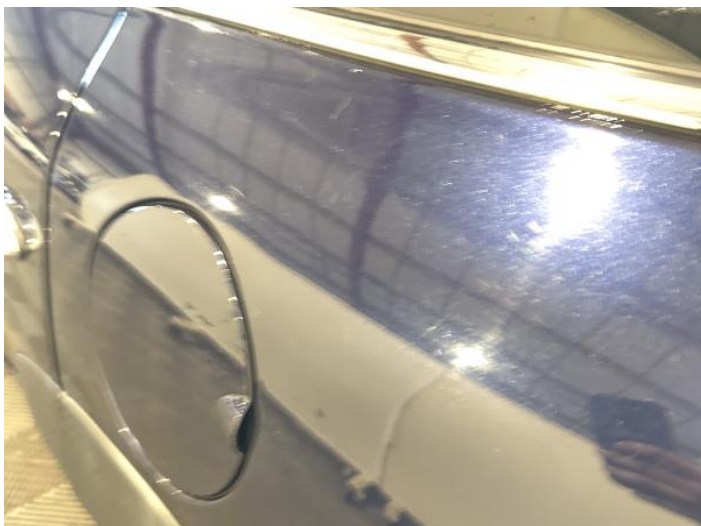
9: Qtr Panel nsr  
Dented  
Over 2 UpTo 10mm

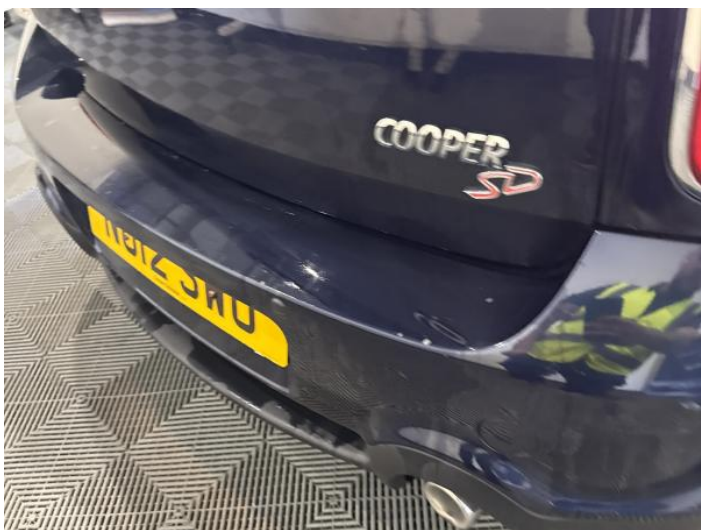
11: Bumper Rear  
Scratched  
25 to 100mm Thru Paint

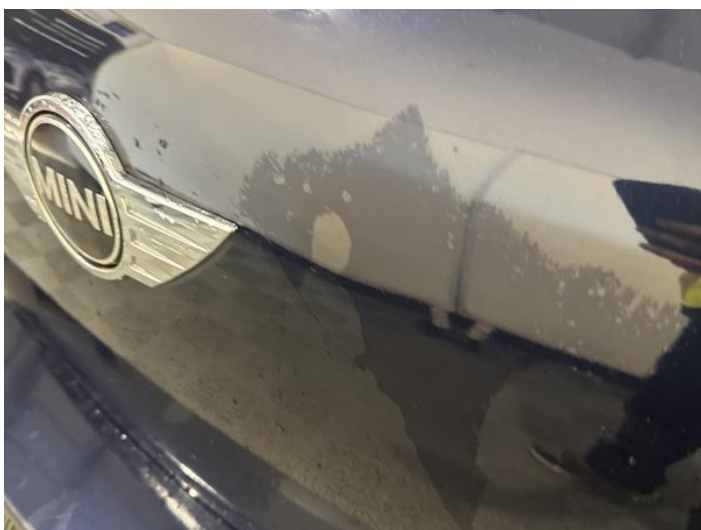
13: Boot Lid  
Dented  
Between 10mm + 30mm

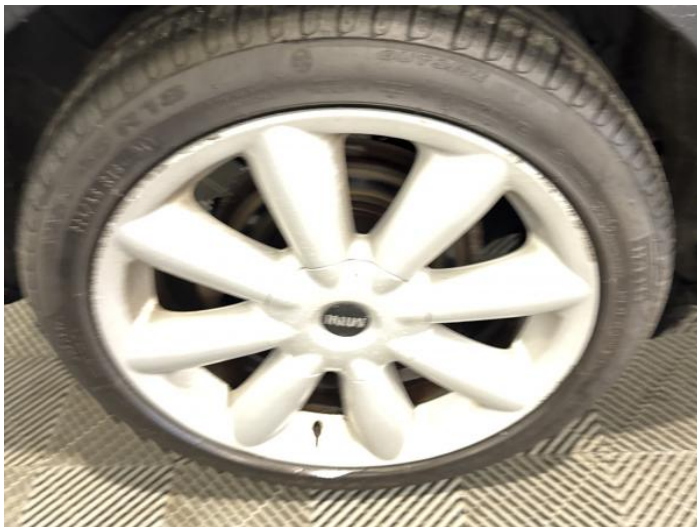
15: Wheel osr  
Scratched  
Over 50mm

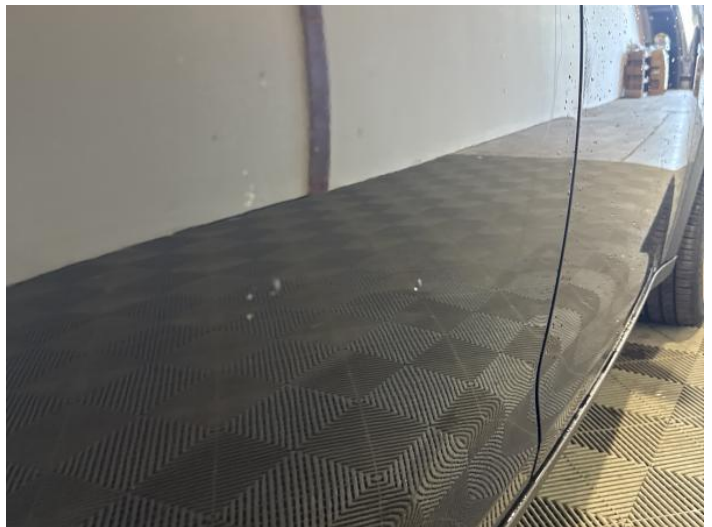
16: Door osr  
Chipped  
1 To 5

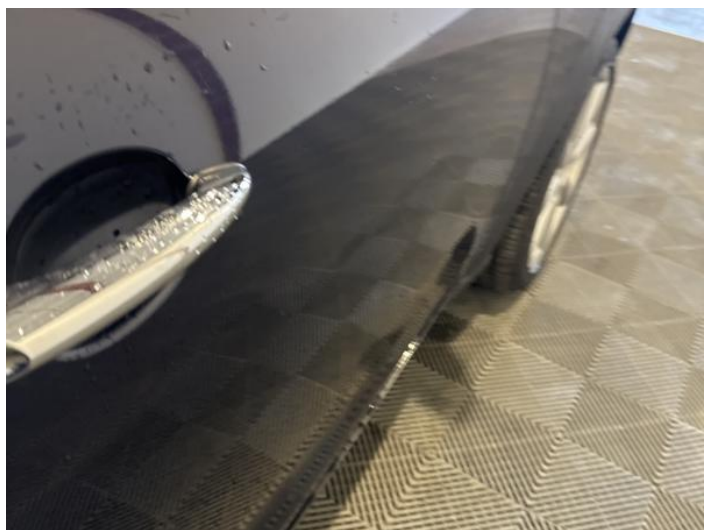
18: Door osf  
Dented  
Over 2 UpTo 10mm

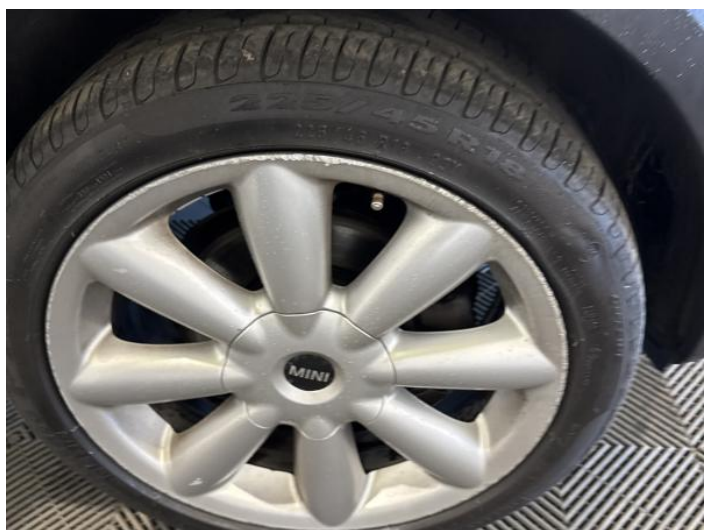
20: Wheel osf  
Scratched  
Over 50mm

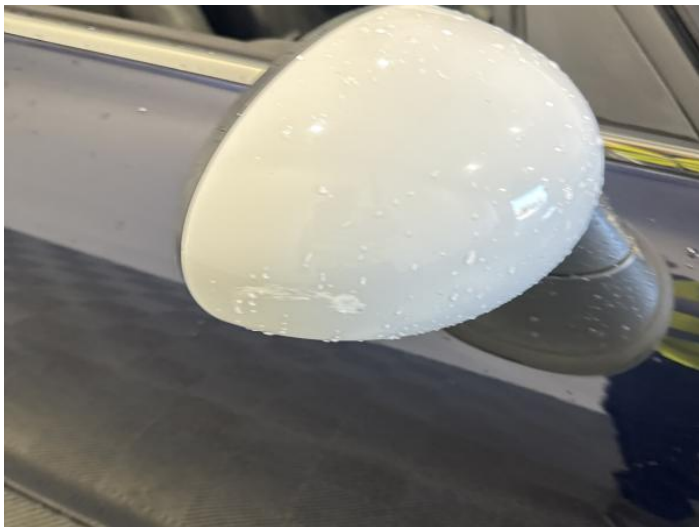
21: Door Mirror Assy osf  
 Scratched (Painted)  
 Over 25mm Thru Paint
