# VEHICLE INSPECTION REPORT

**HV66YKS**

## Kia Sportage 1.6 GDi 1 5dr

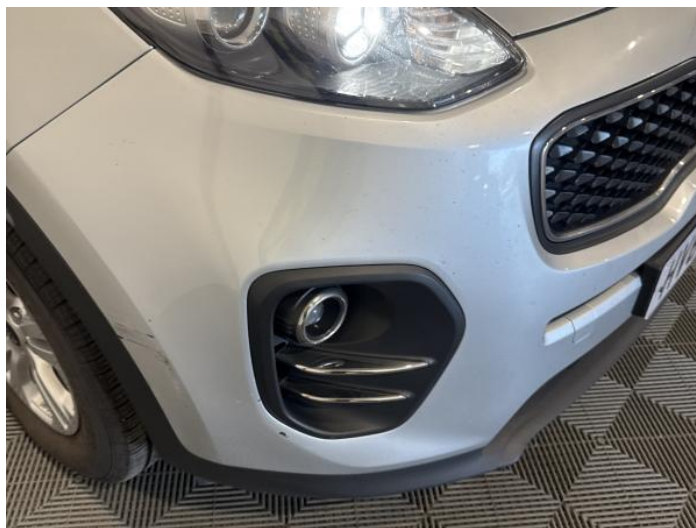
2: Bumper Front  
Scratched  
Over 100mm Thru Paint

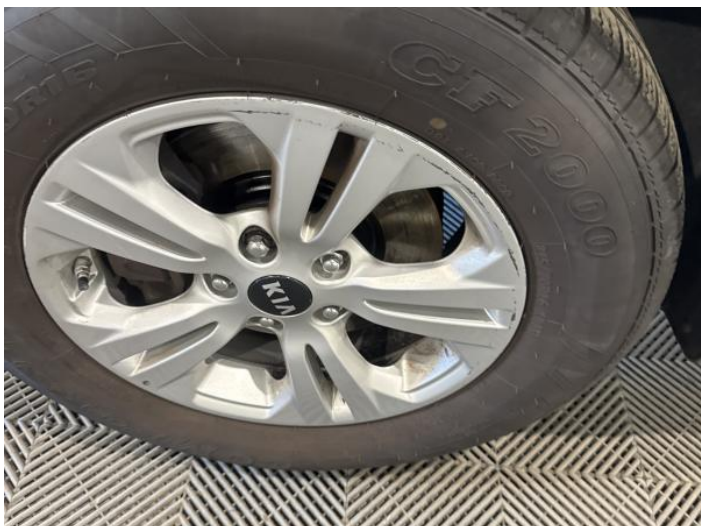
3: Wheel nsf  
Scratched  
Over 50mm

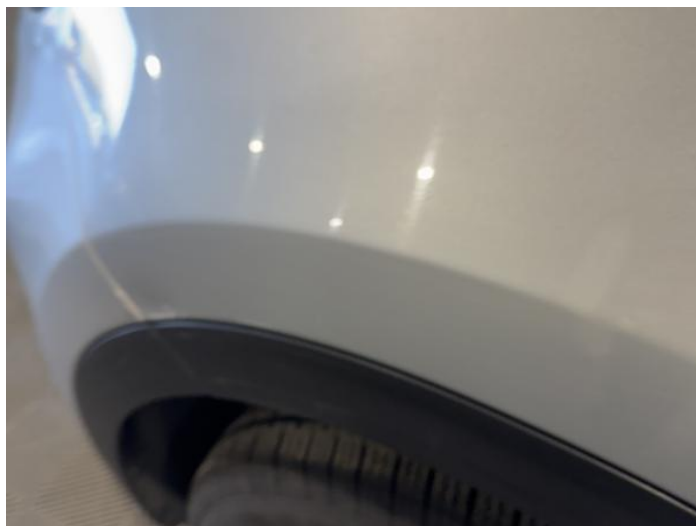
4: Wing nsf  
Dented  
With Paint Damage

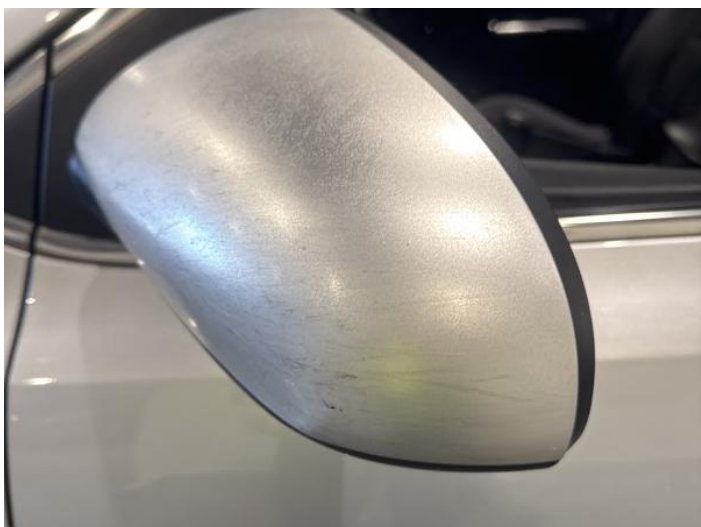
5: Door Mirror Assy nsf  
Scratched (Painted)  
Over 25mm Thru Paint

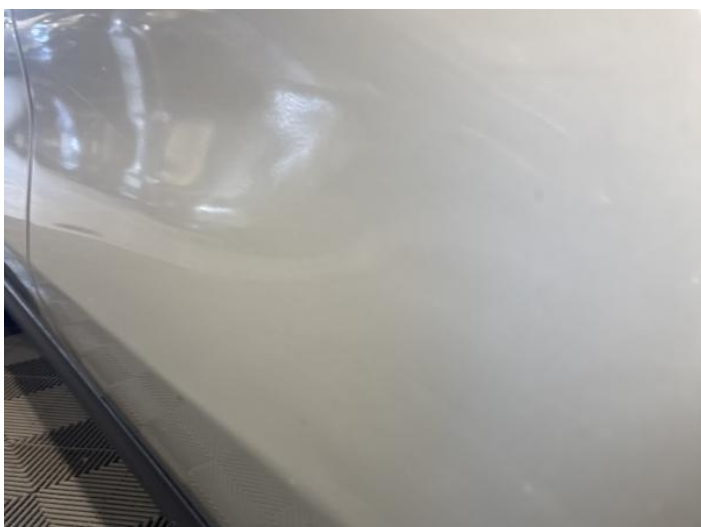
7: Door nsr  
Dented  
With Paint Damage

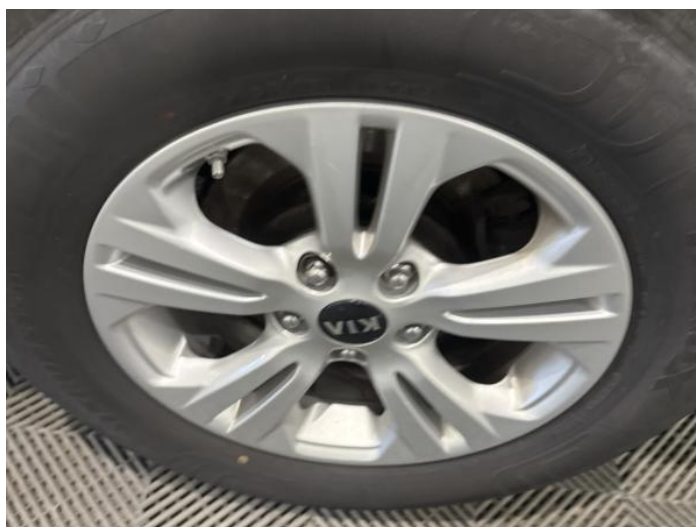
8: Wheel nsr  
Scratched  
Over 50mm

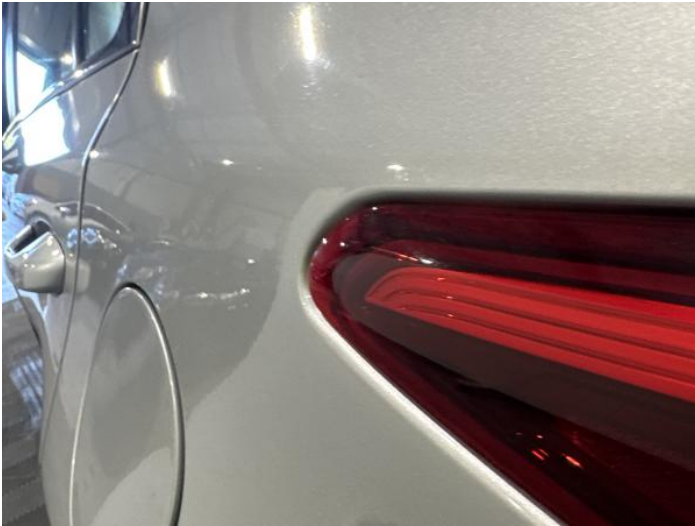
9: Qtr Panel nsr  
Poor Previous Repair  
Poor Paint

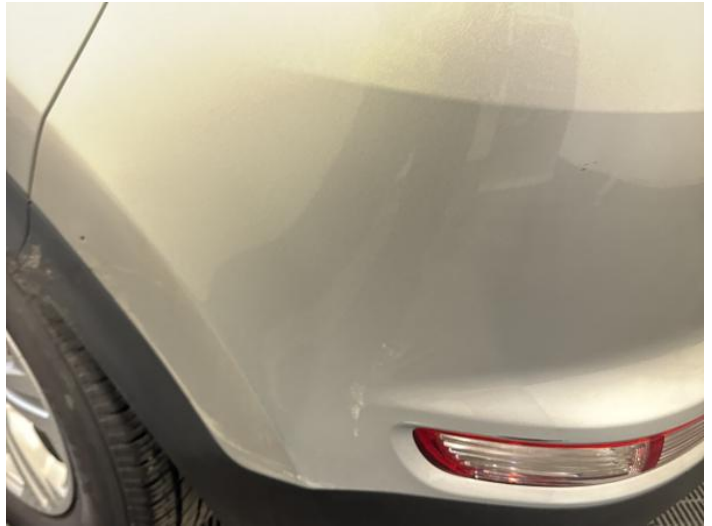
10: Bumper Rear  
Scratched  
Over 100mm Thru Paint

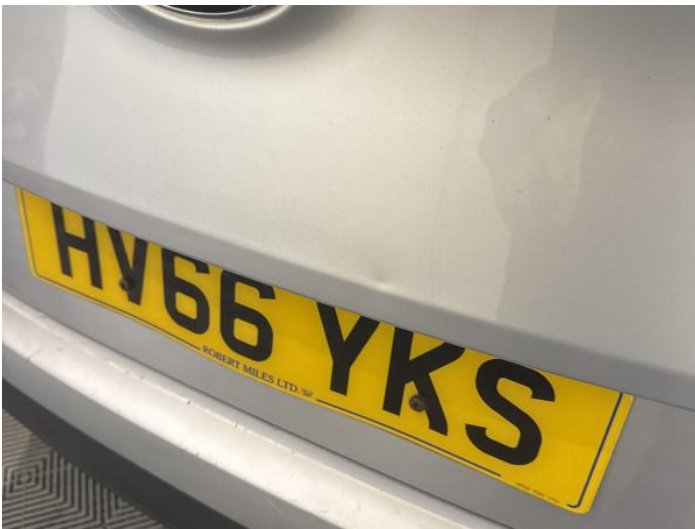
11: Boot Lid  
Dented  
Over 30mm

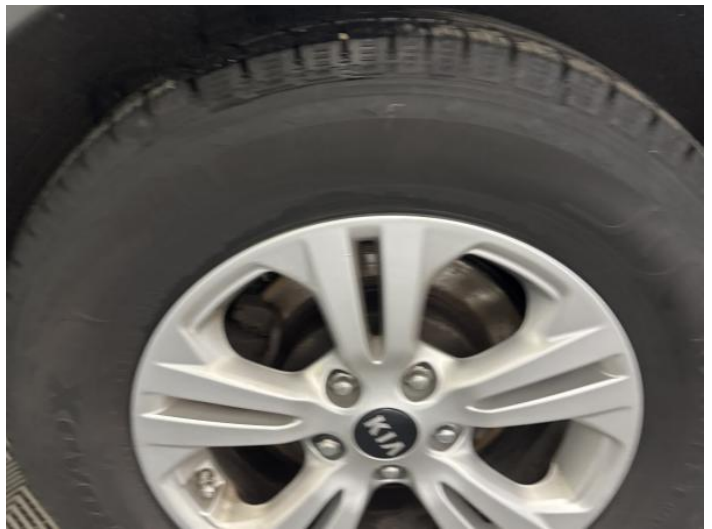
12: Wheel osr  
Scratched  
Up To 50mm

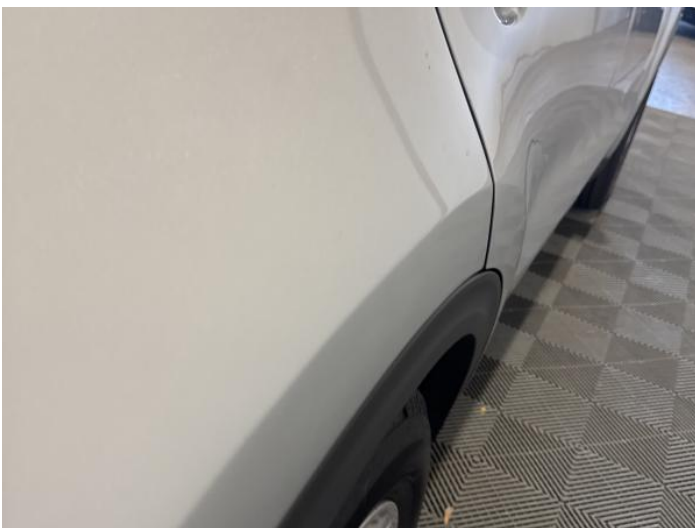
13: Qtr Panel osr  
Chipped  
1 To 5

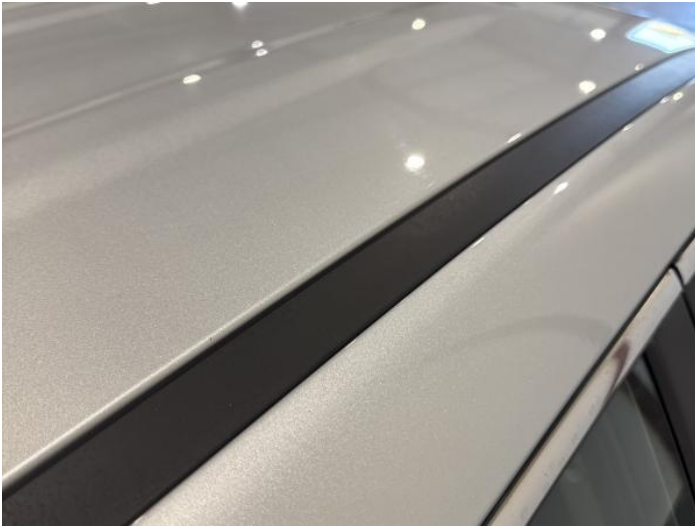
15: Roof  
Dented  
Over 30mm

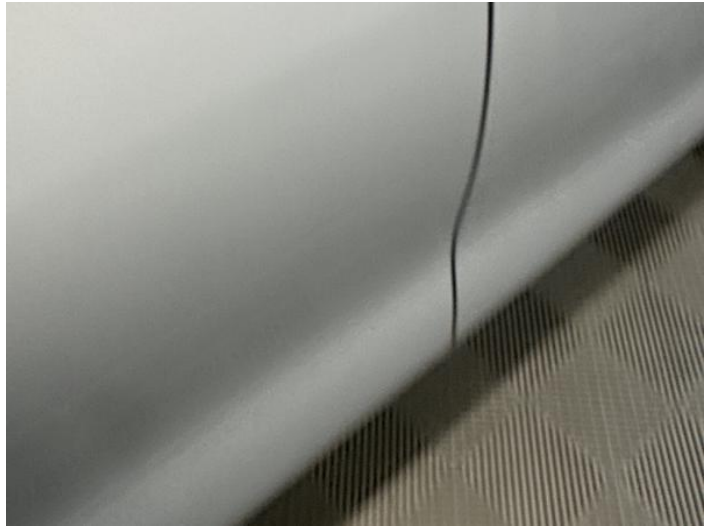
16: Door osr  
Poor Previous Repair  
Poor Paint

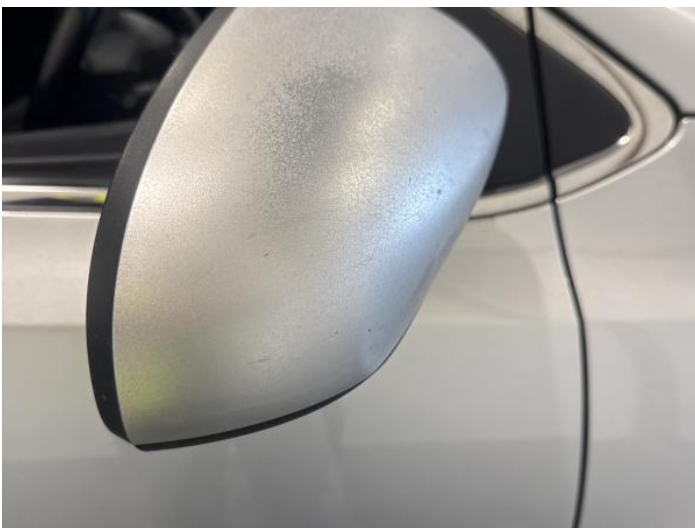
19: Door Mirror Assy osf  
Scratched (Painted)  
Over 25mm Thru Paint

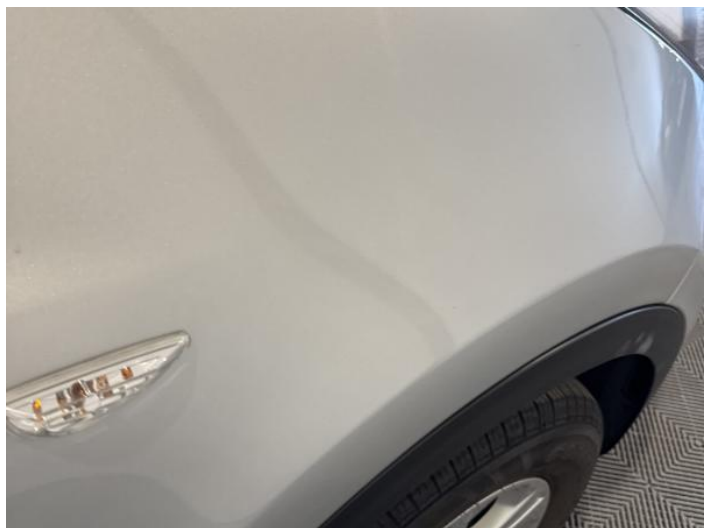
20: Wing osf  
Dented  
Over 2 UpTo 10mm

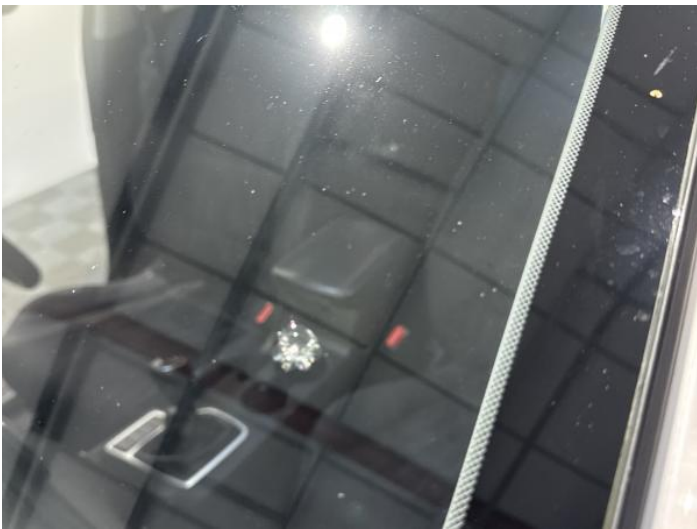
23: Screen Front  
Chipped  
Over 10mm
