# VEHICLE INSPECTION REPORT

**GJ63EOV**

## Hyundai IX35 1.7 CRDi SE 5dr 2WD

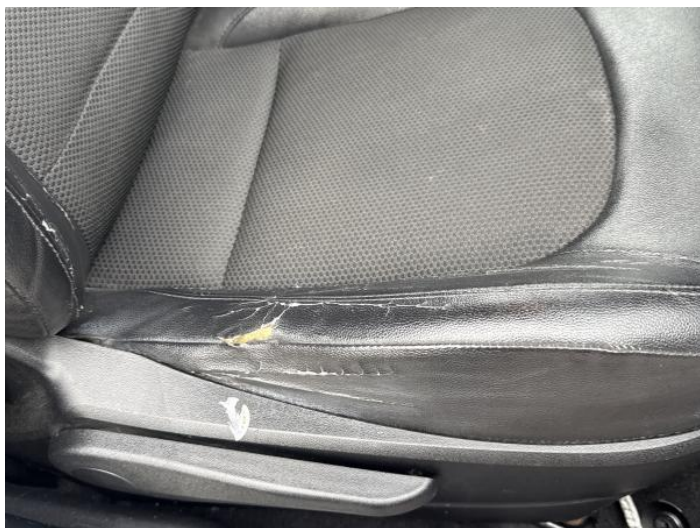
1: Seat Base Cover osf  
Scuffed  
Over 25mm

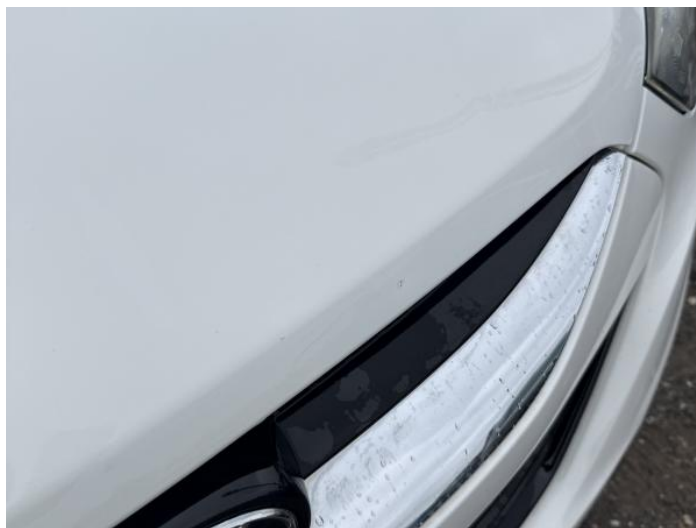
2: Bonnet  
Chipped  
Over 5mm

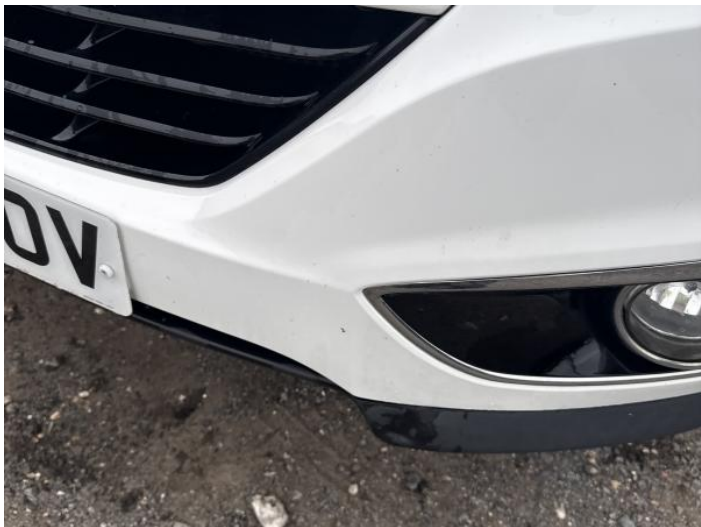
3: Bumper Front  
Chipped  
Multiple Chips

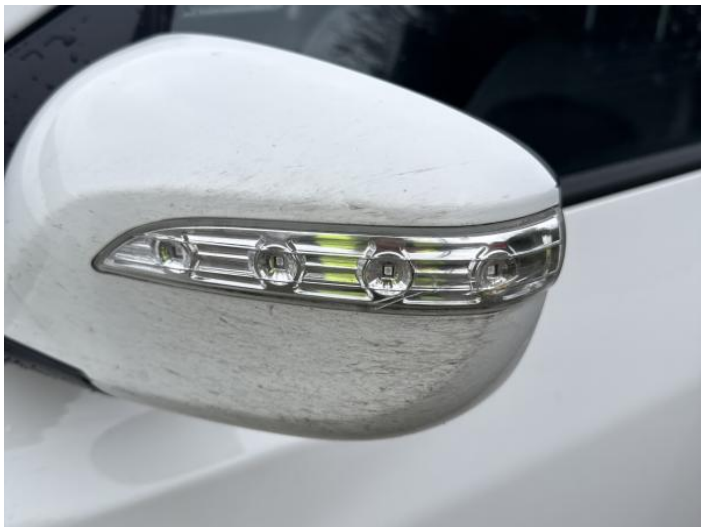
5: Door Mirror Assy nsf  
Scratched (Painted)  
Over 25mm Thru Paint

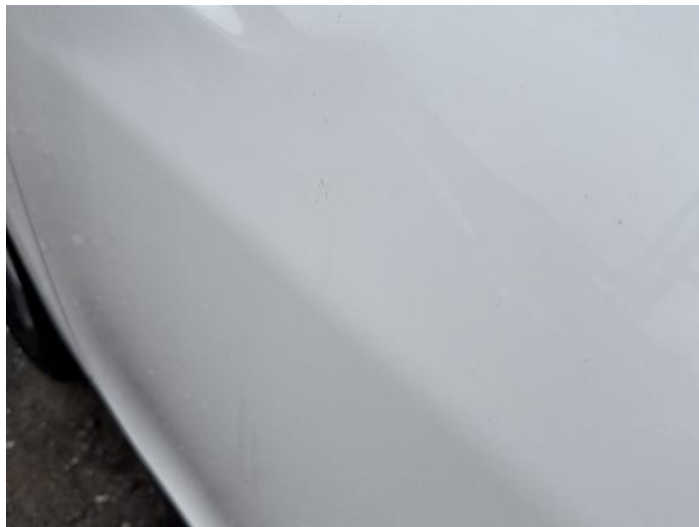
6: Door nsf  
Chipped  
1 To 5

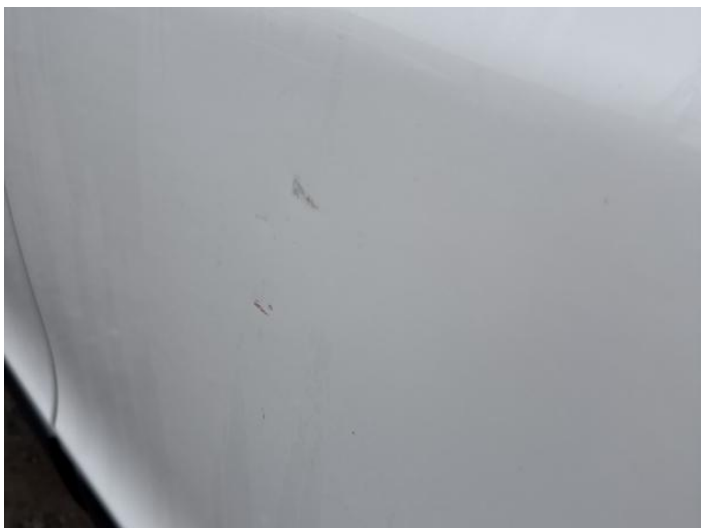
7: Door nsr  
Dented  
Between 10mm + 30mm

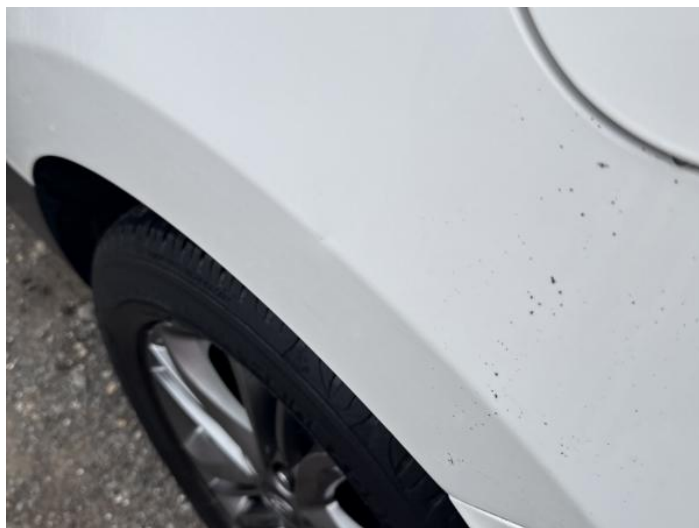
8: Qtr Panel nsr  
Dented  
Between 10mm + 30mm

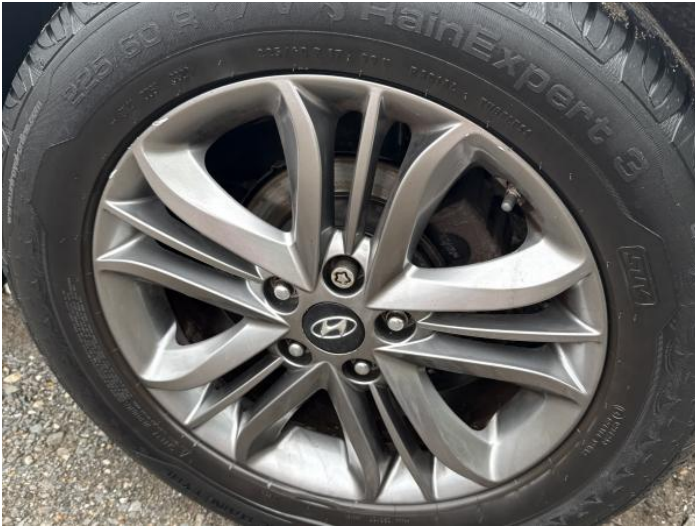
9: Wheel nsr  
Scratched  
Over 50mm

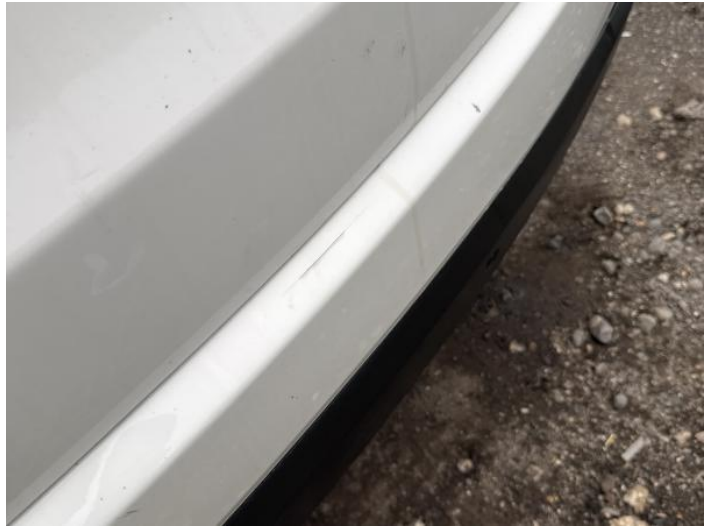
10: Bumper Rear  
Dented  
With Paint Damage

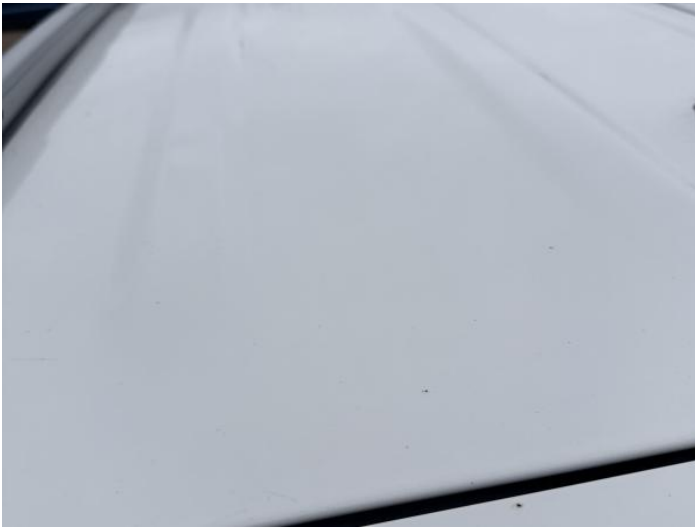
11: Roof  
Dented  
Over 30mm

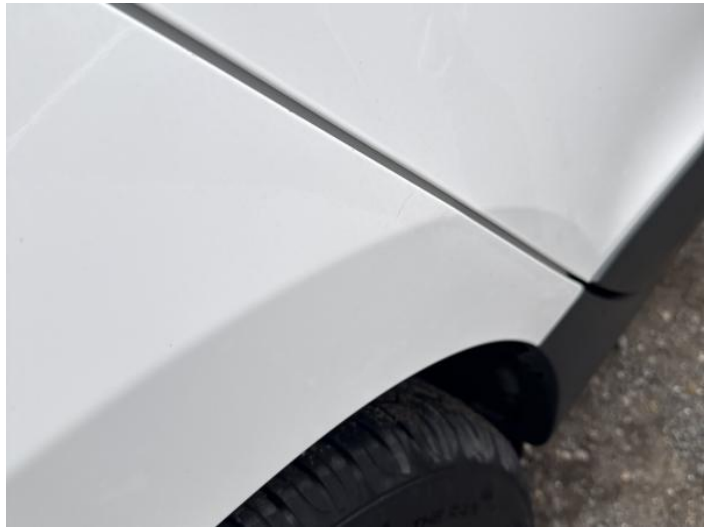
12: Qtr Panel osr  
Dented  
2 Or Less UpTo 10mm

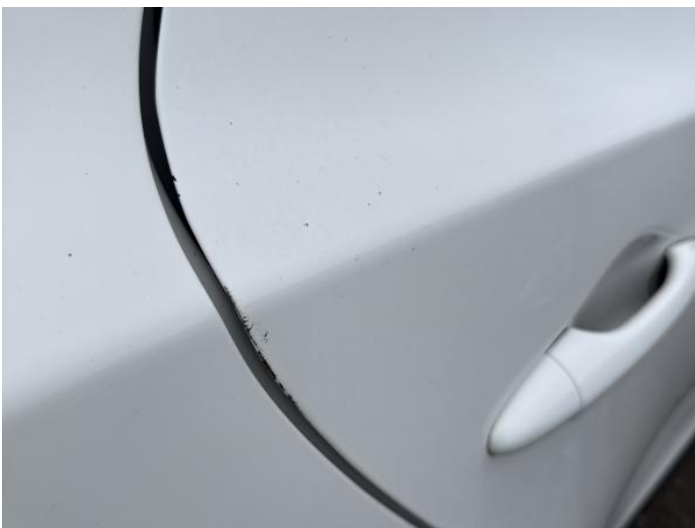
13: Door osr  
Chipped  
Edge Chip

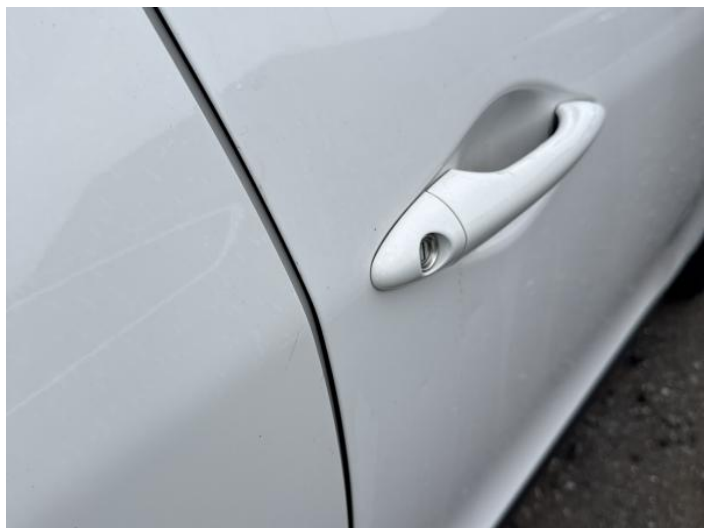
14: Door osf  
Chipped  
Edge Chip

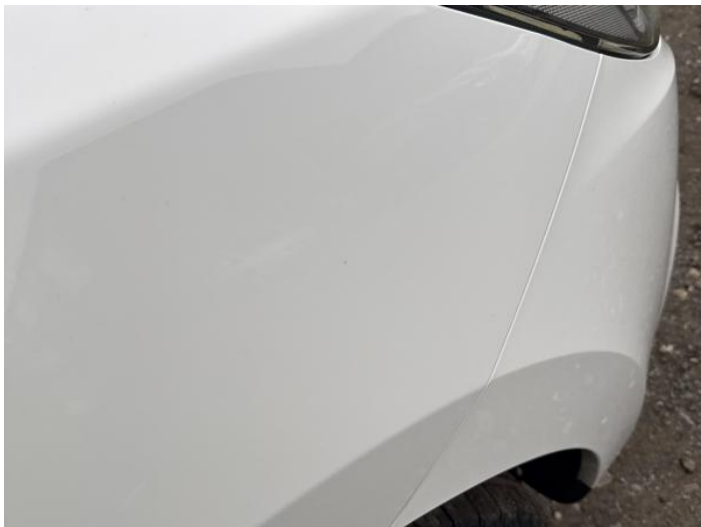
15: Wing osf  
Chipped  
1 To 5
