# VEHICLE INSPECTION REPORT

**KM15VPT**

## Vauxhall Mokka 1.4T SE 5dr

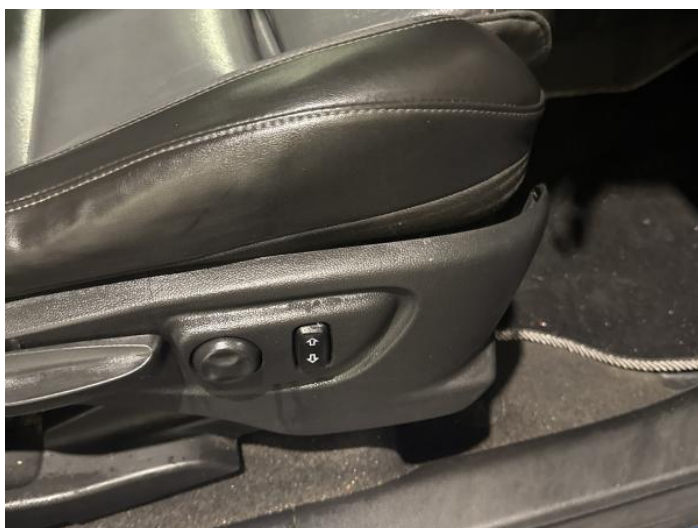
1: Fascia Trim  
Damaged  
Replace

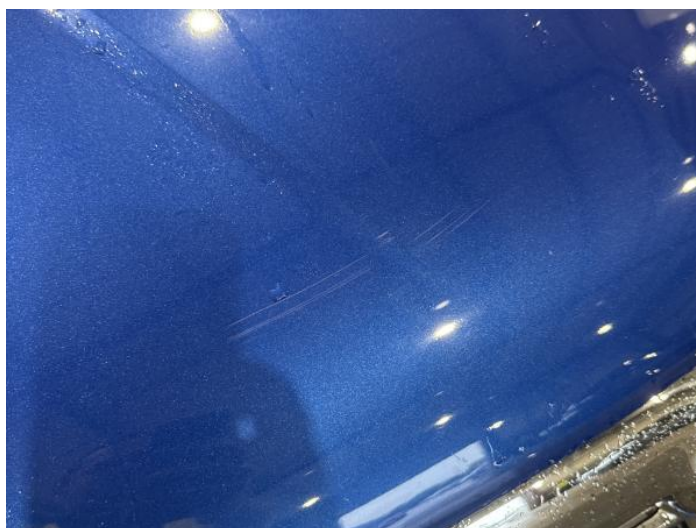
2: Bonnet  
Scratched  
Over 25mm Thru Paint

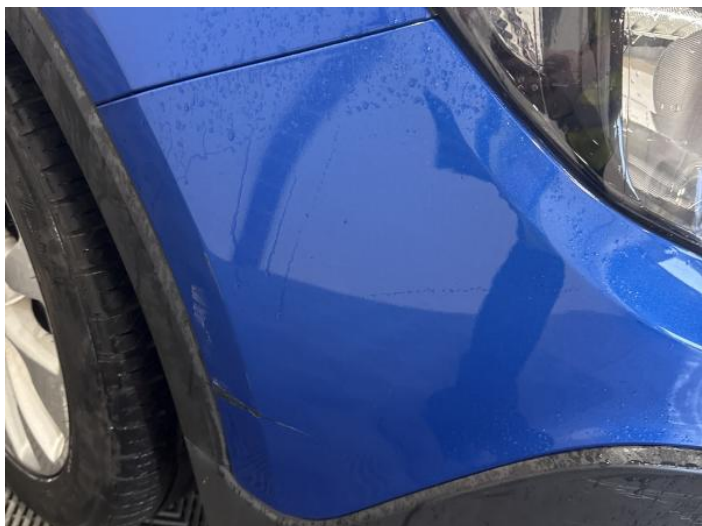
3: Bumper Front  
Scratched  
Over 100mm Thru Paint

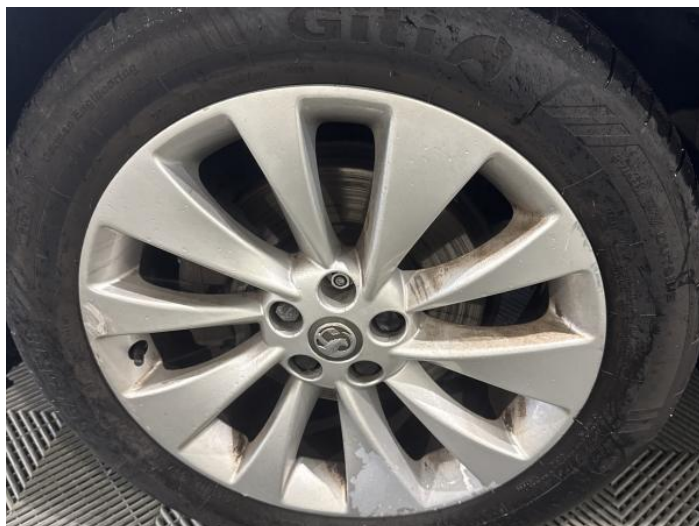
4: Wheel nsf  
Scratched  
Over 50mm

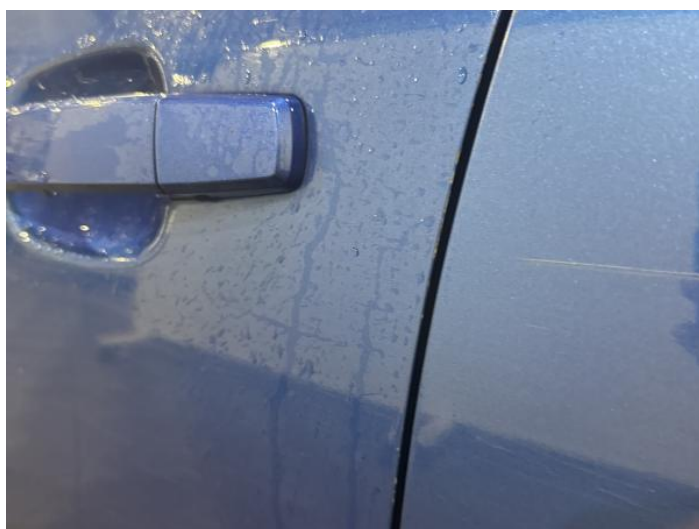
6: Door nsf  
Chipped  
Edge Chip

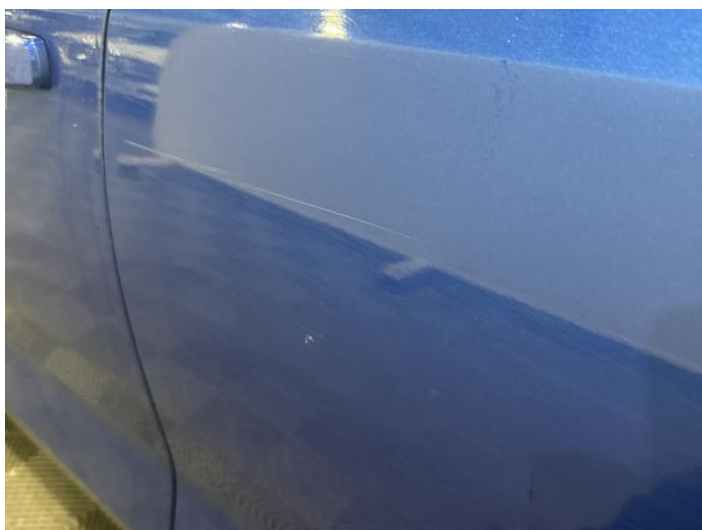
7: Door nsr  
Scratched  
Over 25mm Thru Paint

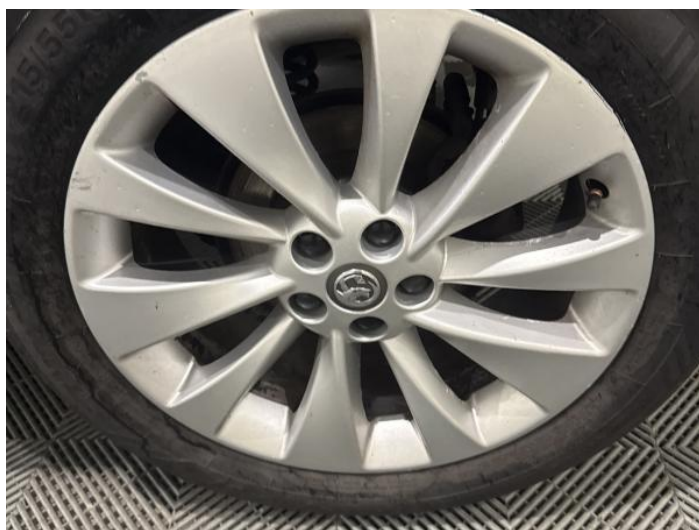
8: Wheel nsr  
Scratched  
Over 50mm

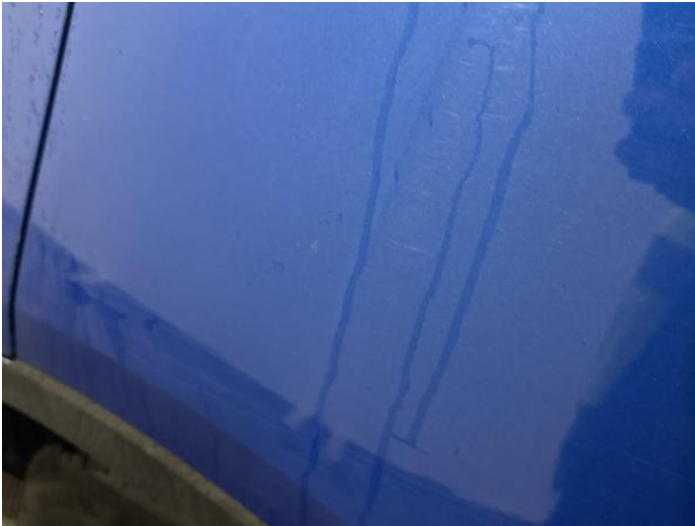
9: Qtr Panel nsr  
Scratched  
UpTo 25mm Thru Paint

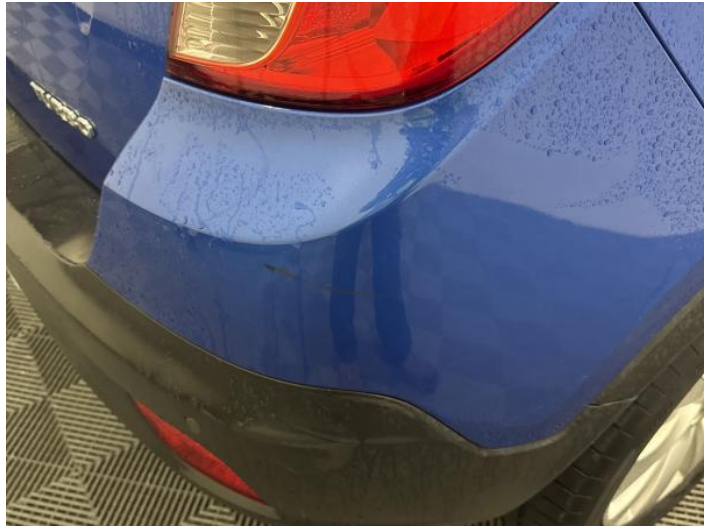
10: Bumper Rear  
Scratched  
25 to 100mm Thru Paint

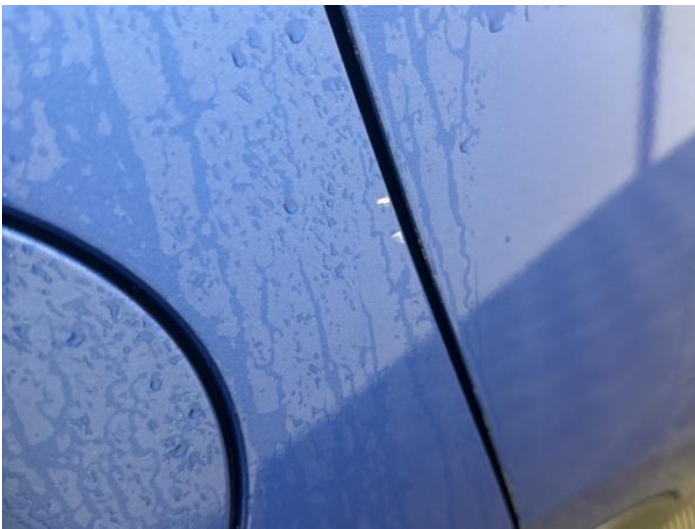
11: Qtr Panel osr  
Chipped  
1 To 5

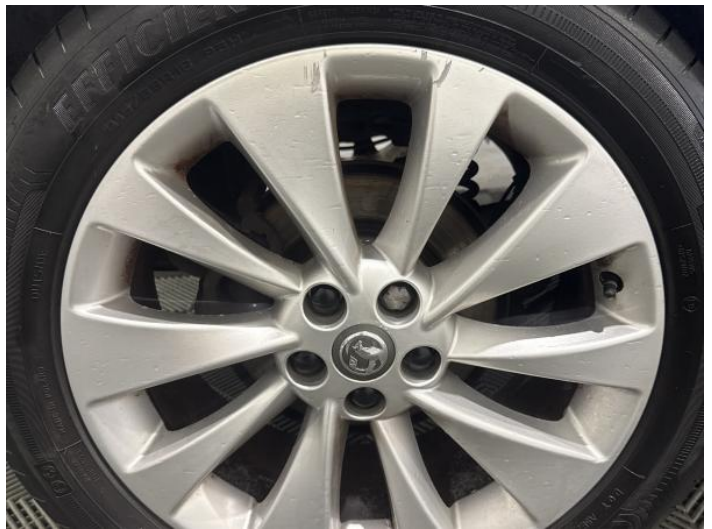
12: Wheel osr  
Scratched  
Over 50mm

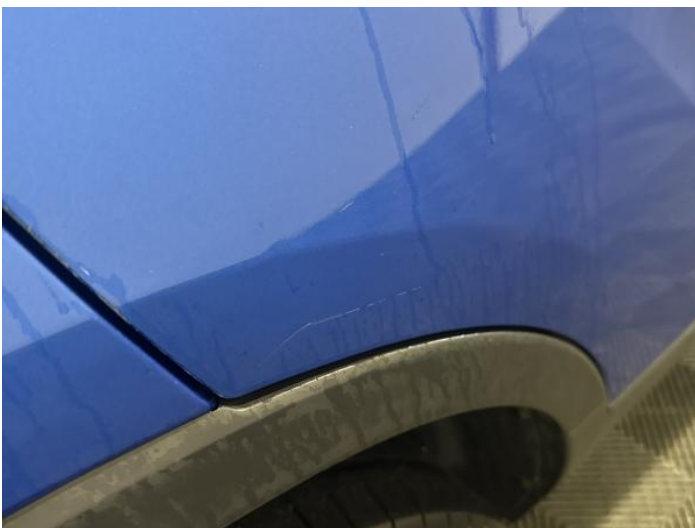
13: Door osr  
Scratched  
Over 25mm Thru Paint

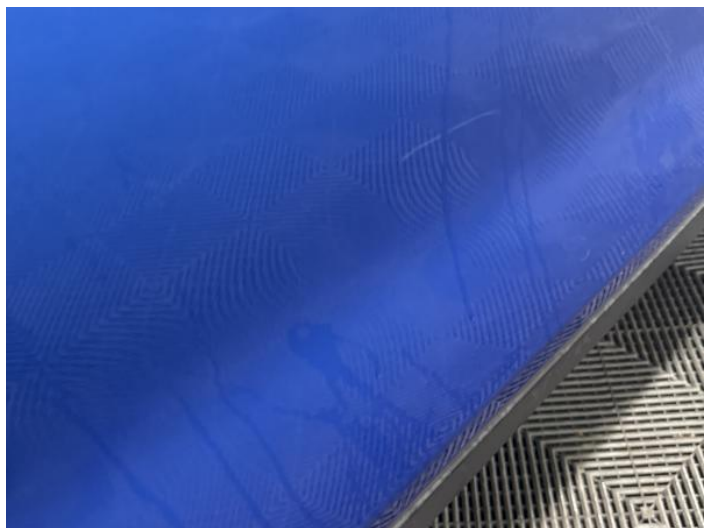
14: Door osf  
Scratched  
Over 25mm Thru Paint

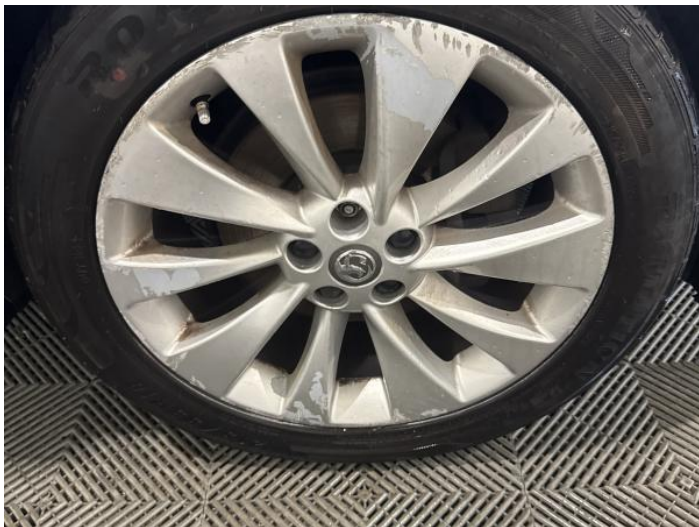
15: Wheel osf  
Scratched  
Over 50mm

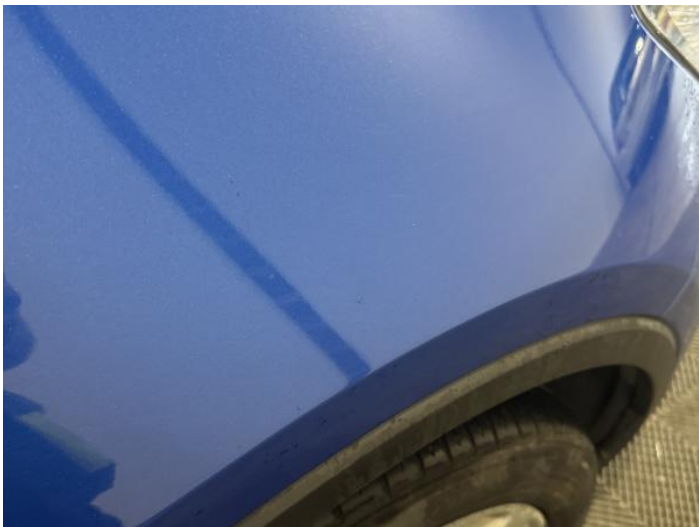
16: Wing osf  
Scratched  
UpTo 25mm Thru Paint

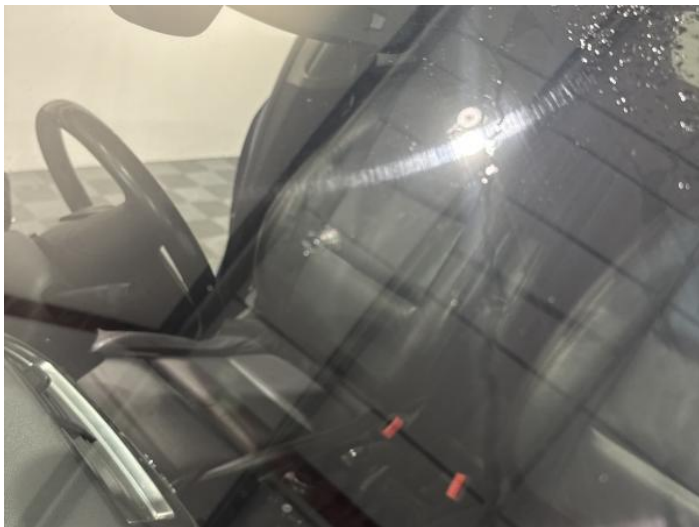
17: Screen Front  
Chipped  
UpTo 10mm
