# VEHICLE INSPECTION REPORT

**LN15LDJ**

## Ford Fiesta 1.0 EcoBoost 125 Titanium 5dr

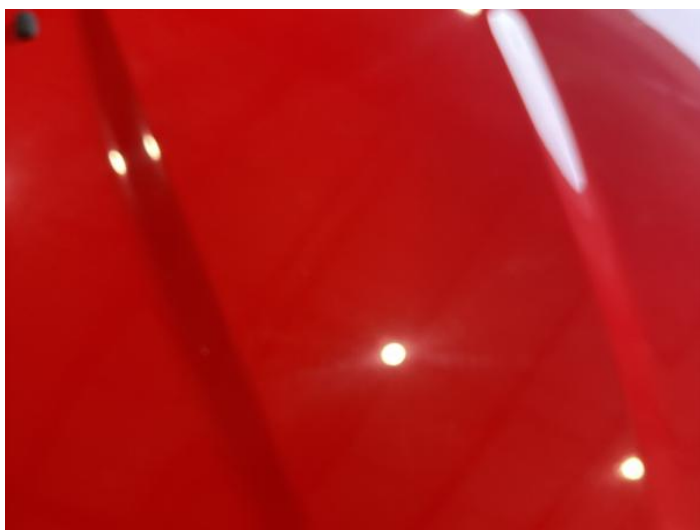
1: Bonnet  
Chipped  
1 To 5

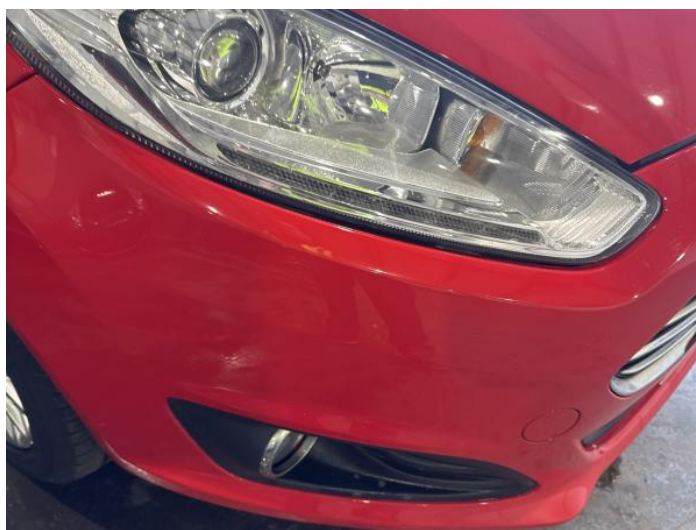
2: Bumper Front  
Scratched  
Over 100mm Thru Paint

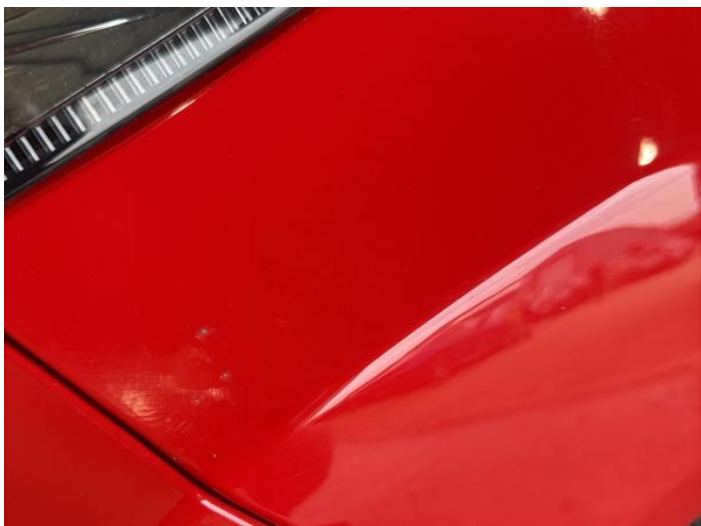
3: Wing nsf  
Chipped  
1 To 5

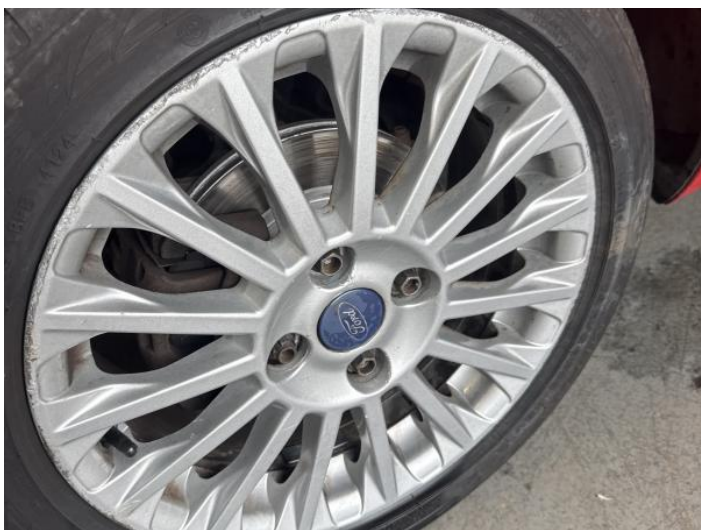
5: Wheel nsf  
Scratched  
Over 50mm

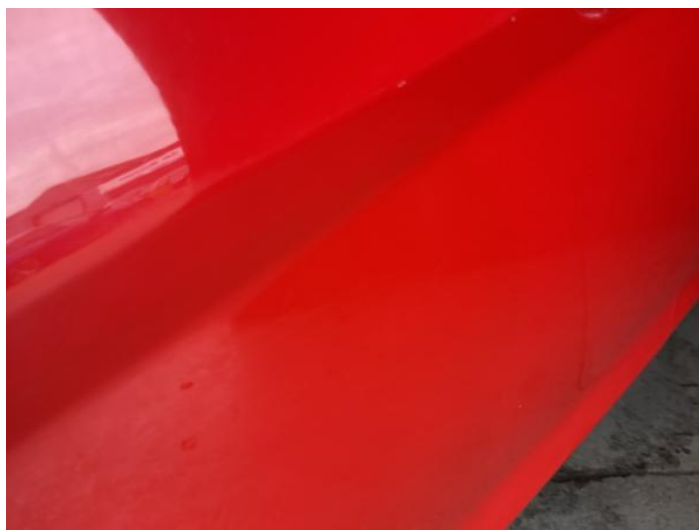
6: Door nsf  
Chipped  
1 To 5

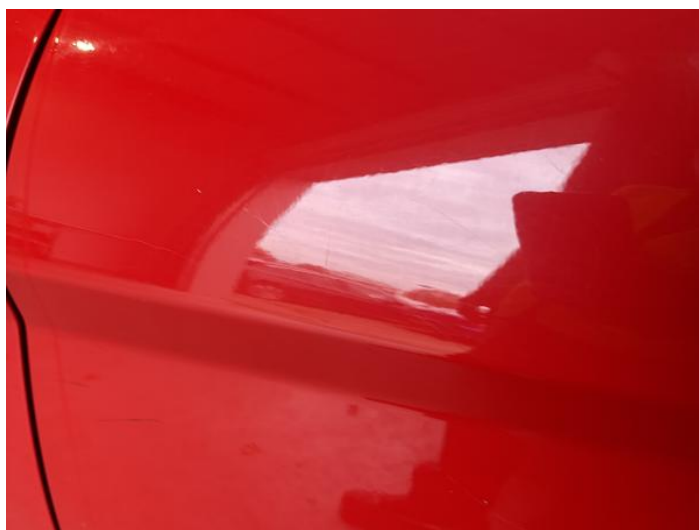
8: Door nsr  
Scratched  
Over 25mm Thru Paint

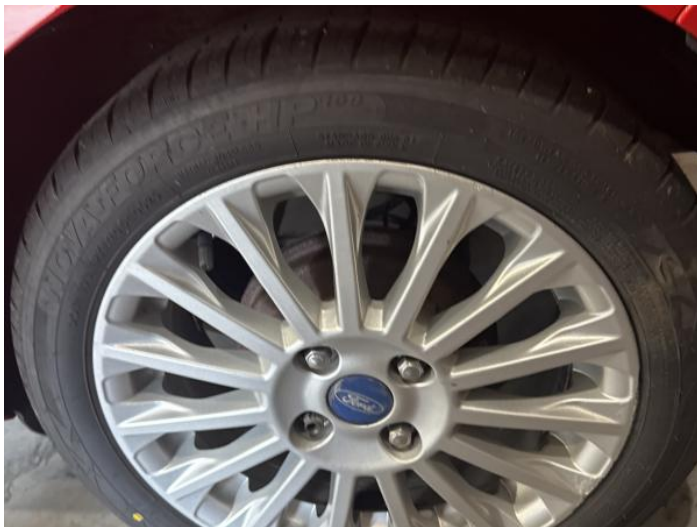
9: Wheel nsr  
Scratched  
Over 50mm

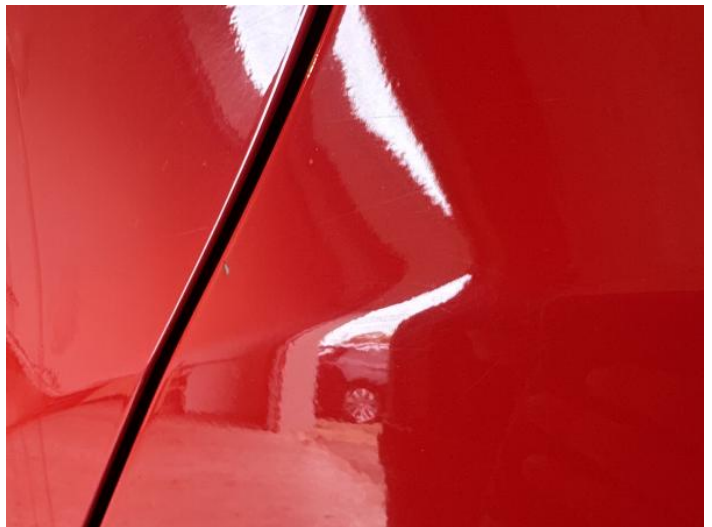
10: Qtr Panel nsr  
Poor Previous Repair  
Poor Paint

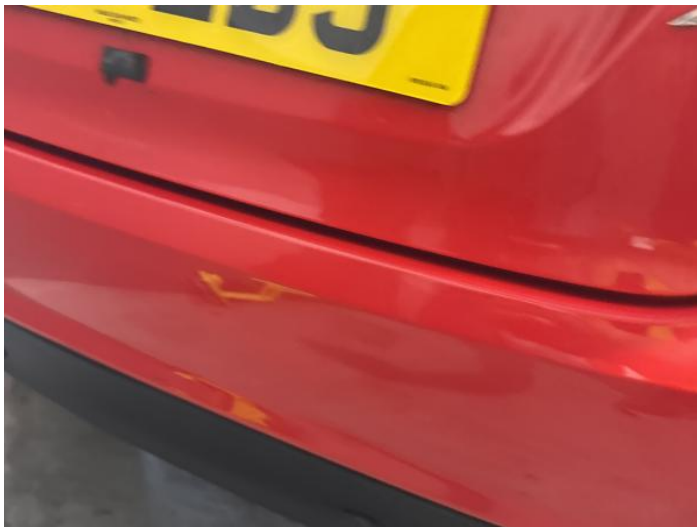
11: Bumper Rear  
Chipped  
Multiple Chips

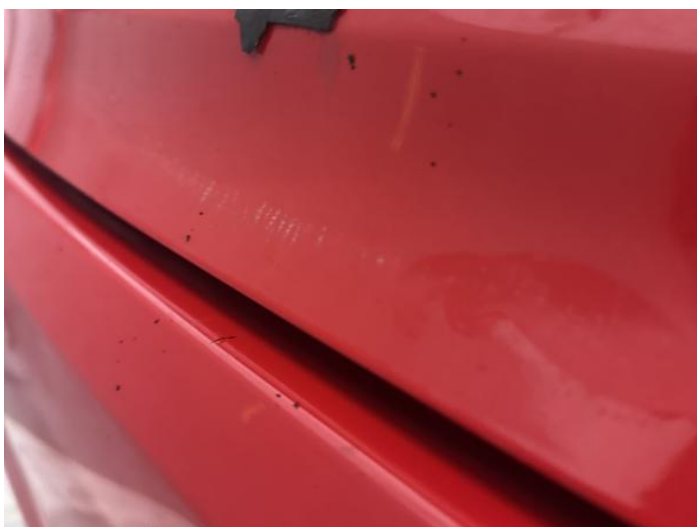
13: Boot Lid  
Scratched  
Over 25mm Thru Paint

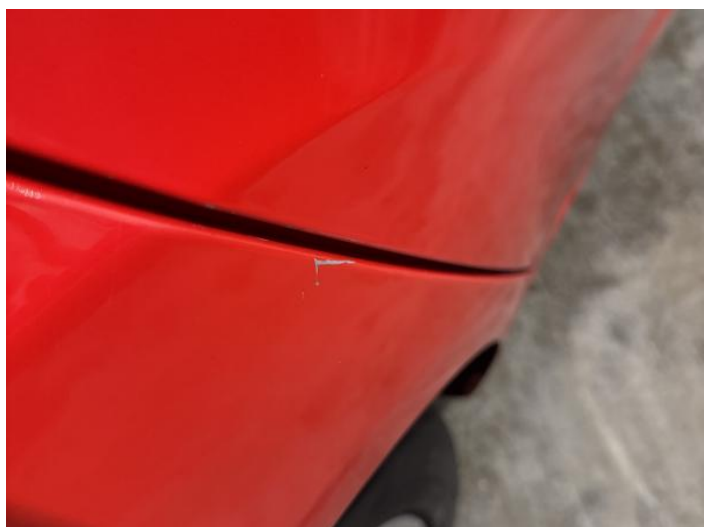
14: Qtr Panel osr  
Scratched  
Over 25mm Thru Paint

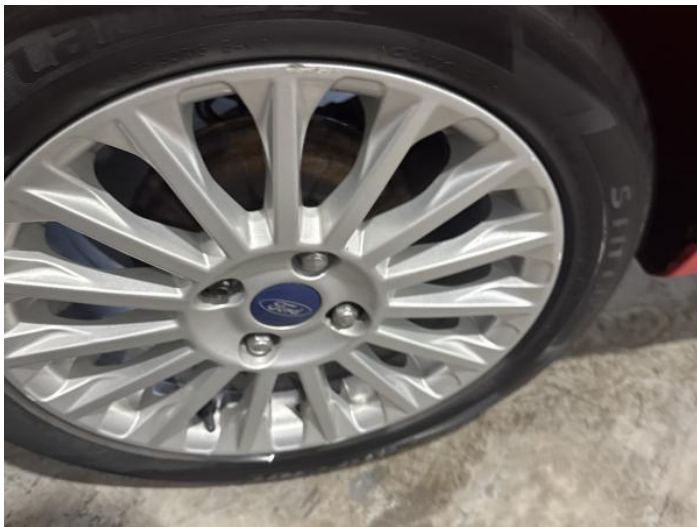
15: Wheel osr  
Scratched  
Over 50mm

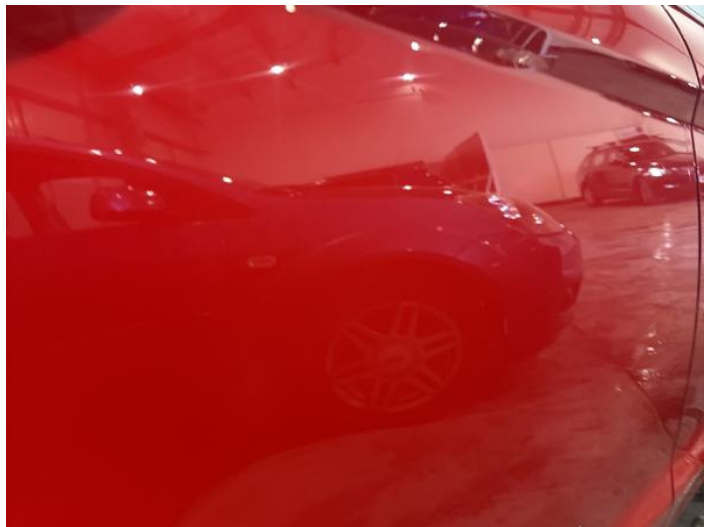
16: Door osr  
Scratched  
Over 25mm Thru Paint

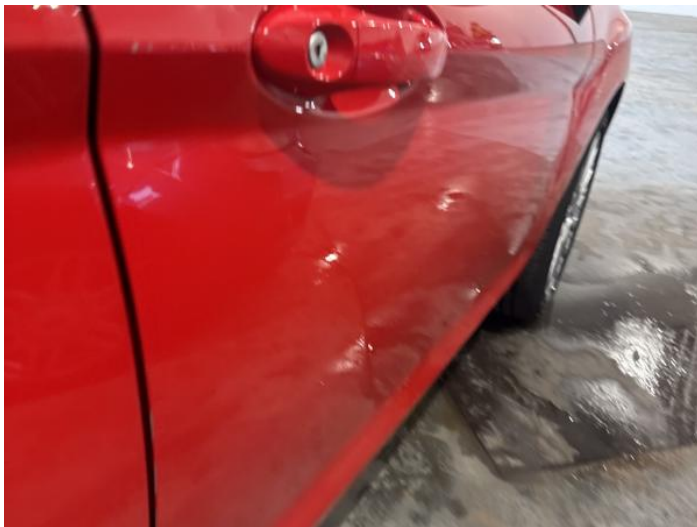
17: Door osf  
Dented  
With Paint Damage

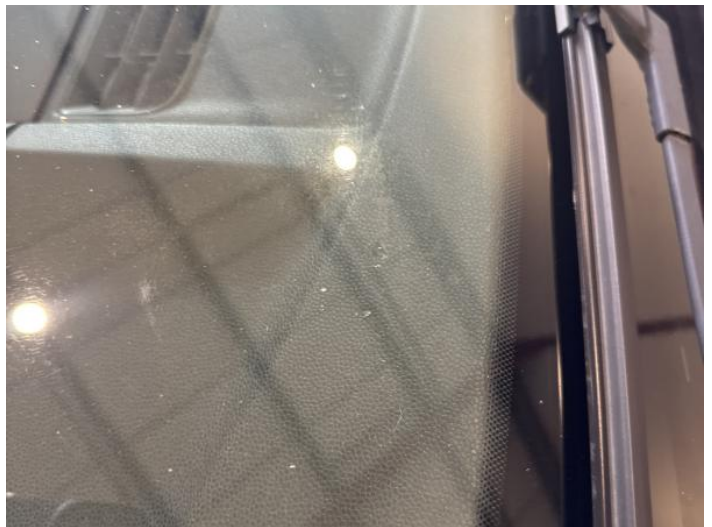
18: Screen Front  
Chipped  
UpTo 10mm

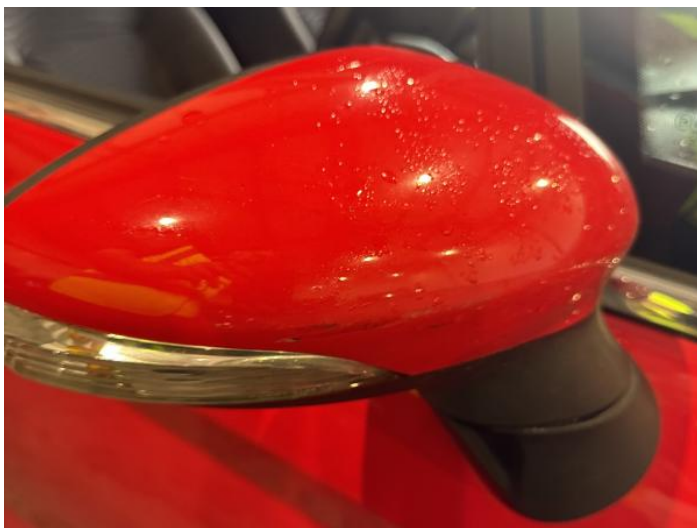
19: Door Mirror Assy osf  
Scratched (Painted)  
UpTo 25mm Thru Paint

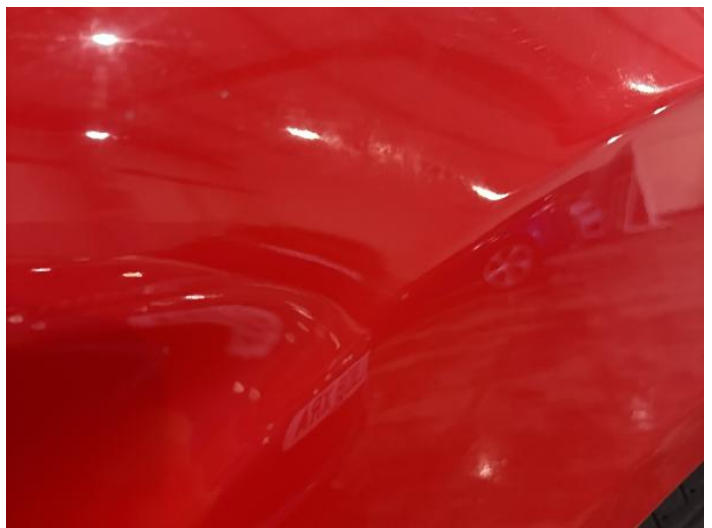
20: Wing osf  
Chipped  
1 To 5

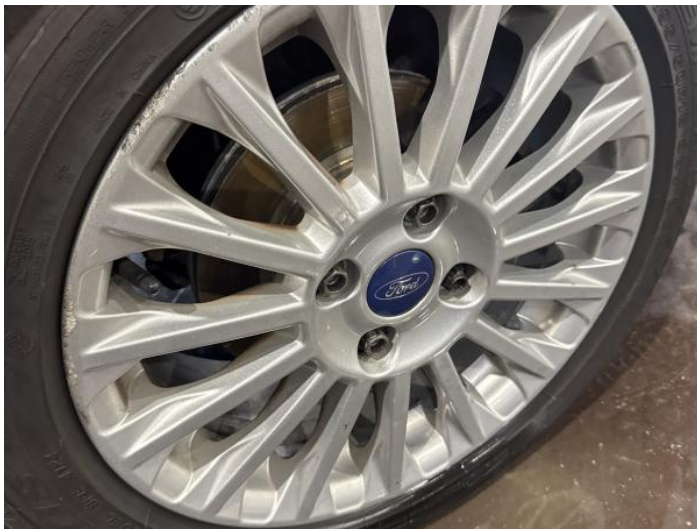
21: Wheel of  
Scratched  
Over 50mm

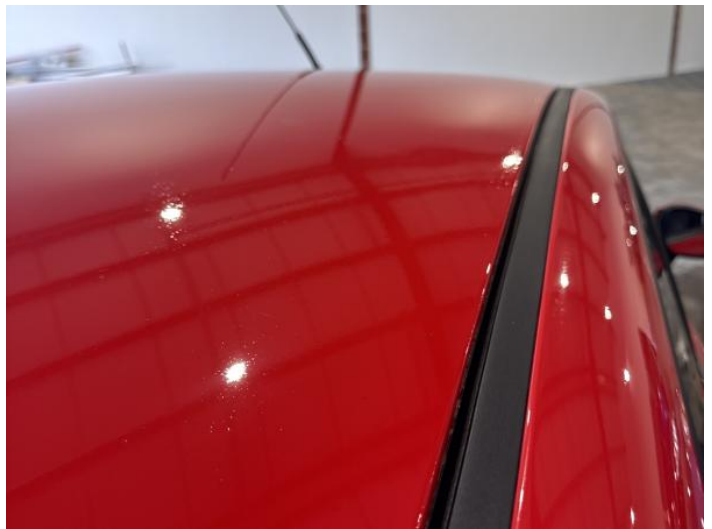
22: Roof  
Dented  
Over 30mm
