# VEHICLE INSPECTION REPORT

GP66FVD

## Toyota Yaris 1.5 Hybrid Design 5dr CVT

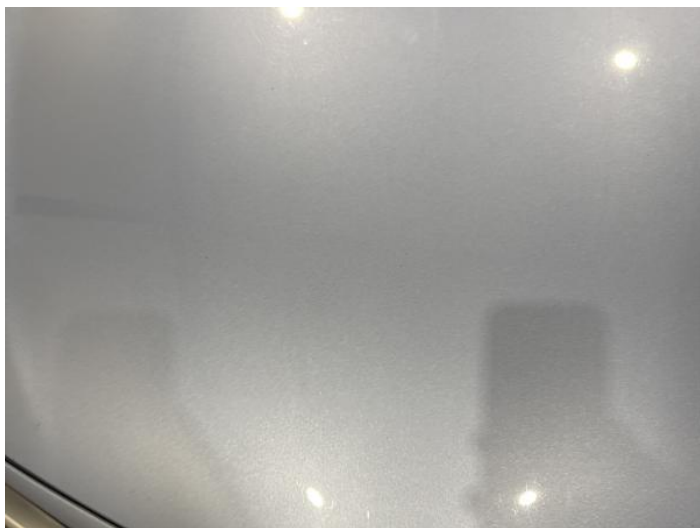
1: Bonnet  
Chipped  
1 To 5

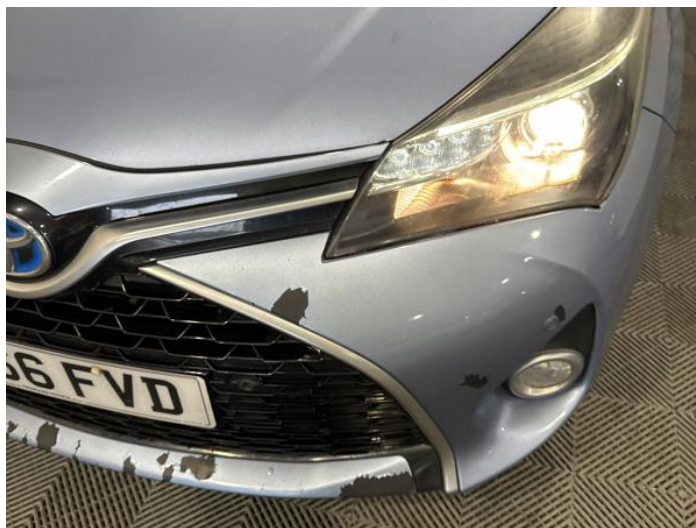
2: Bumper Front  
Poor Previous Repair  
Paint Flake

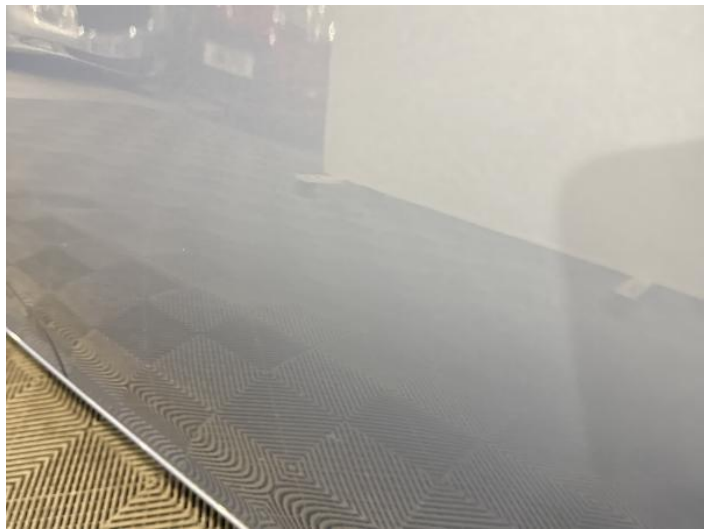
5: Door nsf  
Poor Previous Repair  
Poor Paint

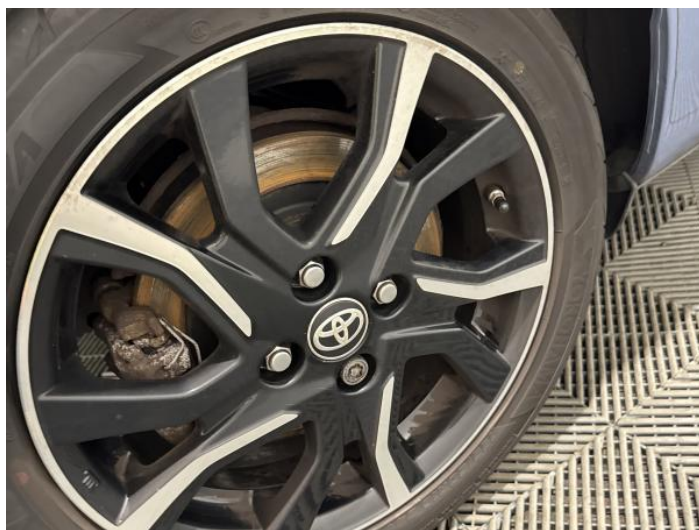
12: Wheel osr  
Scratched  
Up To 50mm

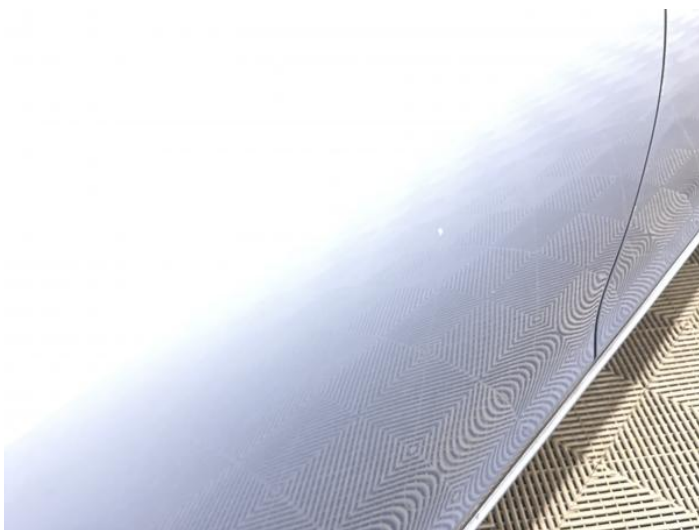
13: Door osr  
Chipped  
1 To 5

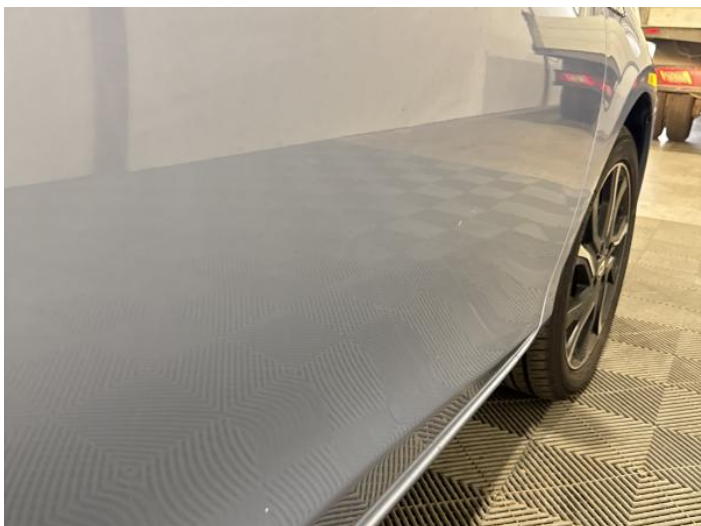
15: Door osf  
Chipped  
1 To 5

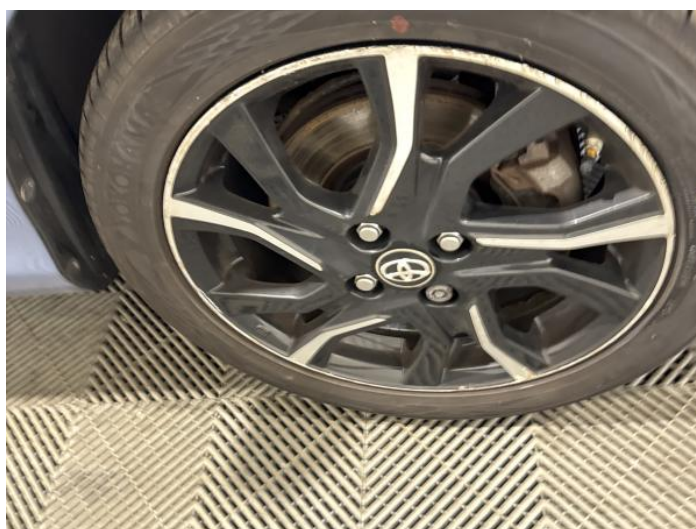
18: Wheel osf  
Scratched  
Over 50mm

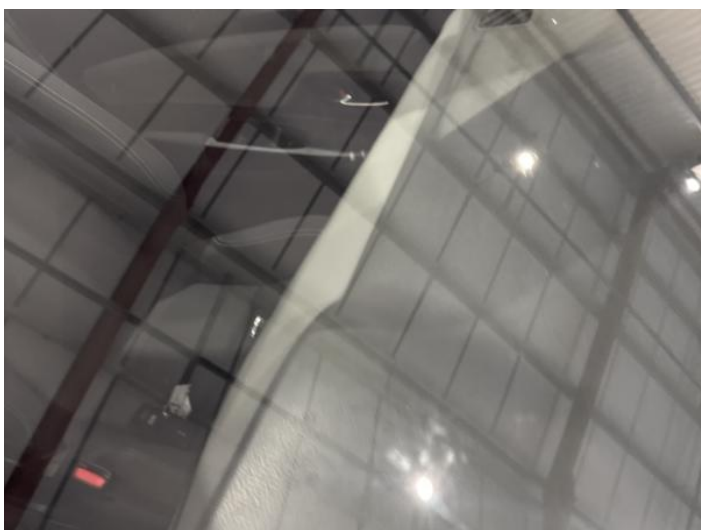
19: Screen Front  
Chipped  
UpTo 10mm
