VEHICLE INSPECTION REPORT

GV69NYW

Volkswagen T-Roc 1.5 TSI EVO SE 5dr

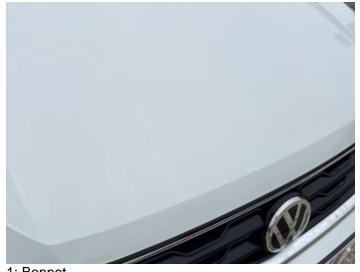
1: Bonnet Chipped 1 To 5

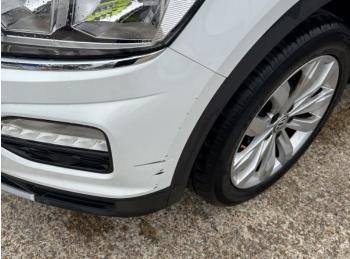
2: Bumper Front Scratched Over 100mm Thru Paint

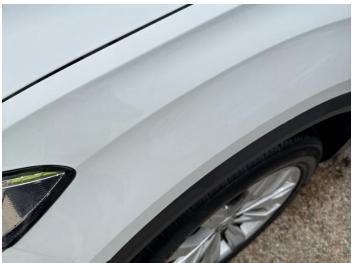
3: Wing nsf Chipped 1 To 5

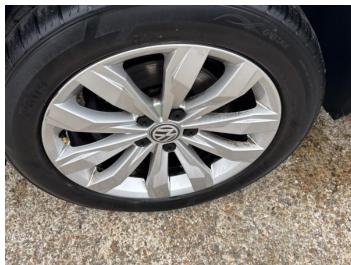
4: Wheel nsf Scratched Over 50mm

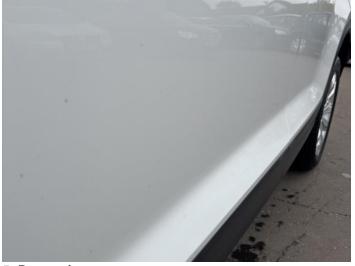
5: Door nsf Chipped 1 To 5

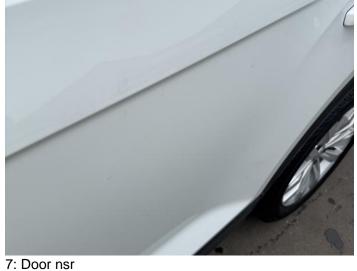
7: Door nsr Chipped 1 To 5

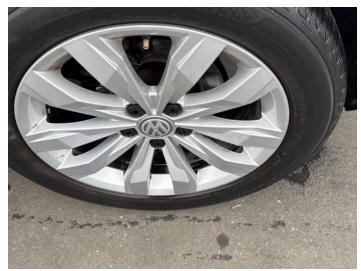
9: Wheel nsr Scratched Up To 50mm

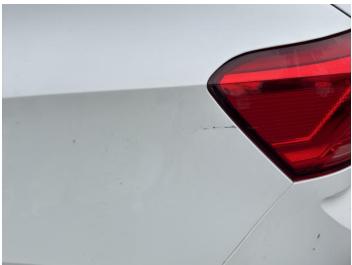
10: Qtr Panel nsr Scratched Over 25mm Thru Paint

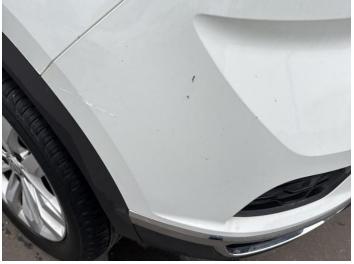
11: Bumper Rear Poor Previous Repair Poor Paint

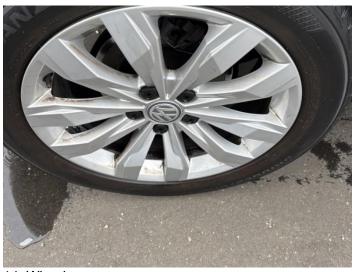
14: Wheel osr Scratched Up To 50mm

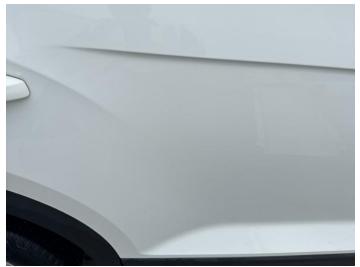
15: Door osr Chipped 1 To 5

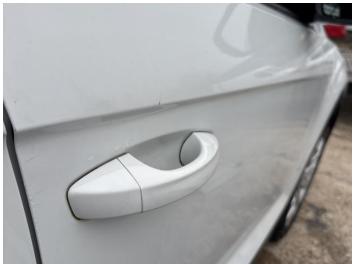
17: Door osf Chipped 1 To 5

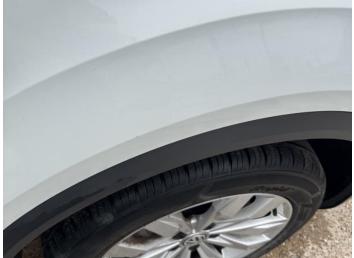
18: Wing osf Chipped 1 To 5

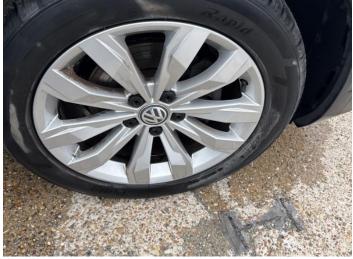
19: Wheel osf Scratched Up To 50mm
