VEHICLE INSPECTION REPORT

FG14VND

Vauxhall Zafira 2.0 CDTi [165] Elite 5dr [non Start Stop]

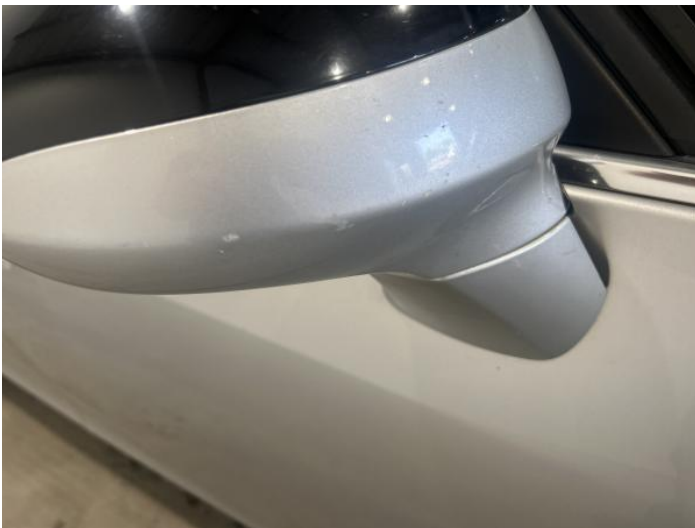
1: Door Mirror Assy osf
Scratched (Painted)
UpTo 25mm Thru Paint

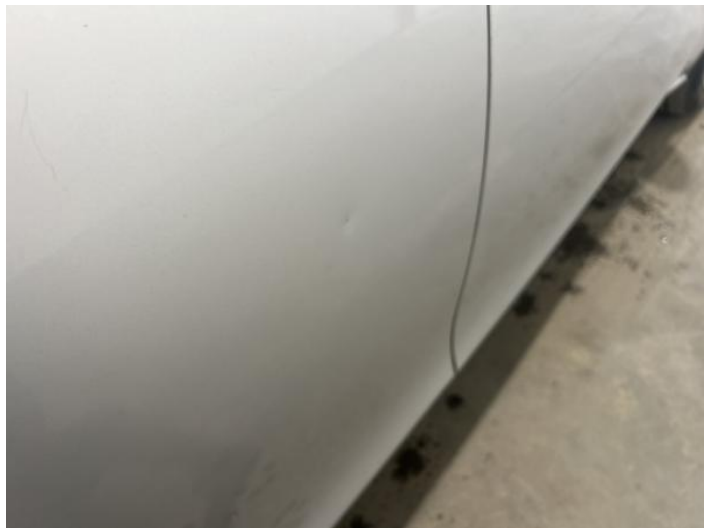
2: Door osr
Dented
2 Or Less UpTo 10mm

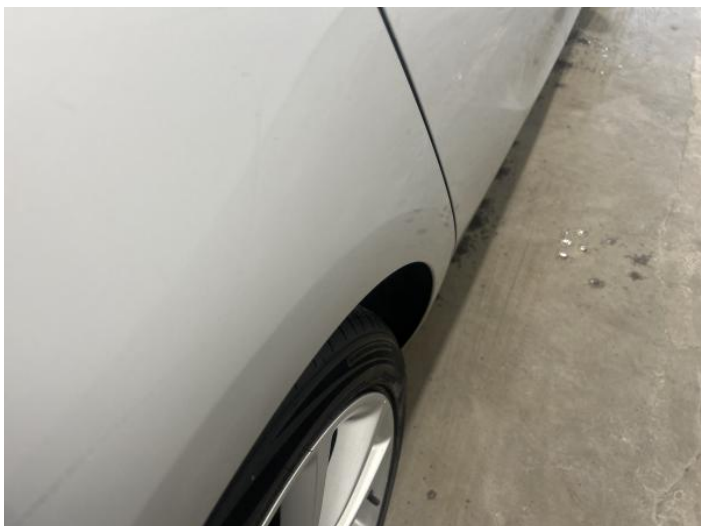
3: Qtr Panel osr
Dented
2 Or Less UpTo 10mm

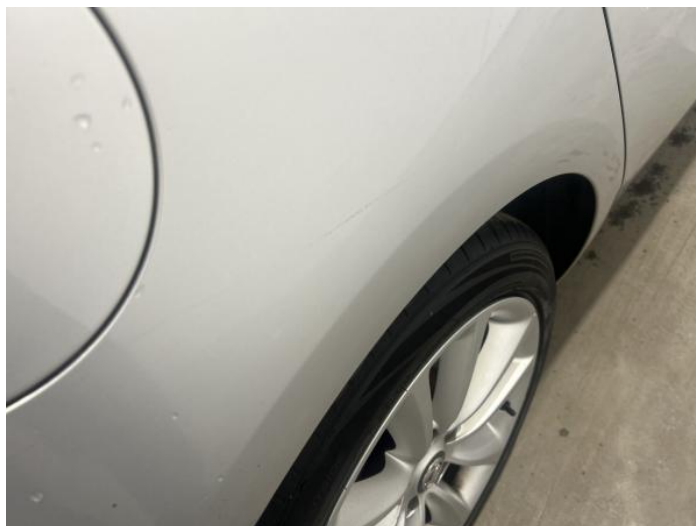
4: Qtr Panel osr
Scratched
Over 25mm Not Thru Paint

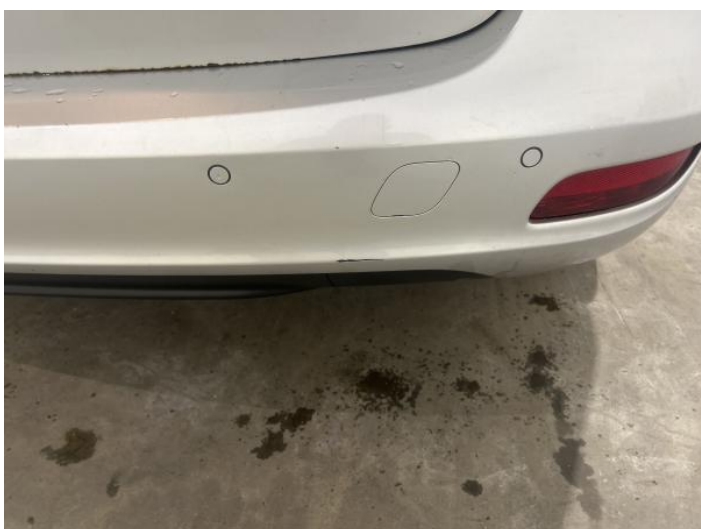
5: Bumper Rear
Scratched
25 to 100mm Thru Paint

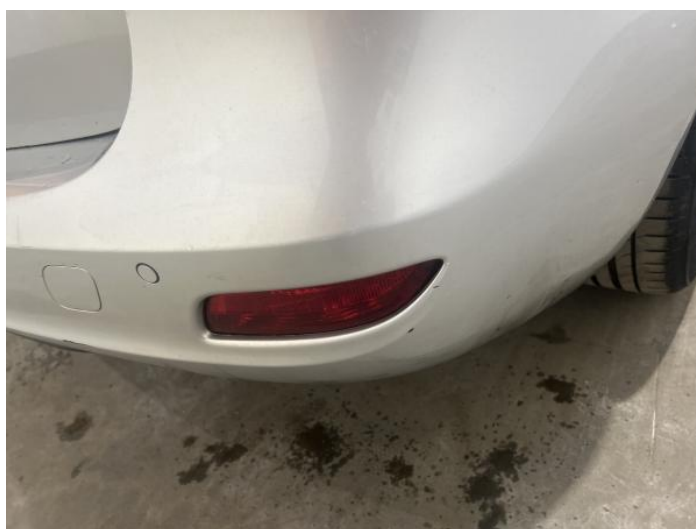
6: Bumper Rear
Chipped
1 To 5

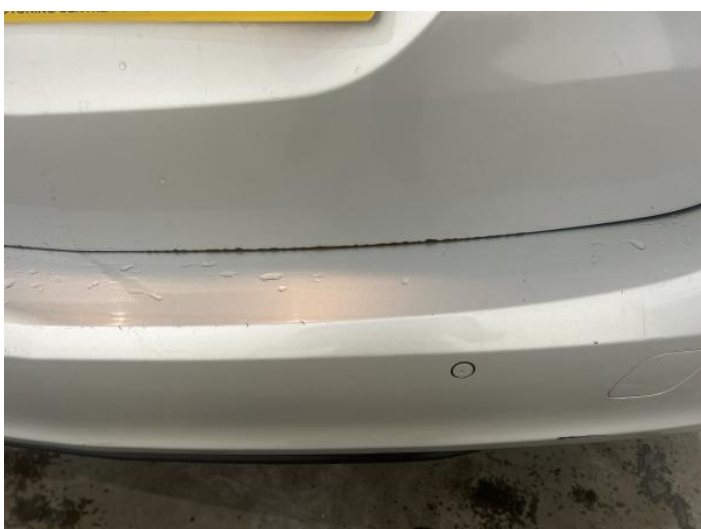
7: Tailgate
Rusted
Over 5mm

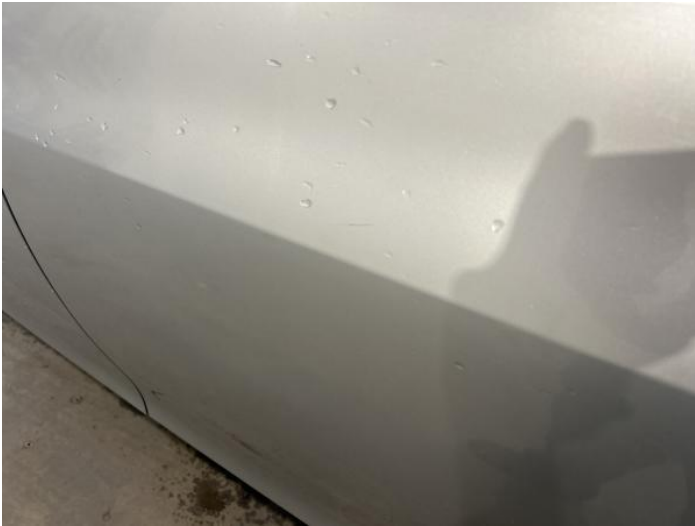
9: Door nsr
Scratched
UpTo 25mm Thru Paint

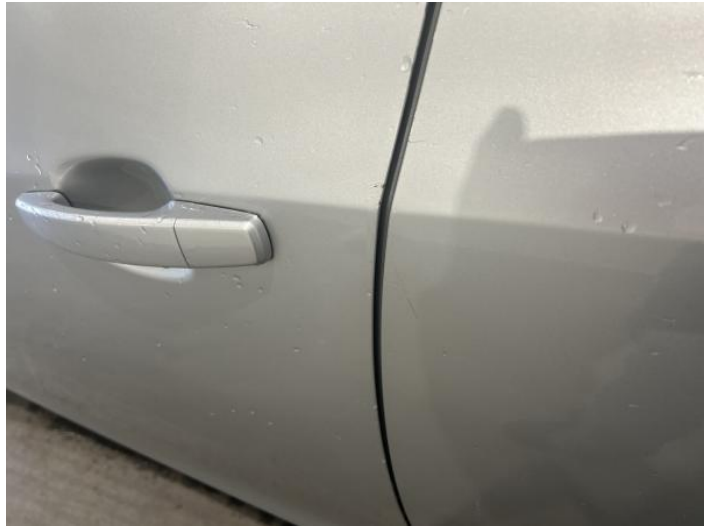
10: Door nsf
Poor Previous Repair
Poor Paint

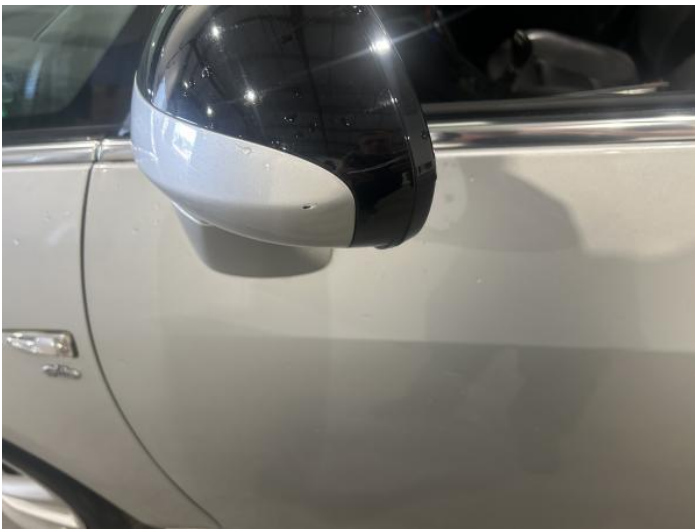
11: Door Mirror Assy nsf
Scratched (Painted)
UpTo 25mm Thru Paint

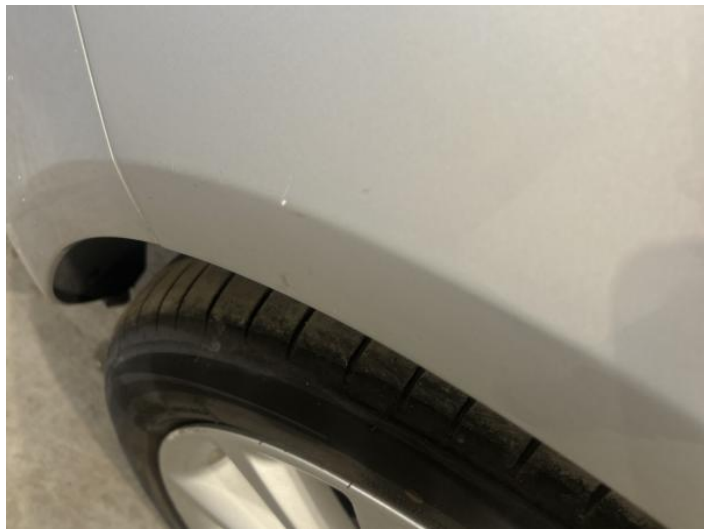
12: Wing nsf
Chipped
1 To 5

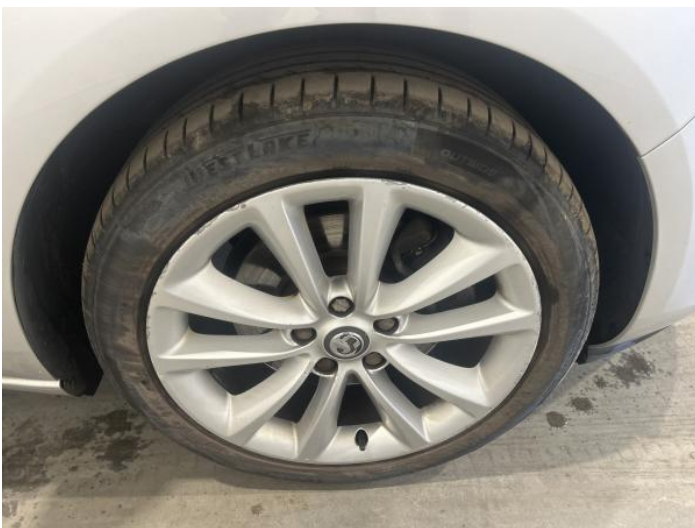
13: Wheel osf
Scratched
Over 50mm

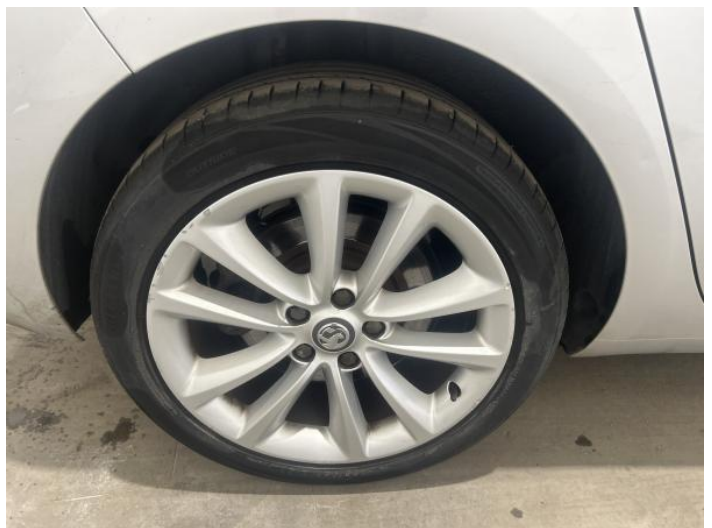
14: Wheel osr
Scratched
Over 50mm

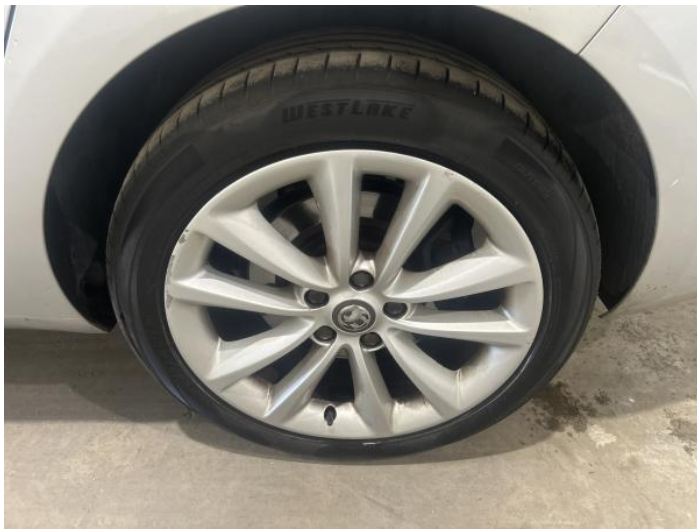
15: Wheel nsr
Scratched
Over 50mm

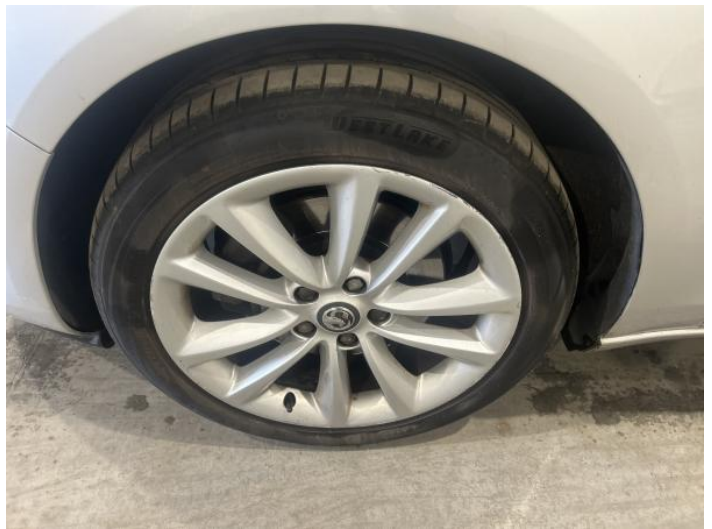
16: Wheel nsf
Scratched
Over 50mm
