## VEHICLE INSPECTION REPORT

**GU69WUK**

### Citroen Grand C4 Spacetourer 1.2 PureTech 130 Feel Plus 5dr

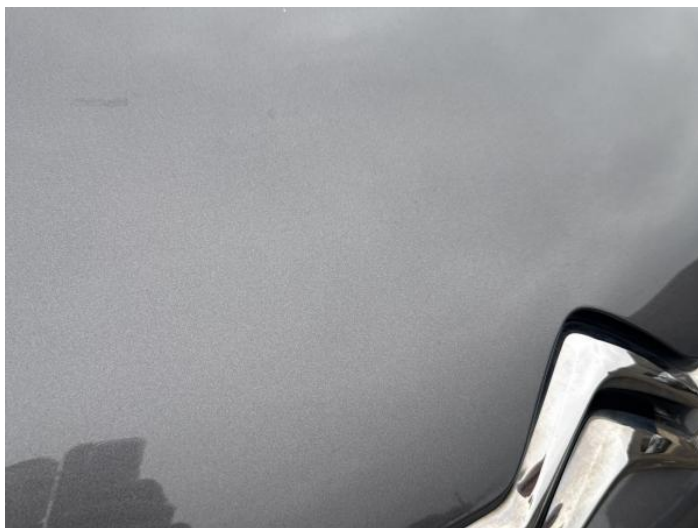
1: Bonnet  
Chipped  
Multiple Chips

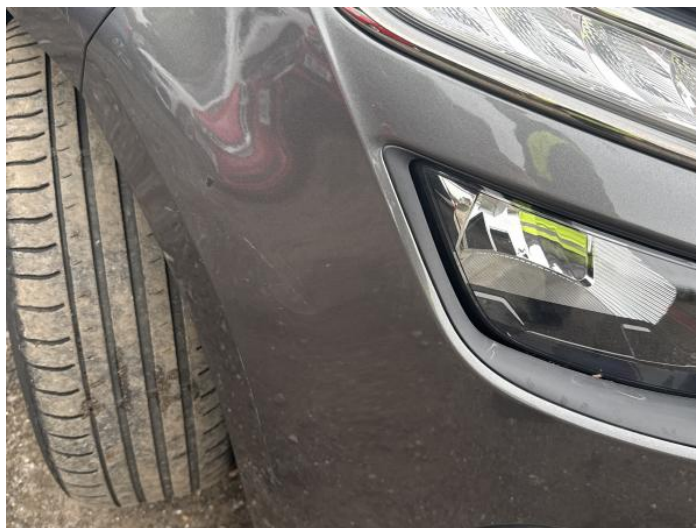
2: Bumper Front  
Scratched  
25 to 100mm Thru Paint

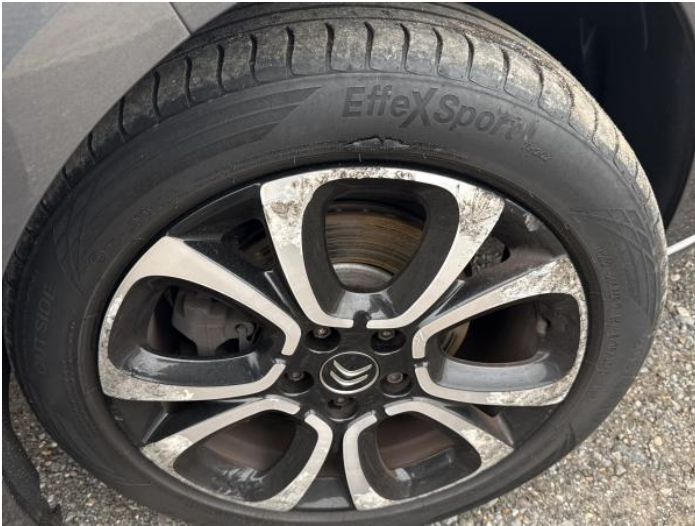
3: Wheel nsf  
Scratched  
Over 50mm

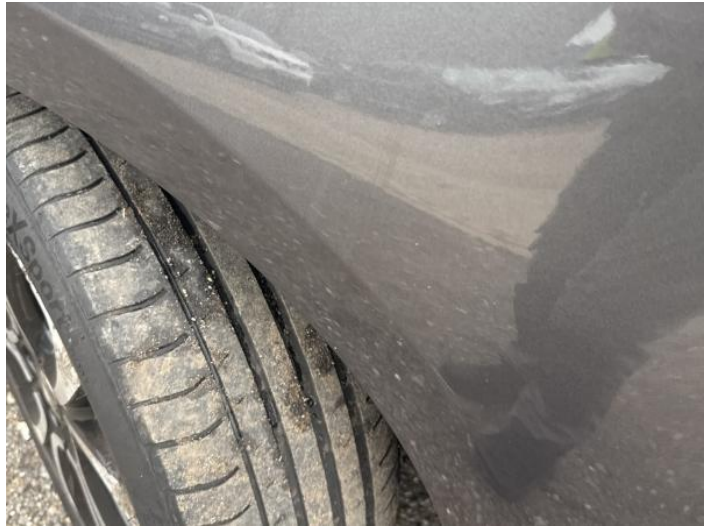
4: Wing nsf  
Scratched  
UpTo 25mm Thru Paint

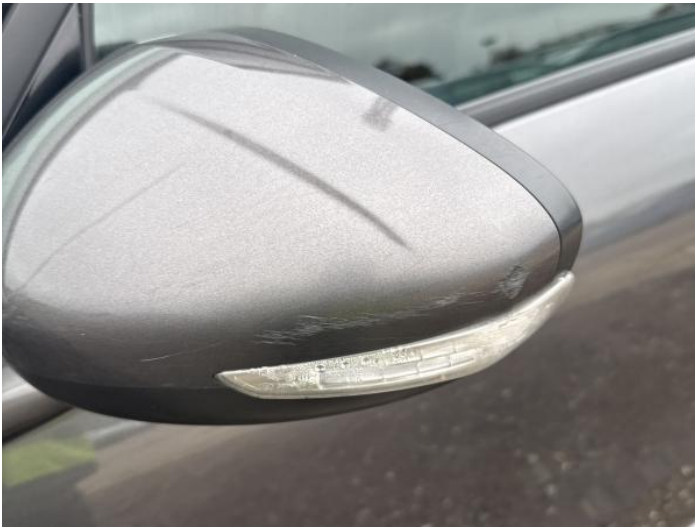
5: Door Mirror Assy nsf  
Scratched (Painted)  
Over 25mm Thru Paint

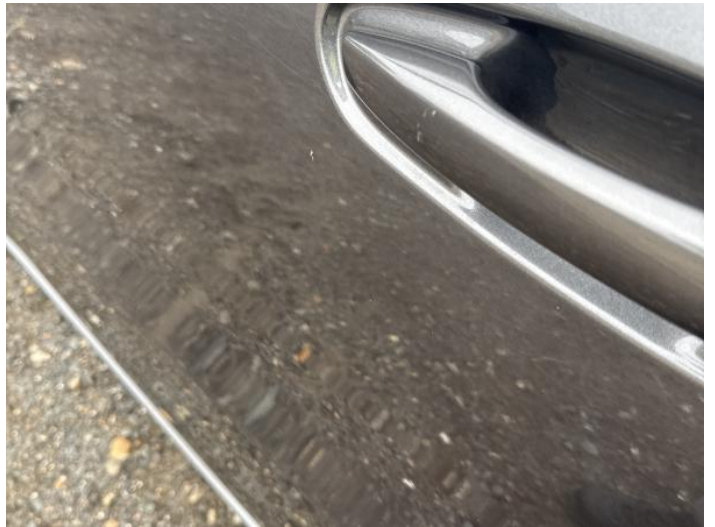
6: Door nsf  
Chipped  
1 To 5

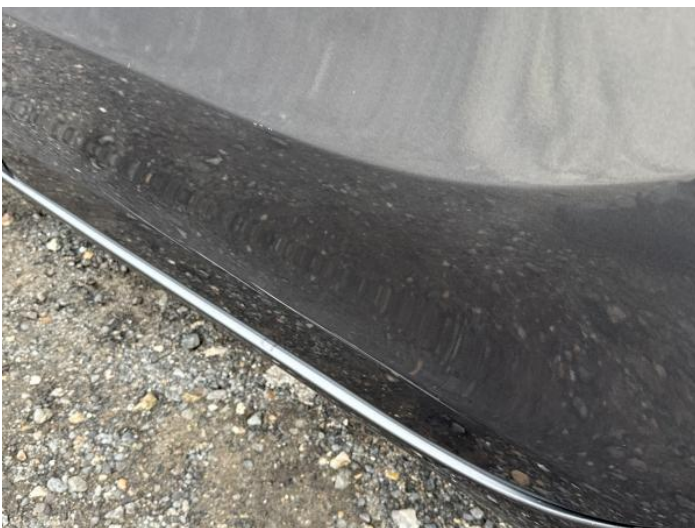
7: Door nsr  
Scratched  
Over 25mm Thru Paint

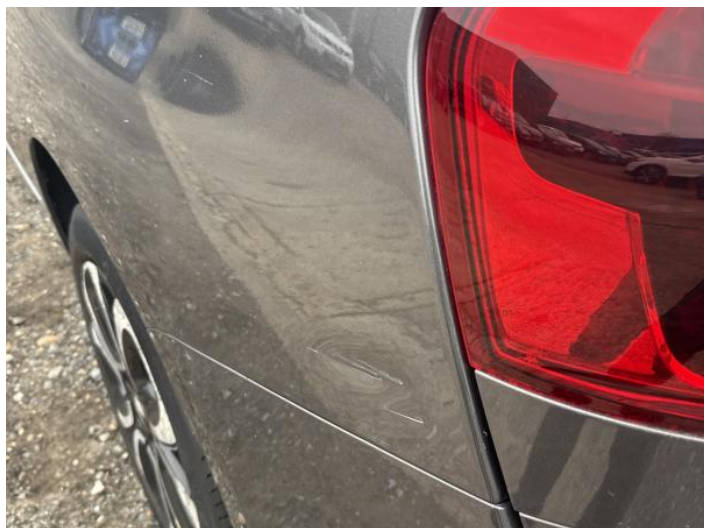
8: Qtr Panel nsr  
Dented  
With Paint Damage

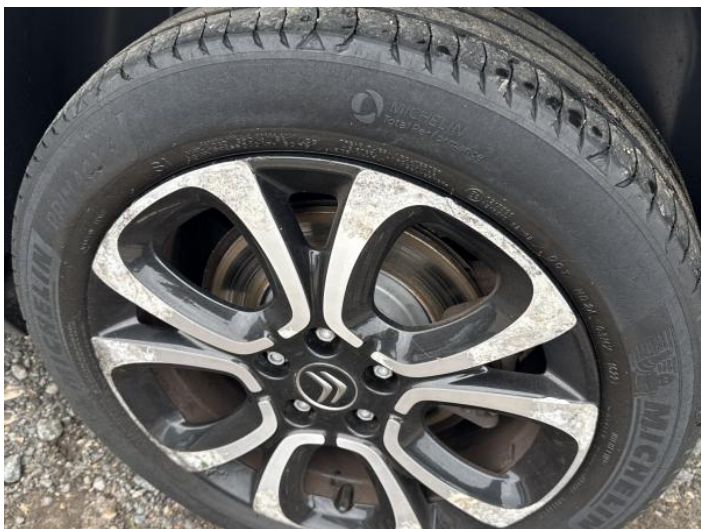
9: Wheel nsr  
Scratched  
Over 50mm

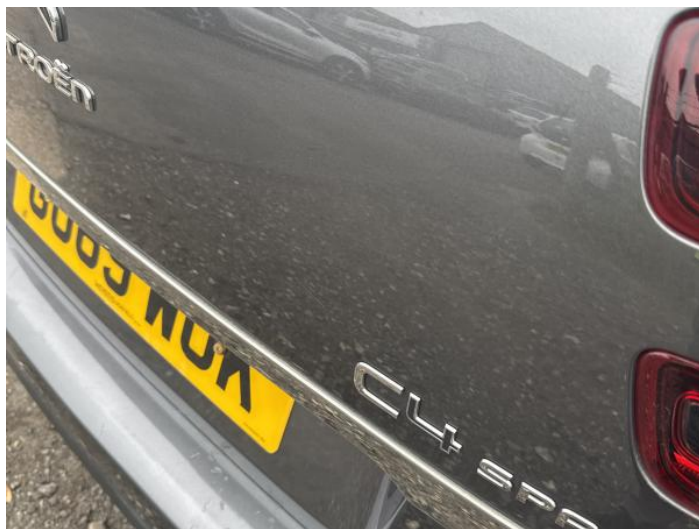
10: Tailgate  
Scratched  
Over 25mm Thru Paint

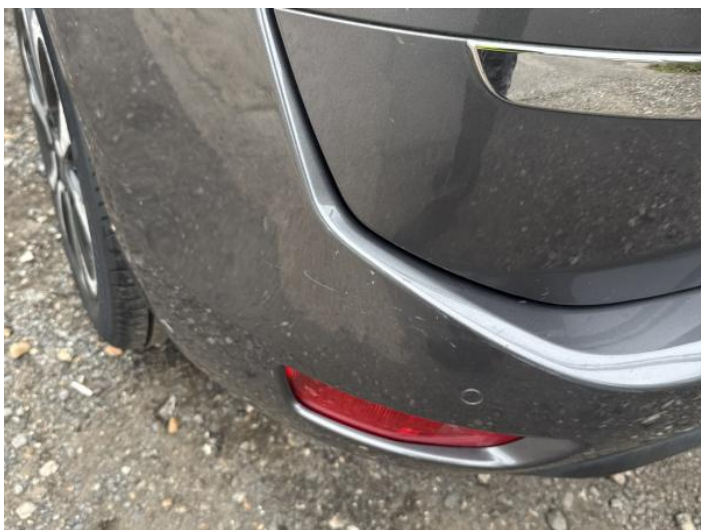
11: Bumper Rear  
Scratched  
Over 100mm Thru Paint

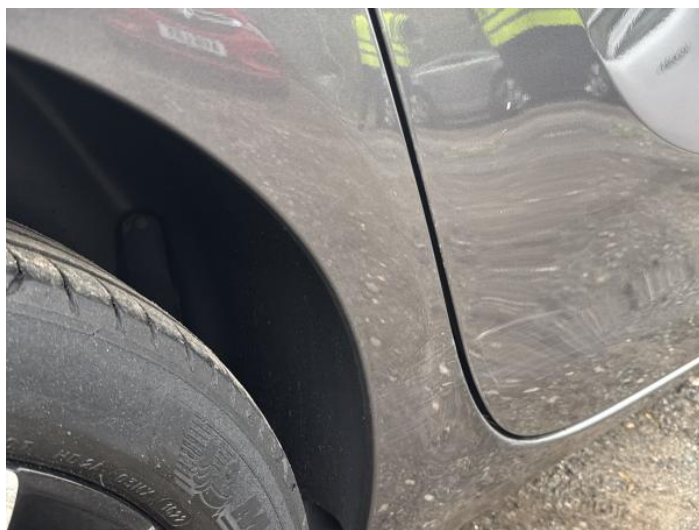
12: Qtr Panel osr  
Dented  
With Paint Damage

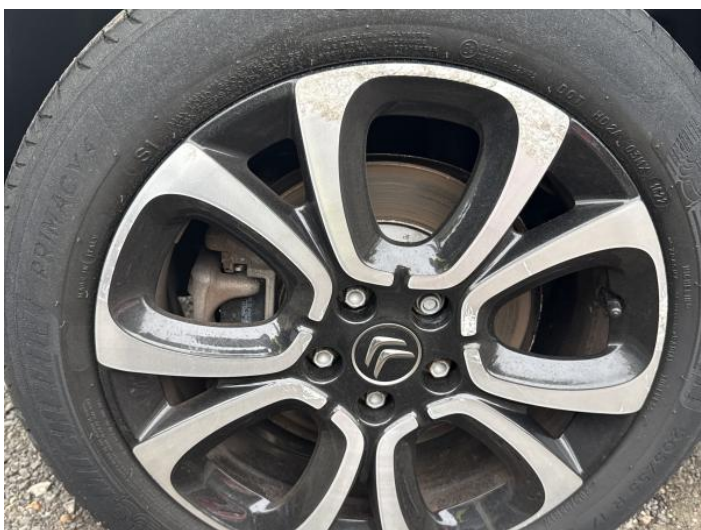
13: Wheel osr  
Corroded  
Light

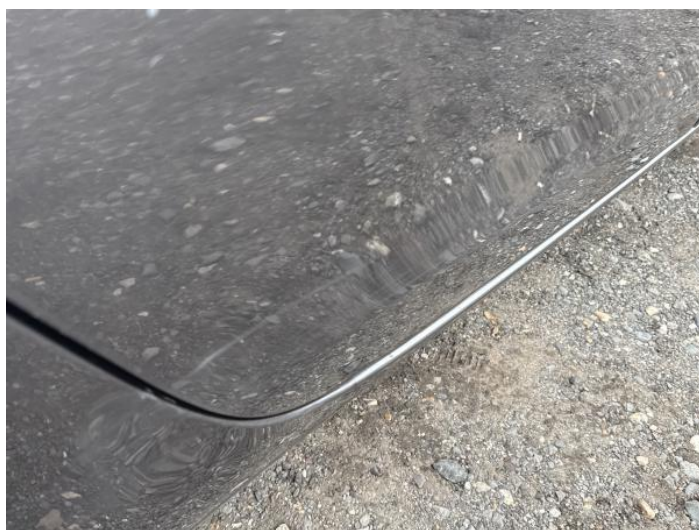
14: Door osr  
Scratched  
Over 25mm Thru Paint

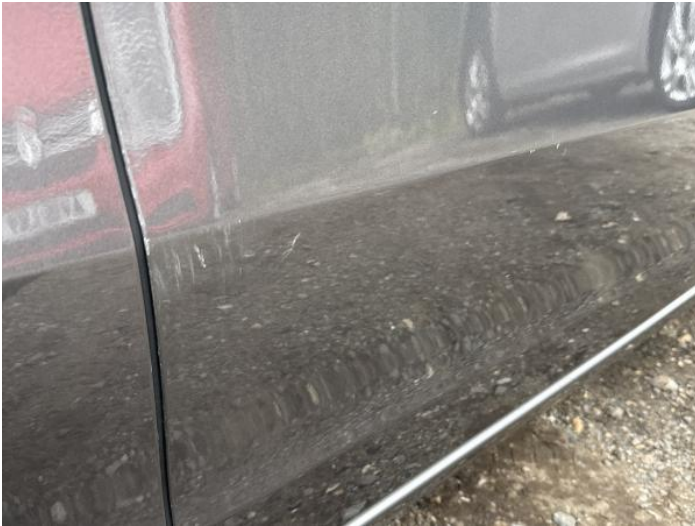
15: Door osf  
 Scratched  
 Over 25mm Thru Paint

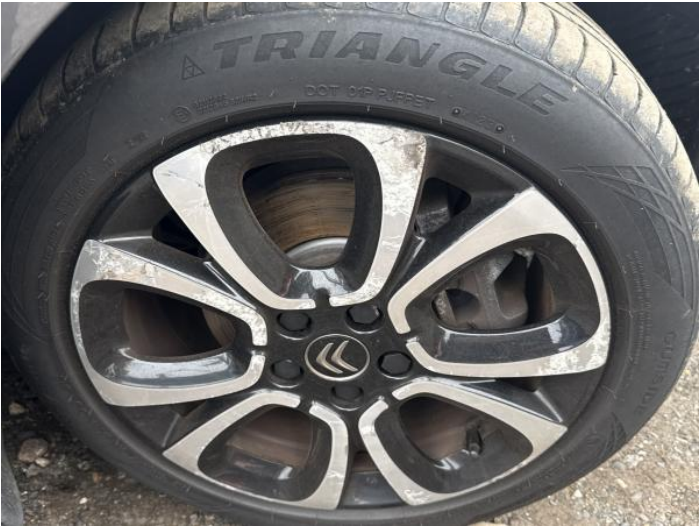
16: Wheel osr  
 Scratched  
 Over 50mm

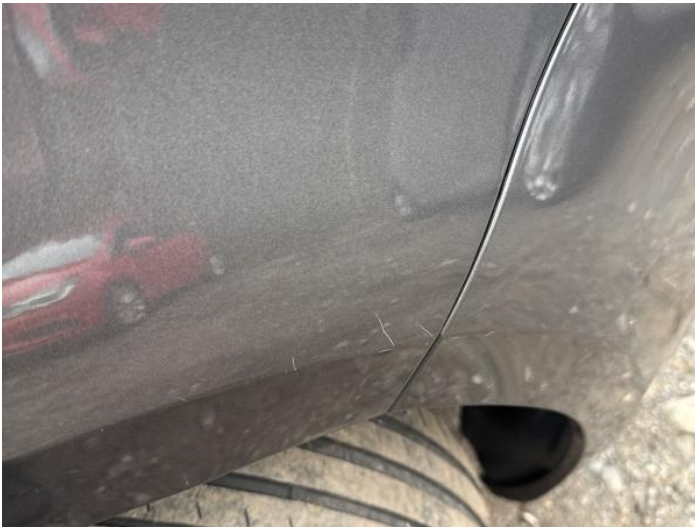
17: Wing osf  
 Scratched  
 UpTo 25mm Thru Paint

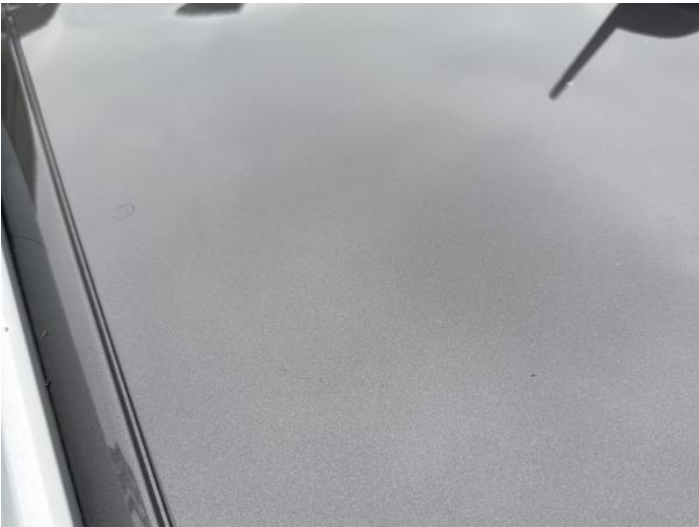
18: Roof  
 Dented  
 Between 10mm + 30mm

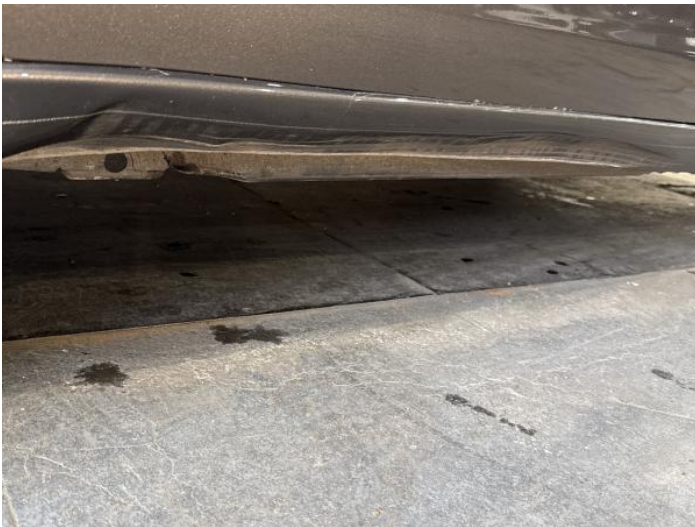
19: Sill ns  
 Dented  
 Over 30mm

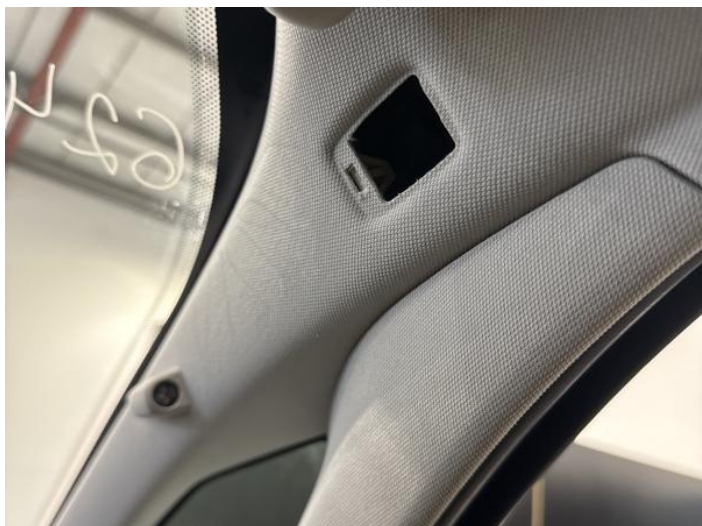
21: Switches And Controls

Missing  
Replace
