## VEHICLE INSPECTION REPORT

**AU71KFF**

### Mazda CX-30 2.0 e-Skyactiv G MHEV SE-L Lux 5dr

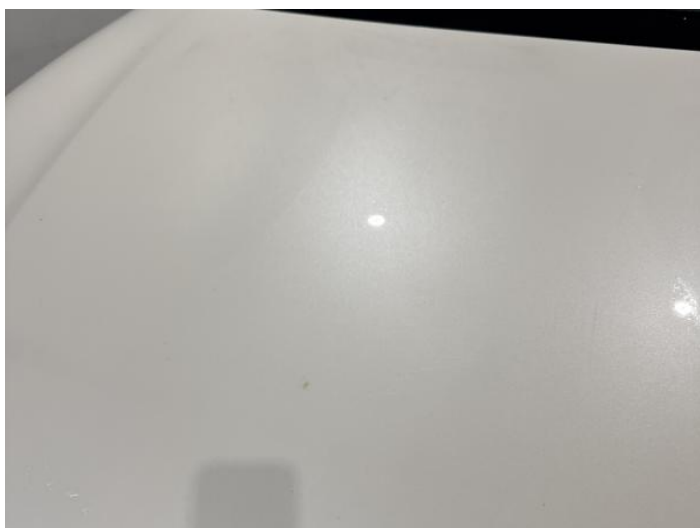
1: Bonnet  
Chipped  
1 To 5

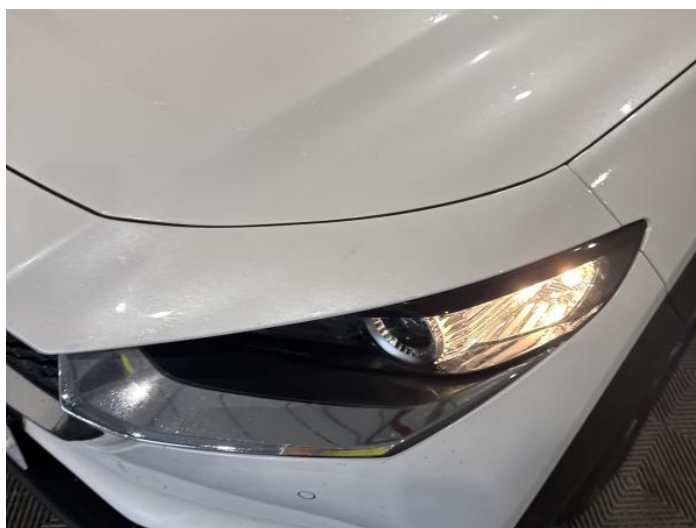
2: Bumper Front  
Chipped  
Multiple Chips

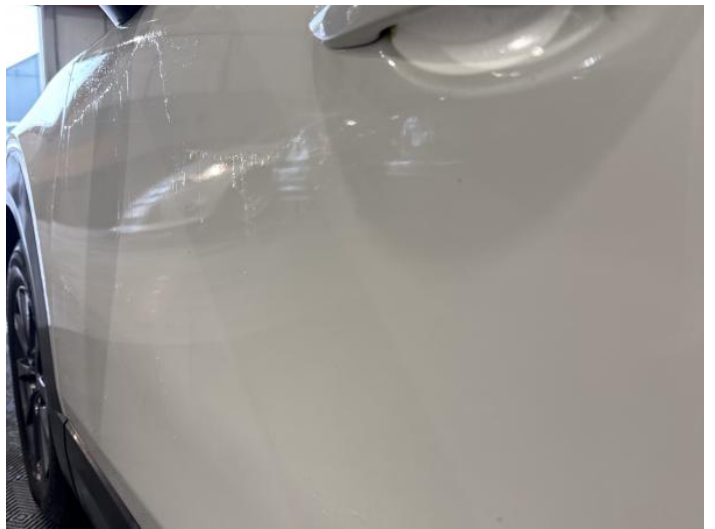
5: Wing nsf  
Scratched  
Over 25mm Not Thru Paint

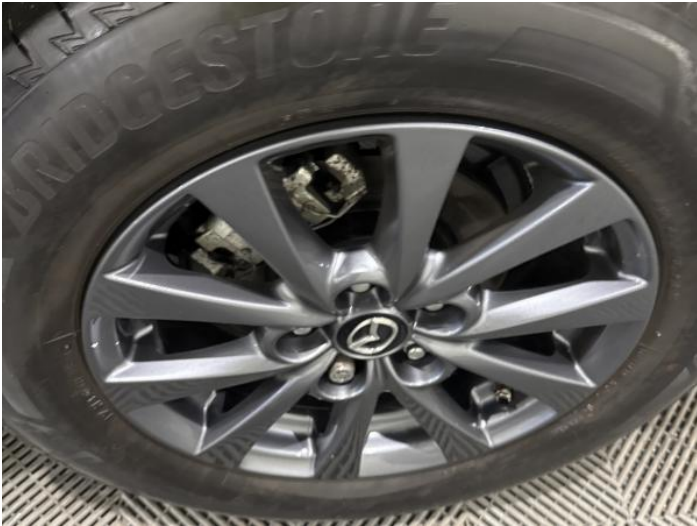
9: Wheel nsr  
Scratched  
Up To 50mm

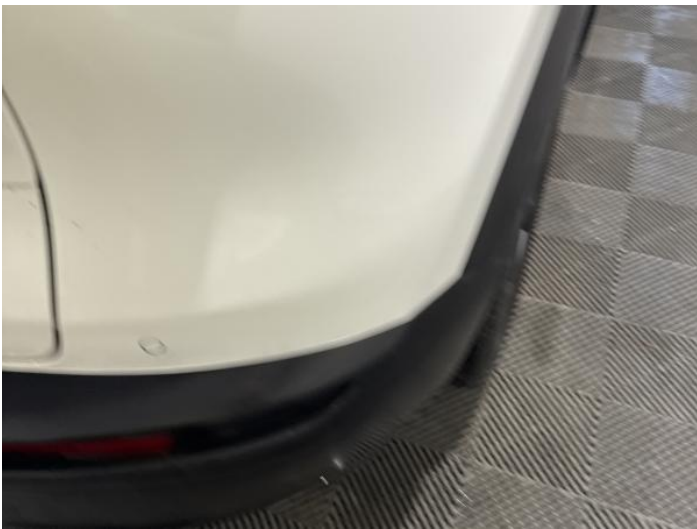
11: Bumper Rear  
Chipped  
Multiple Chips

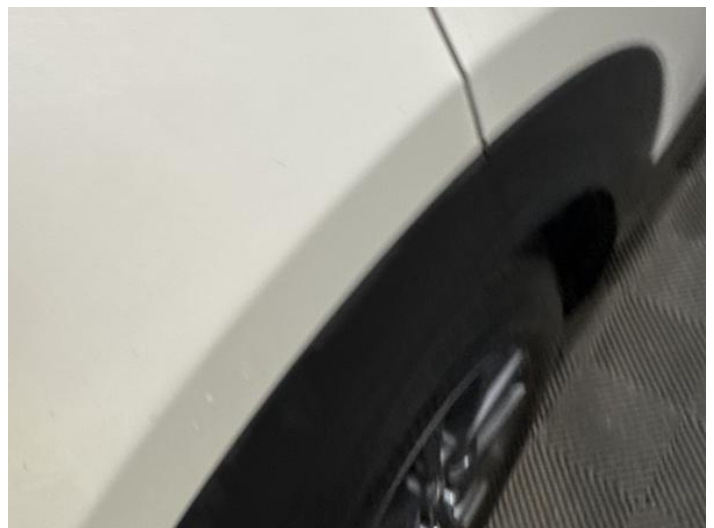
14: Qtr Panel osr  
Dented  
2 Or Less UpTo 10mm

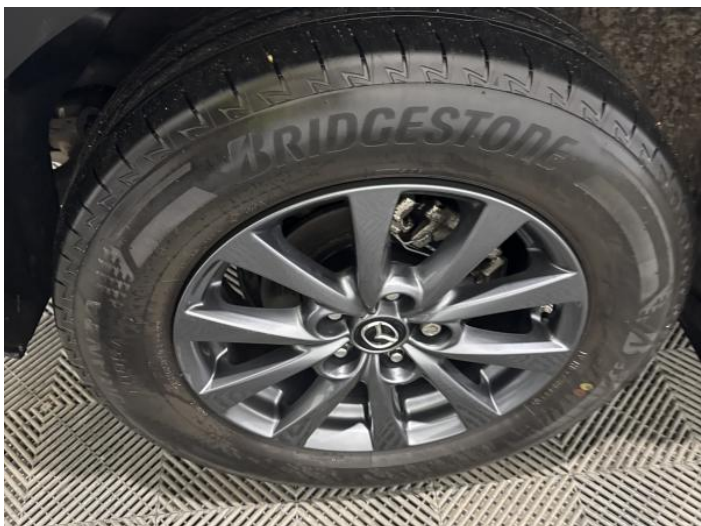
15: Wheel osr  
Scratched  
Up To 50mm

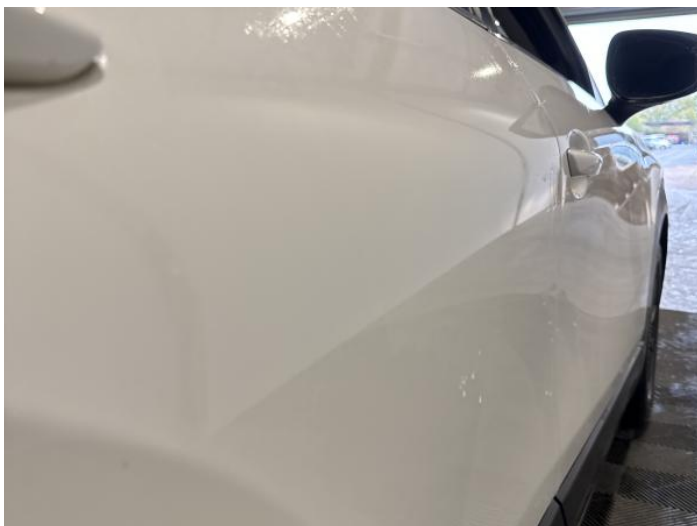
16: Door osr  
Chipped  
1 To 5

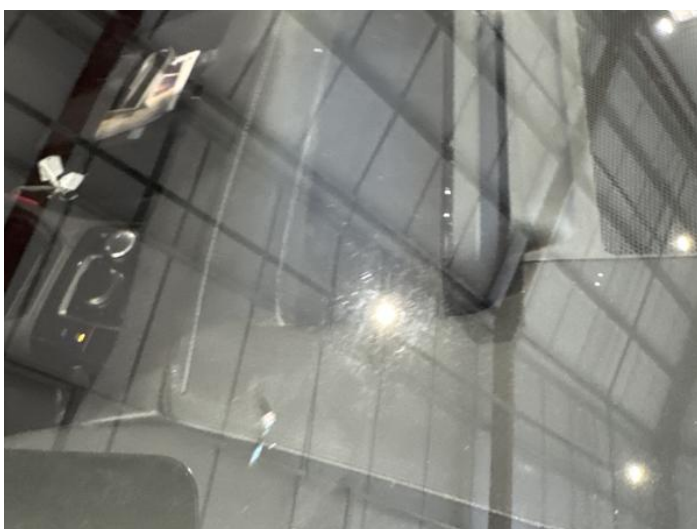
18: Screen Front  
Chipped  
UpTo 10mm

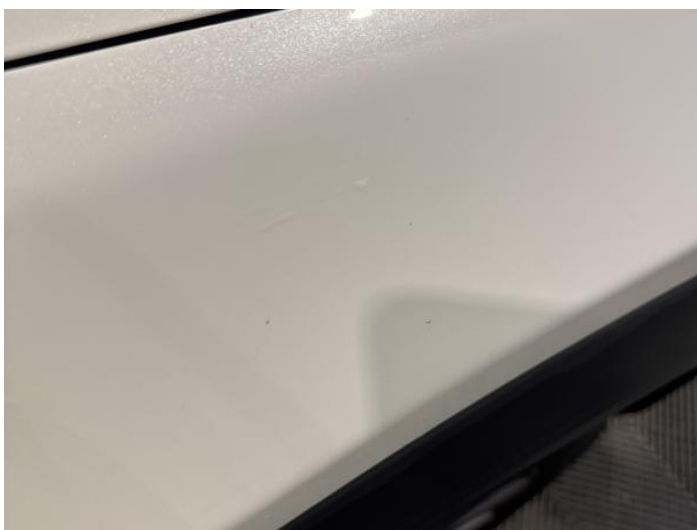
20: Wing osf  
Chipped  
1 To 5
