# VEHICLE INSPECTION REPORT

**RX15VDA**

## Kia Rio 1.4 CRDi 3 5dr

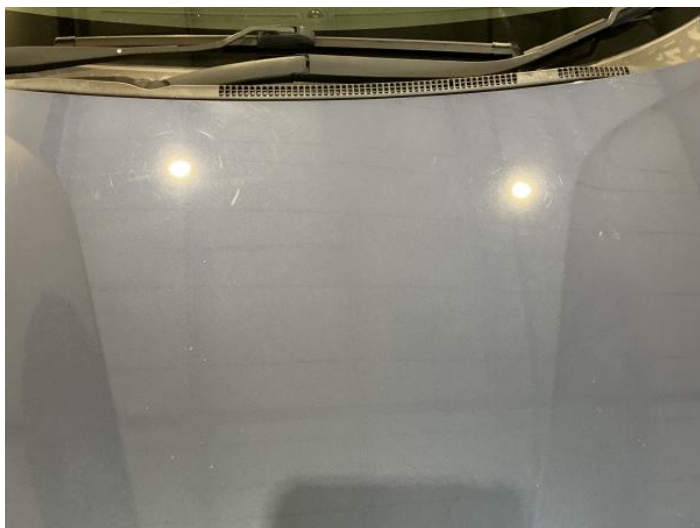
1: Bonnet  
Chipped  
1 To 5

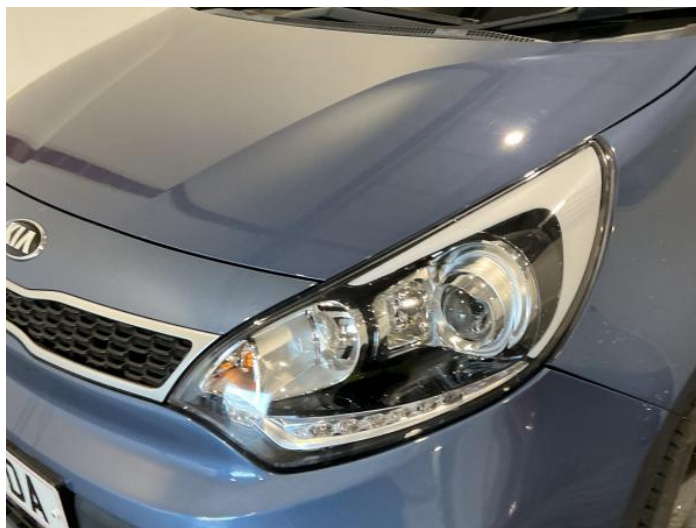
2: Bumper Front  
Scratched  
25 to 100mm Thru Paint

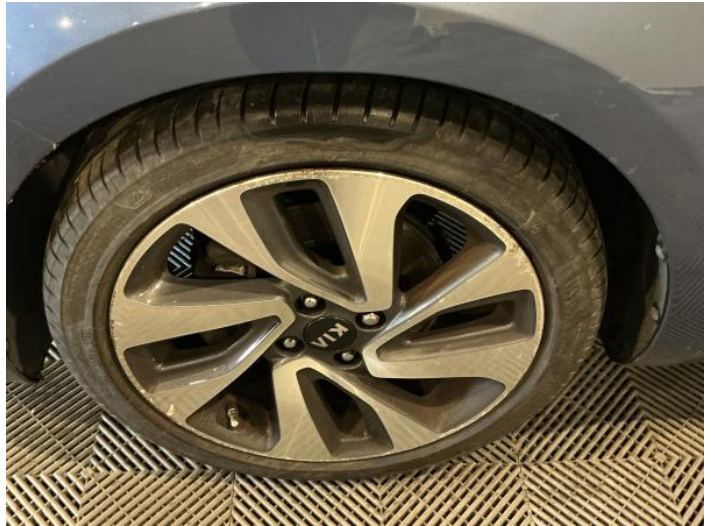
4: Wheel nsf  
Scratched  
Over 50mm

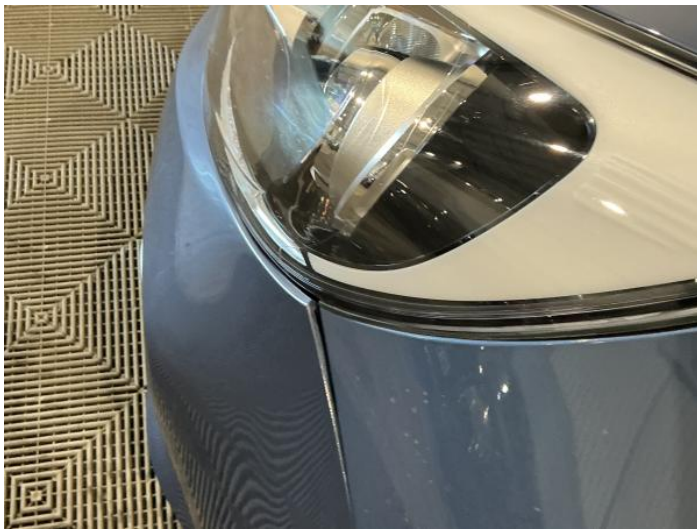
5: Bumper Front  
Insecure  
Action Required

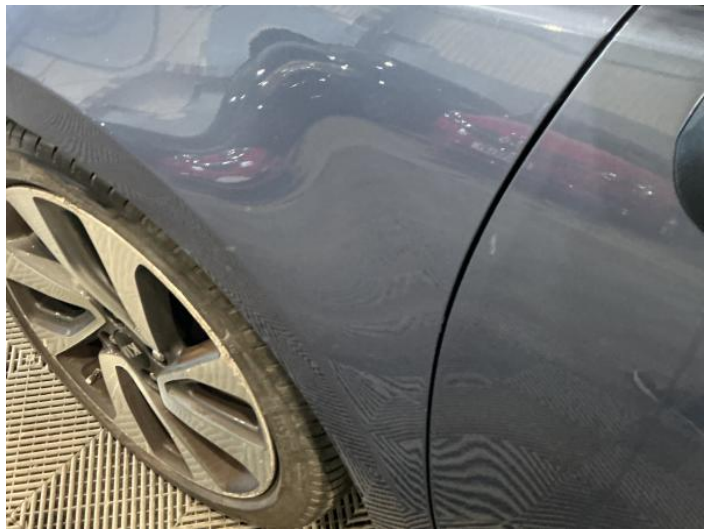
6: Wing nsf  
Dented  
With Paint Damage

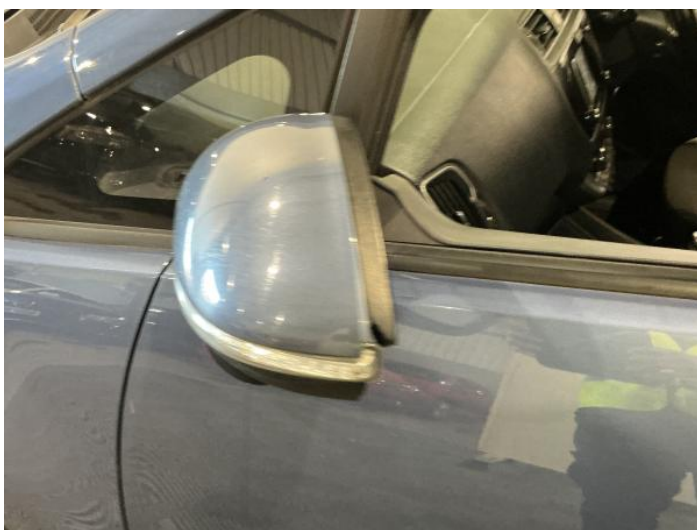
7: Door Mirror Assy nsf  
Broken  
Replace

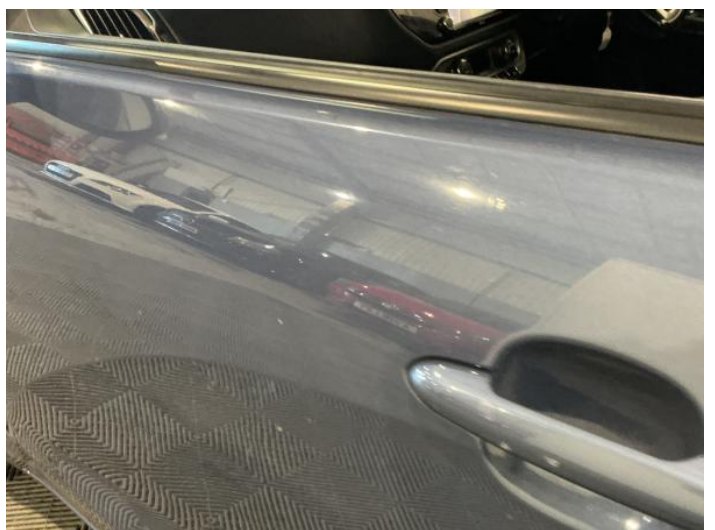
8: Door nsf  
Chipped  
Multiple Chips

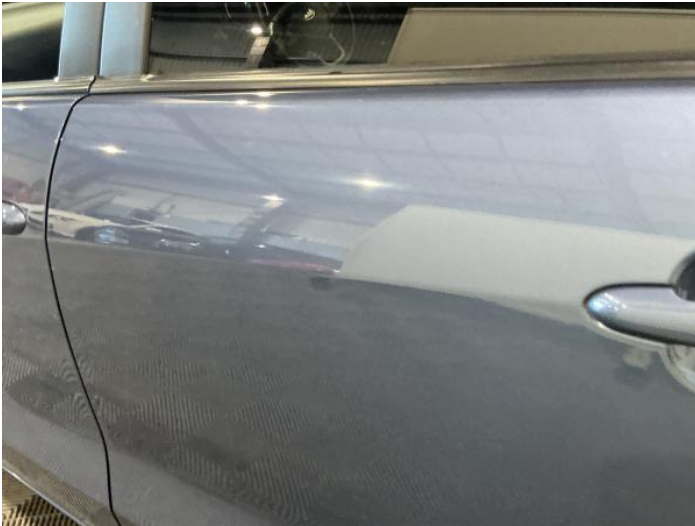
9: Door nsr  
Dented  
2 Or Less UpTo 10mm

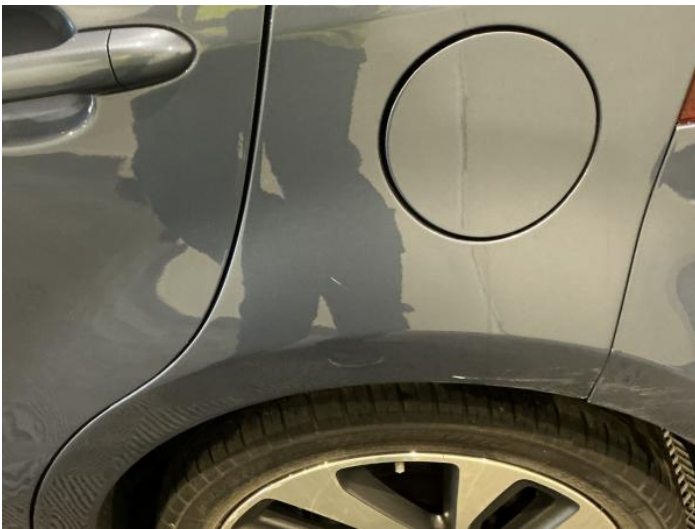
11: Qtr Panel nsr  
Dented  
With Paint Damage

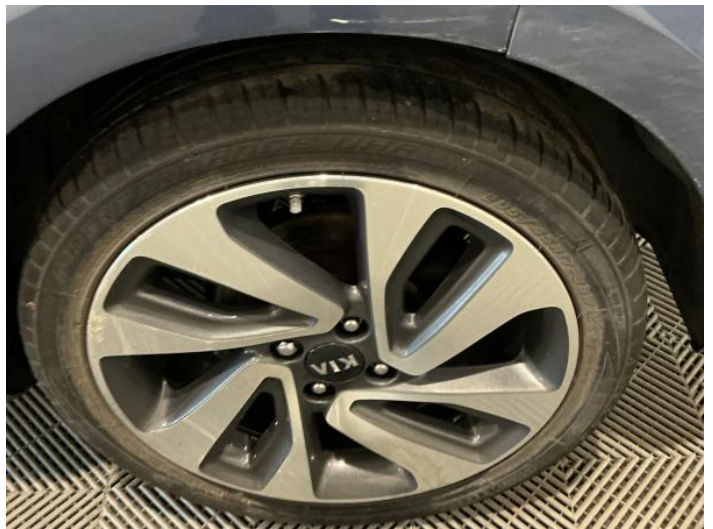
12: Wheel nsr  
Scratched  
Over 50mm

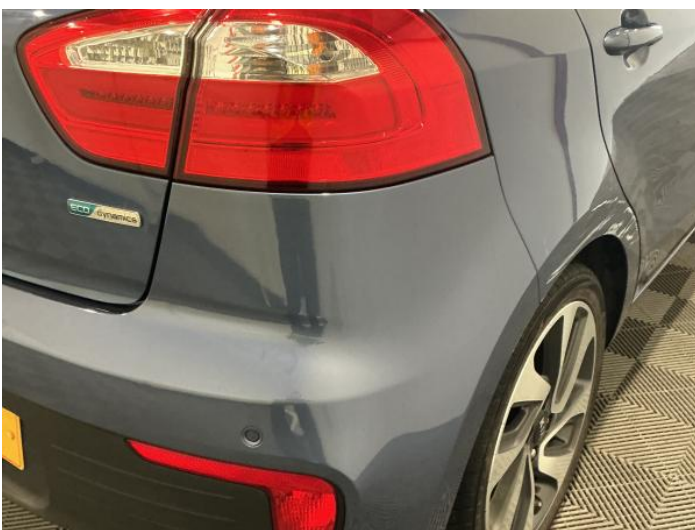
13: Bumper Rear  
Scratched  
25 to 100mm Thru Paint

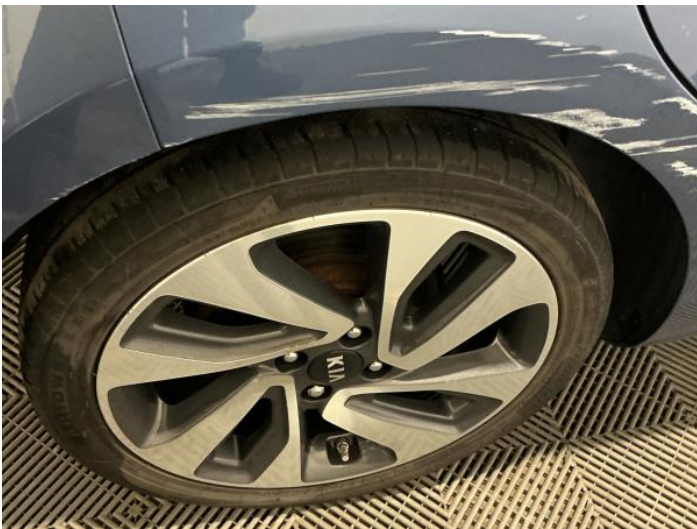
17: Wheel osr  
Scratched  
Up To 50mm

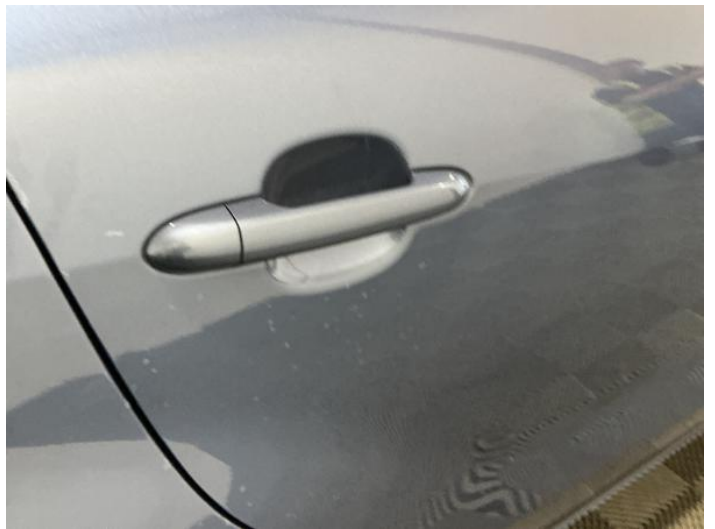
18: Door osr  
Chipped  
Multiple Chips

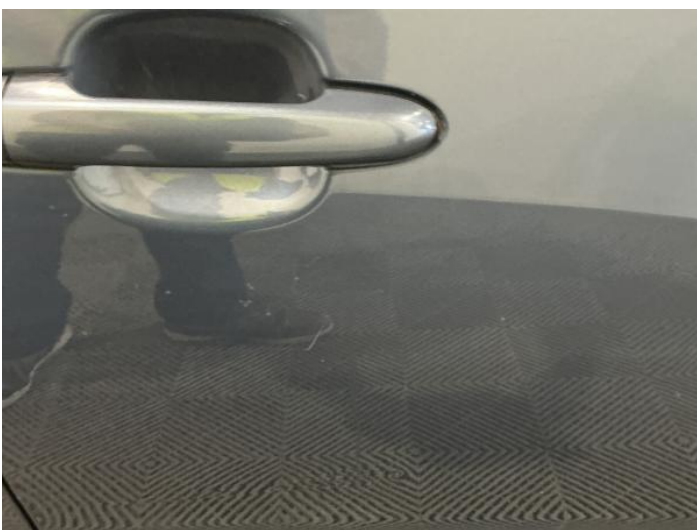
19: Door osf  
Chipped  
1 To 5

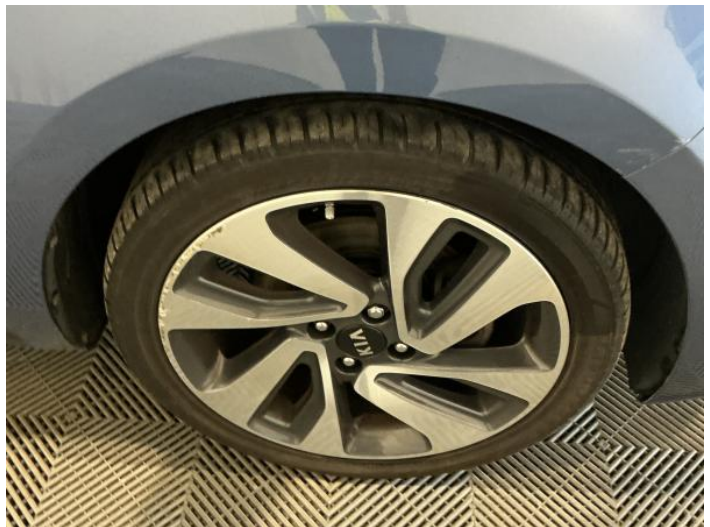
22: Wheel osf  
Scratched  
Over 50mm
