# VEHICLE INSPECTION REPORT

OV17YBS

## Mercedes-Benz A Class A200d SE Executive 5dr

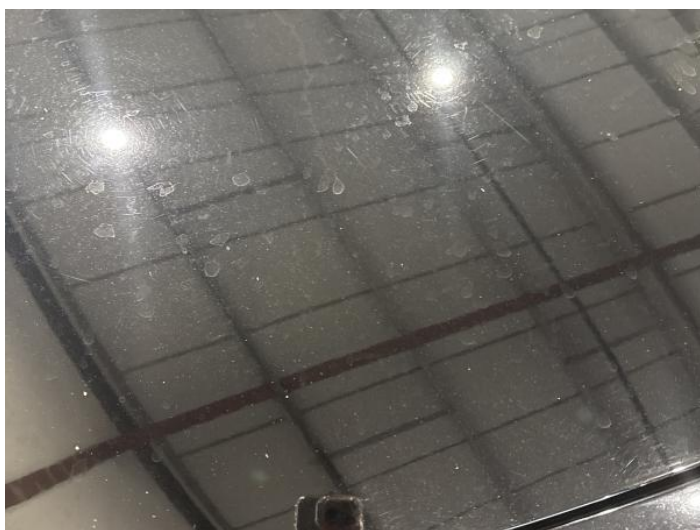
1: Bonnet  
Chipped  
Multiple Chips

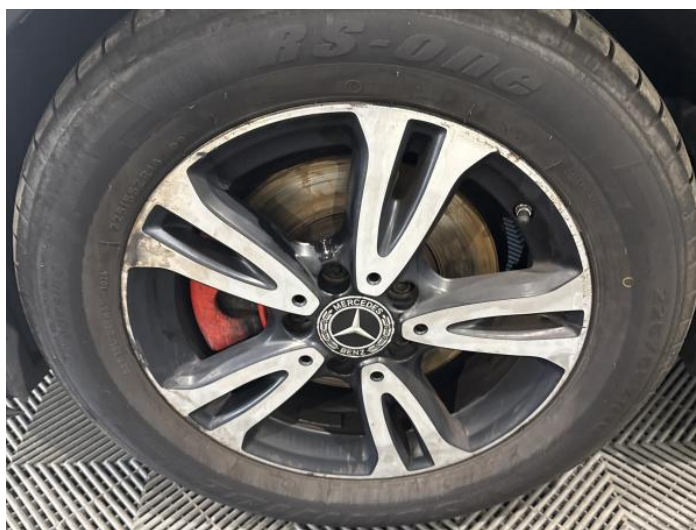
2: Wheel nsf  
Scratched  
Over 50mm

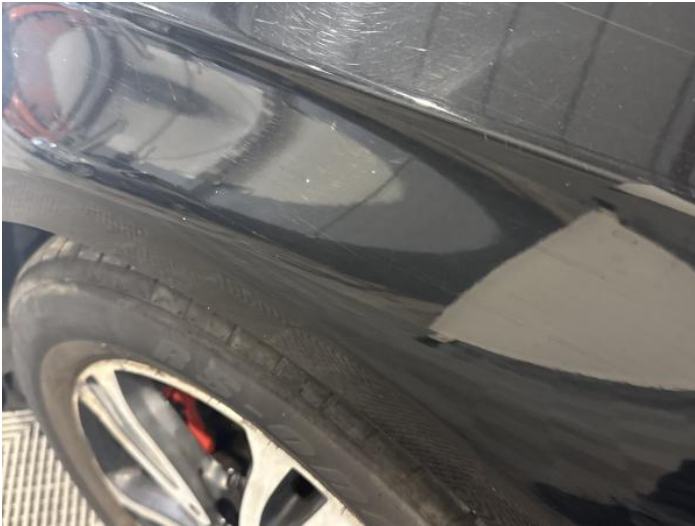
3: Wing nsf  
Chipped  
1 To 5

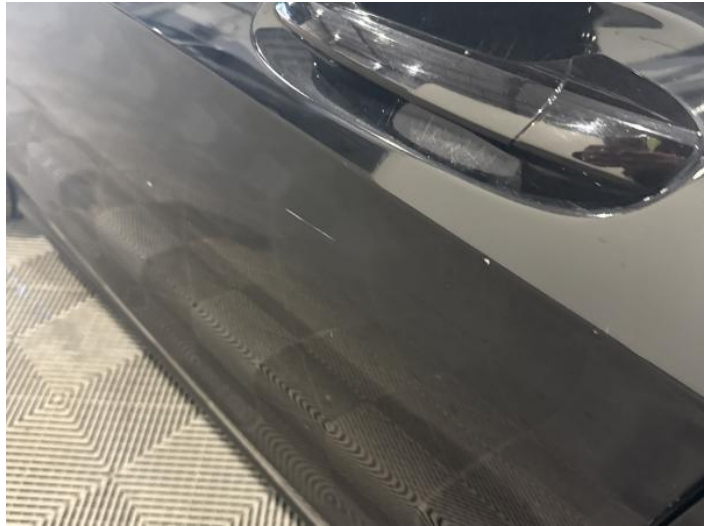
4: Door nsf  
Scratched  
Over 25mm Thru Paint

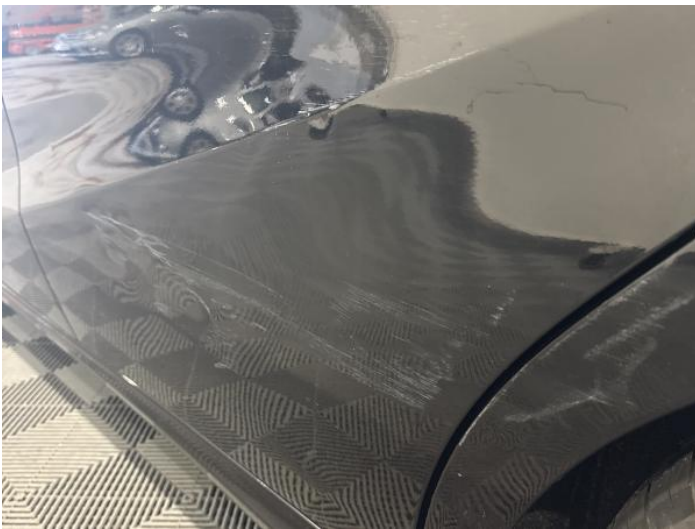
5: Door nsr  
Dented  
With Paint Damage

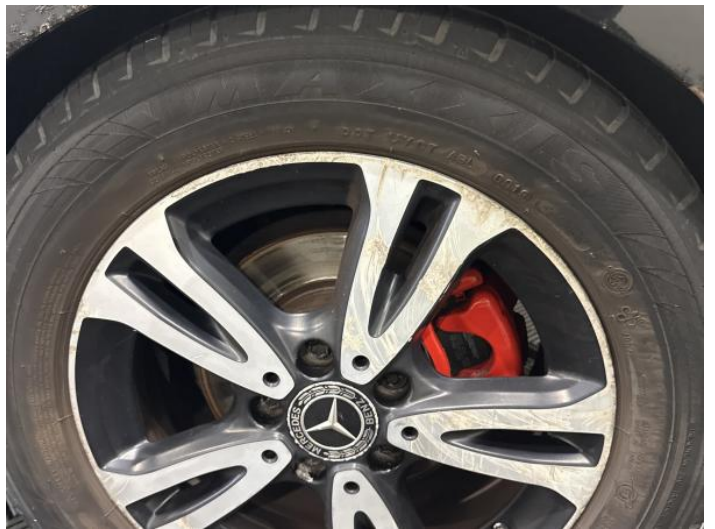
6: Wheel nsr  
Scratched  
Over 50mm

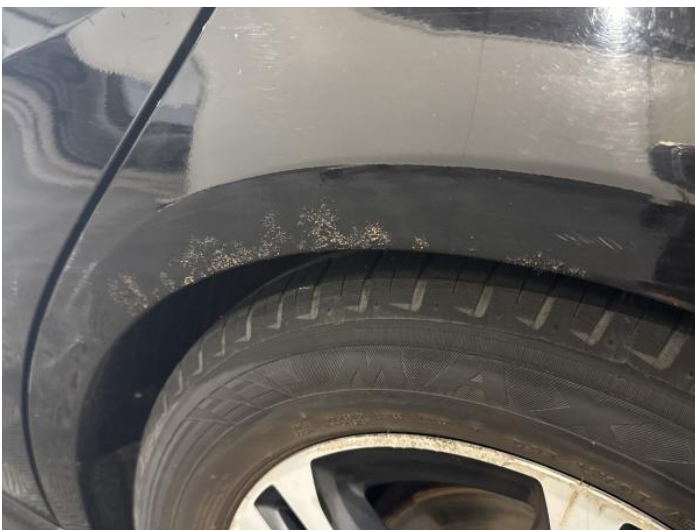
7: Qtr Panel nsr  
Rusted  
Over 5mm

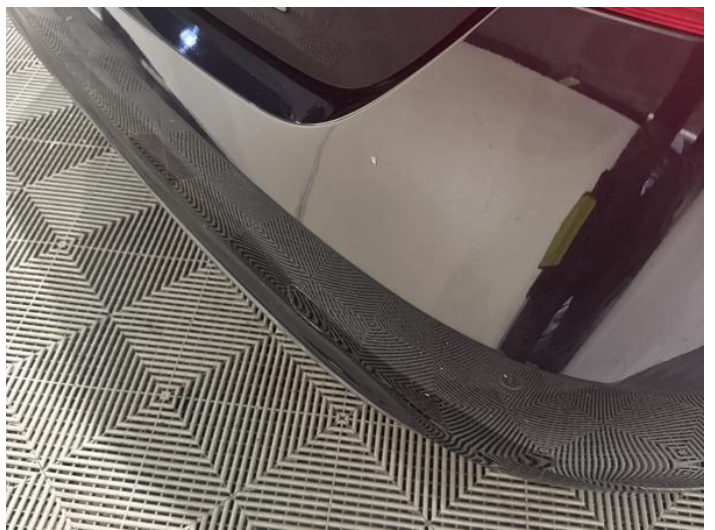
8: Bumper Rear  
Chipped  
Multiple Chips

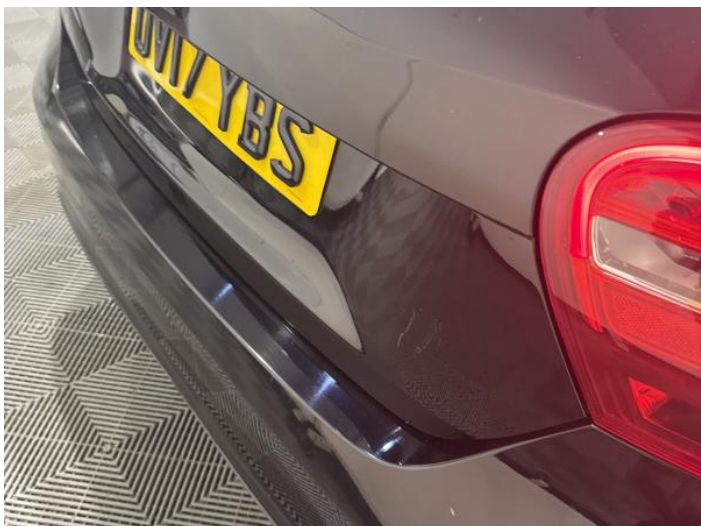
9: Tailgate  
Scratched  
Over 25mm Thru Paint

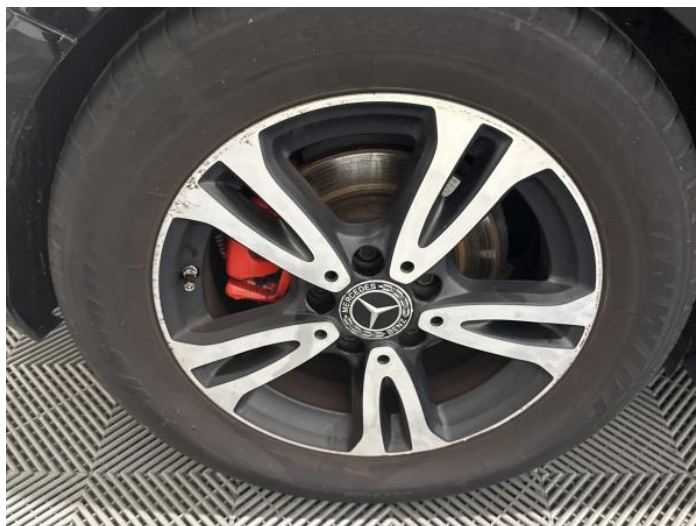
10: Wheel osr  
Scratched  
Over 50mm

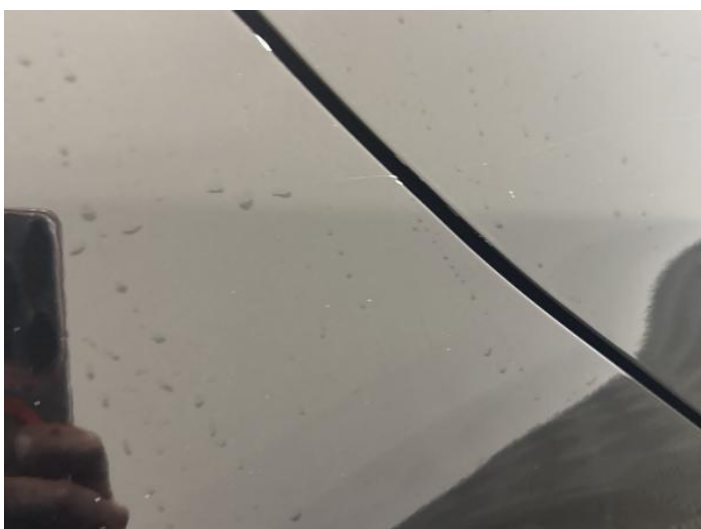
11: Qtr Panel osr  
Chipped  
Edge Chip

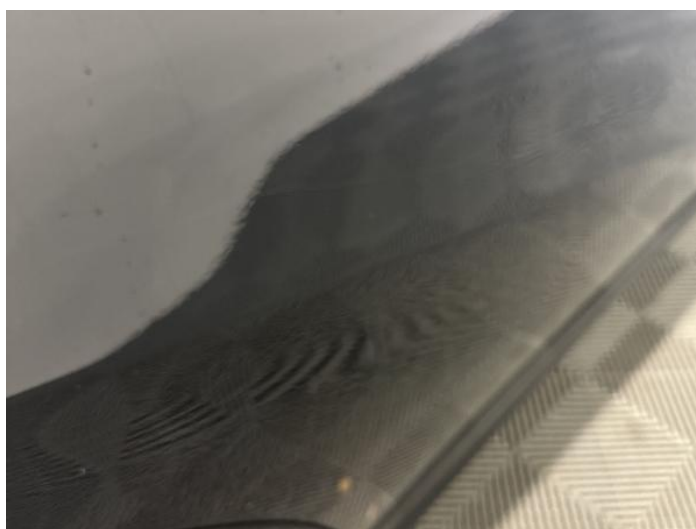
12: Door osr  
Scratched  
Over 25mm Thru Paint

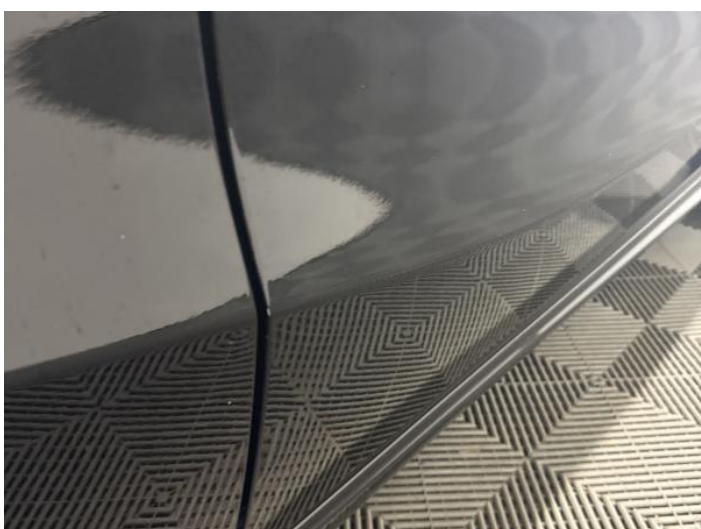
13: Door osf  
Chipped  
Edge Chip

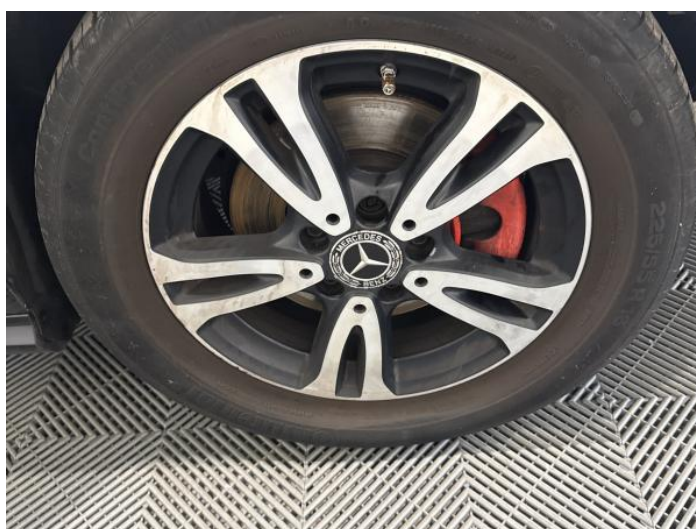
14: Wheel osf  
Scratched  
Up To 50mm

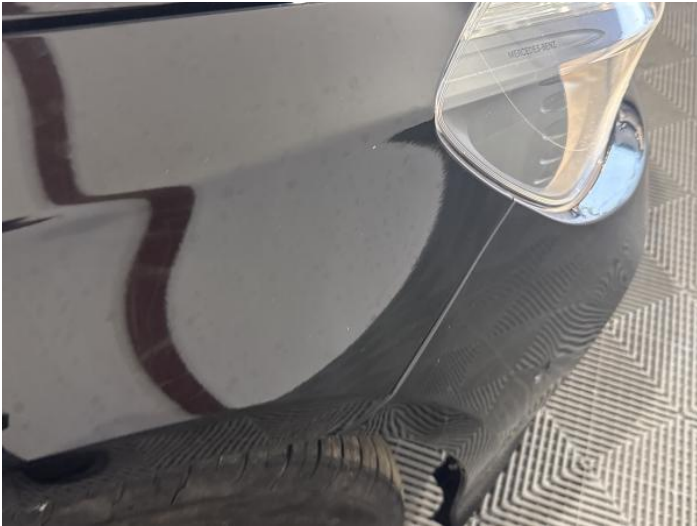
15: Wing osf  
Chipped  
1 To 5

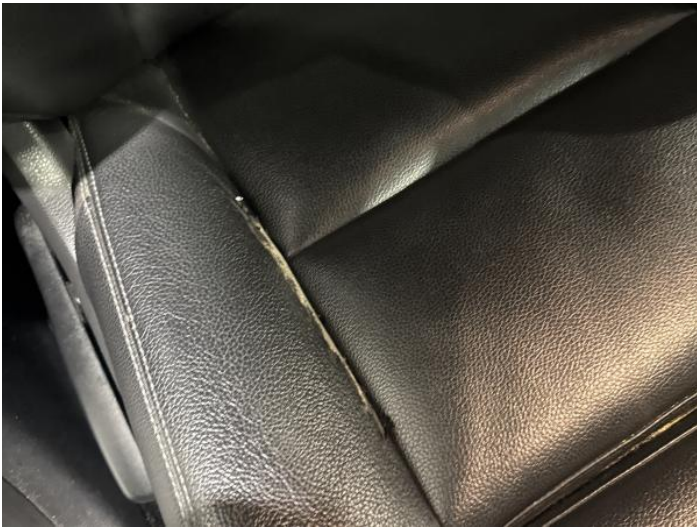
17: Seat Base Cover osf  
Scuffed  
Over 25mm

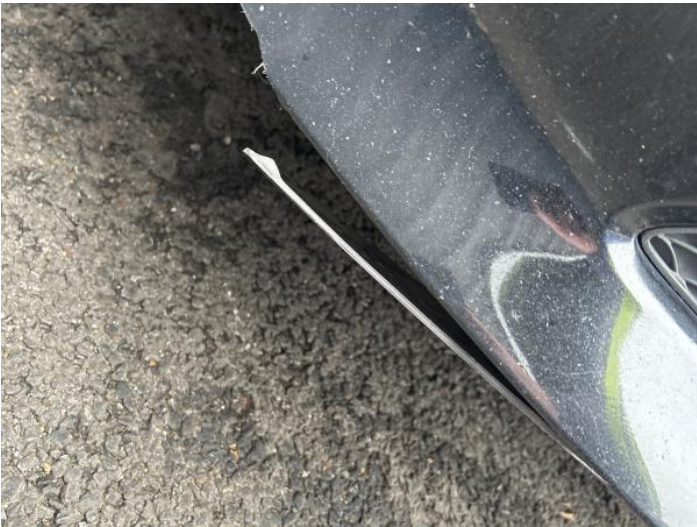
18: Bumper Front  
Cracked  
Over 25mm
