VEHICLE INSPECTION REPORT

VK13NHZ

Nissan Qashqai 1.6 dCi 360 5dr [Start Stop]

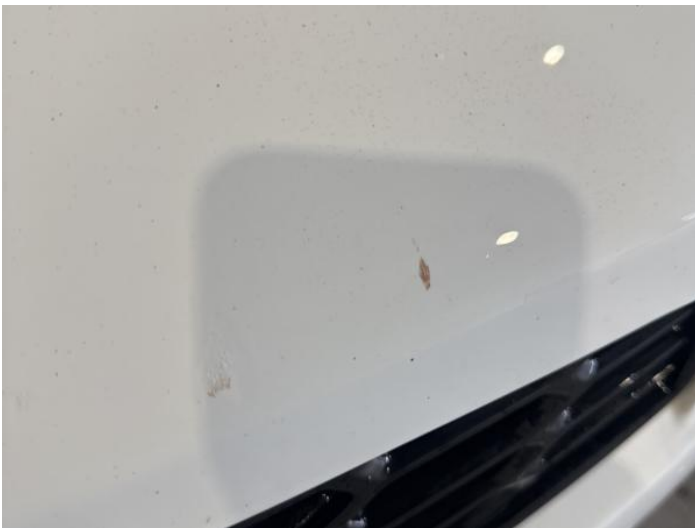
1: Bonnet
Poor Previous Repair
Poor Paint

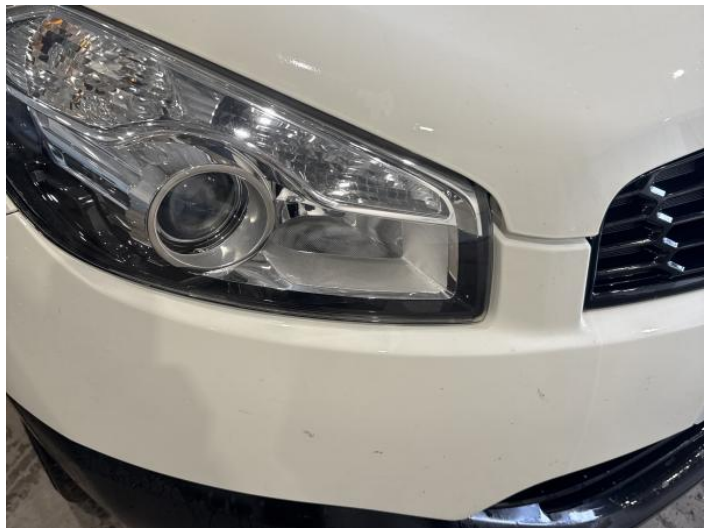
2: Bumper Front
Poor Previous Repair
Poor Colour

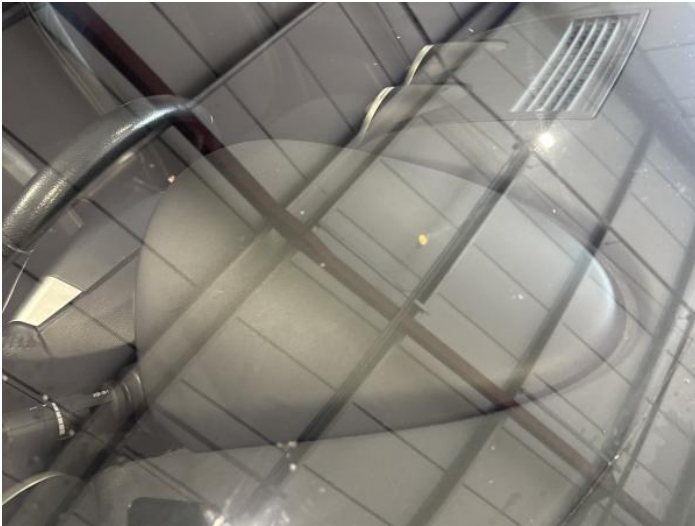
3: Screen Front
Chipped
UpTo 10mm

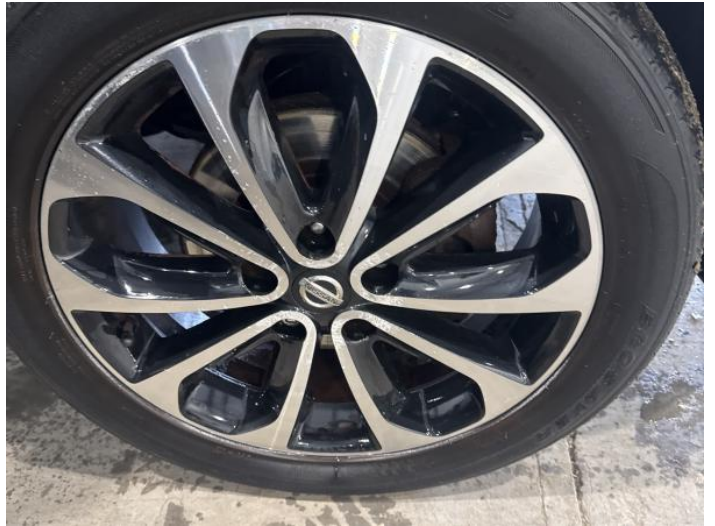
4: Wheel osf
Scratched
Over 50mm

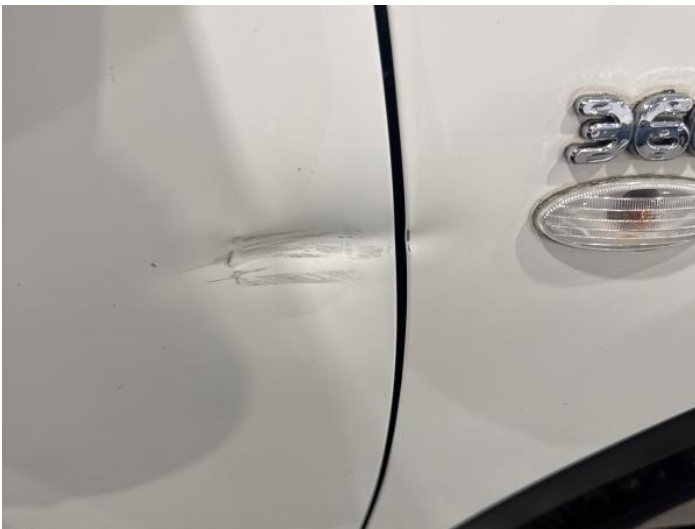
5: Door osf
Dented
With Paint Damage

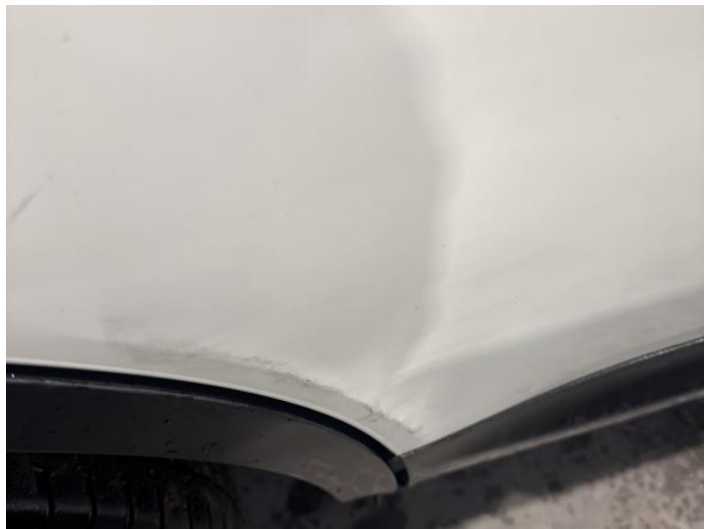
6: Door osr
Dented
With Paint Damage

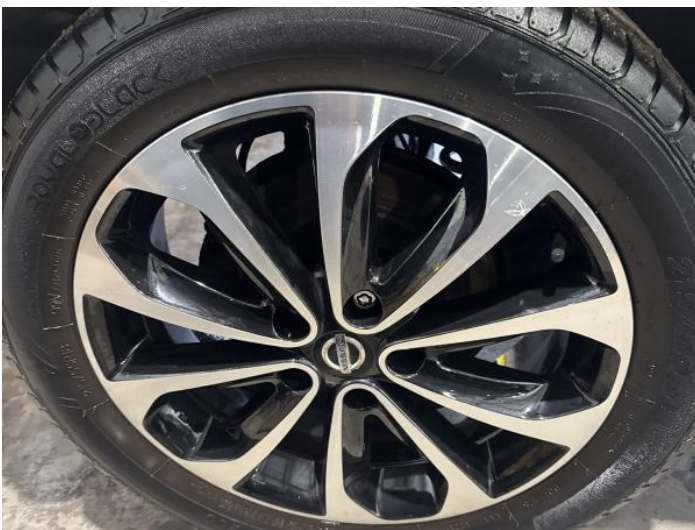
7: Wheel osr
Scratched
Over 50mm

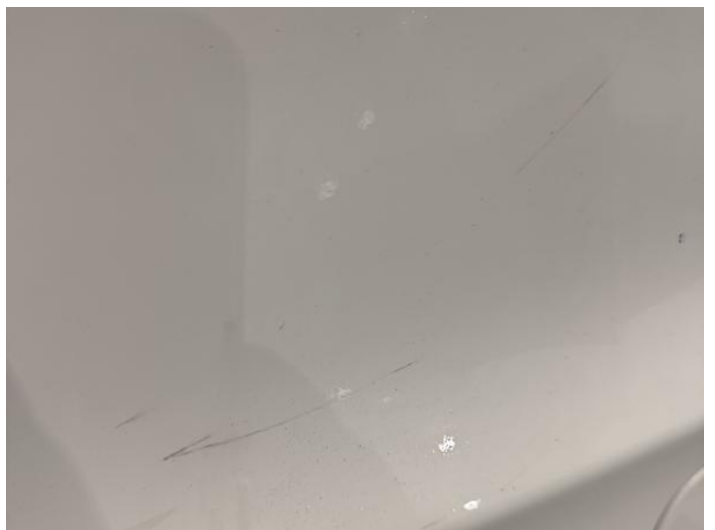
8: Qtr Panel osr
Poor Previous Repair
Poor Paint

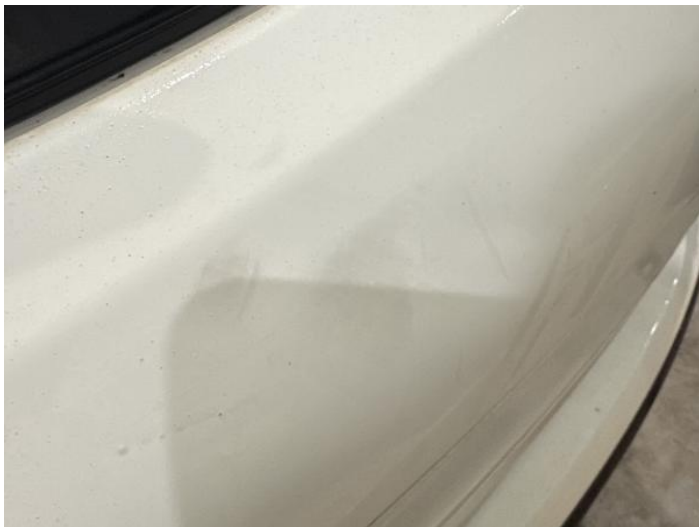
9: Boot Lid
Poor Previous Repair
Poor Paint

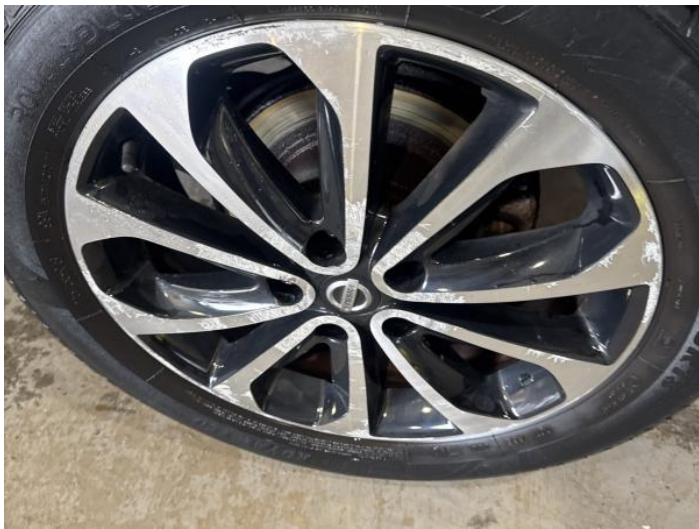
11: Wheel nsr
Scratched
Over 50mm

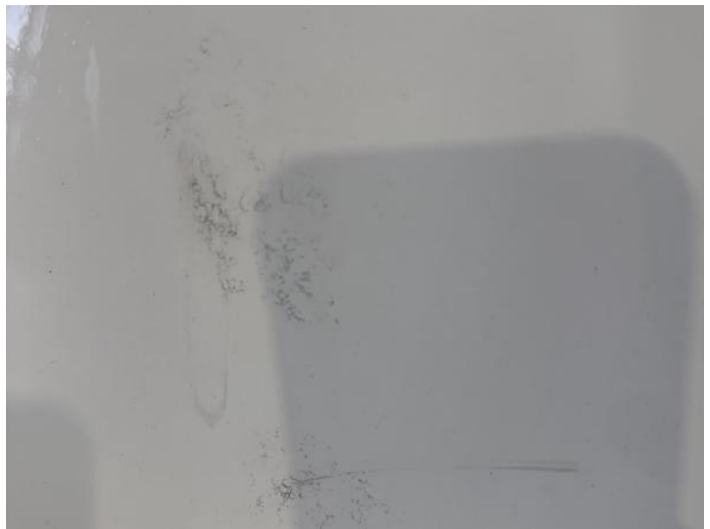
12: Qtr Panel nsr
Poor Previous Repair
Poor Paint

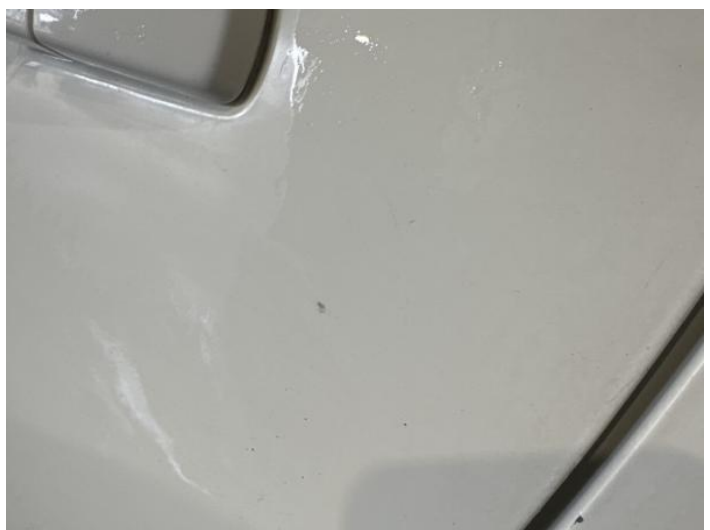
14: Door nsr
Chipped
1 To 5
