# VEHICLE INSPECTION REPORT

**AK69NJE**

## Volkswagen Tiguan 1.5 TSi EVO 150 Match 5dr

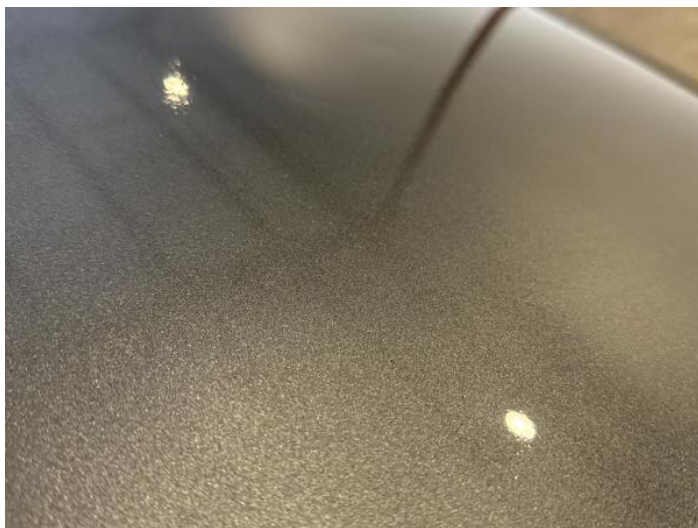
1: Bonnet  
Dented  
Between 10mm + 30mm

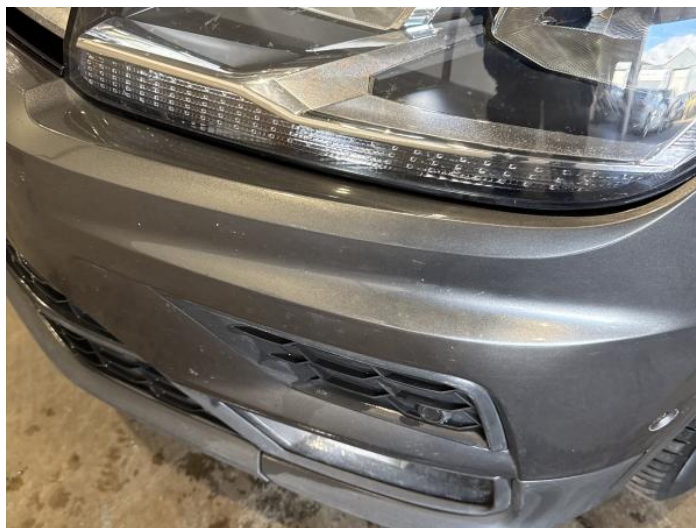
2: Bumper Front  
Scratched  
25 to 100mm Thru Paint

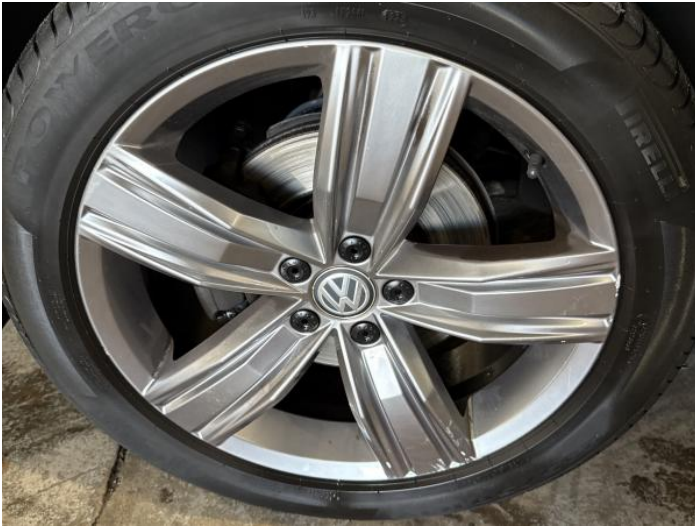
3: Wheel nsf  
Scratched  
Over 50mm

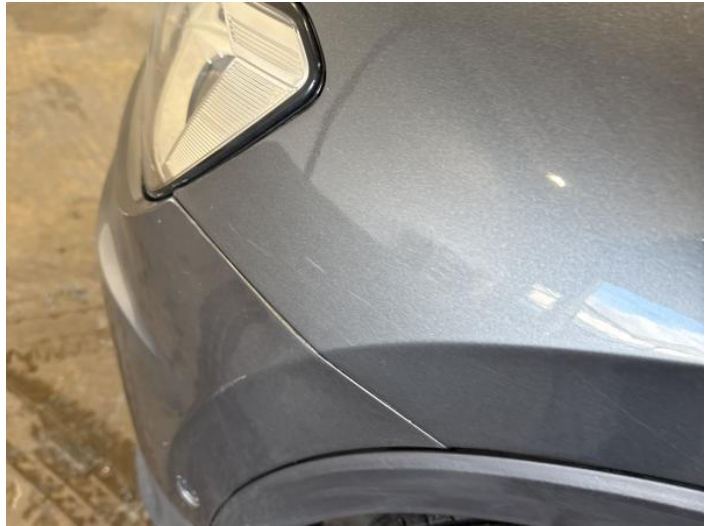
4: Wing nsf  
Scratched  
UpTo 25mm Thru Paint

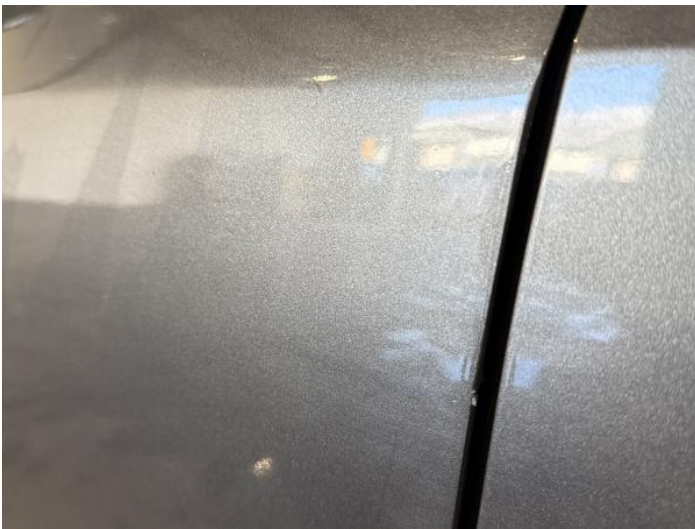
5: Door nsf  
Poor Previous Repair  
Poor Paint

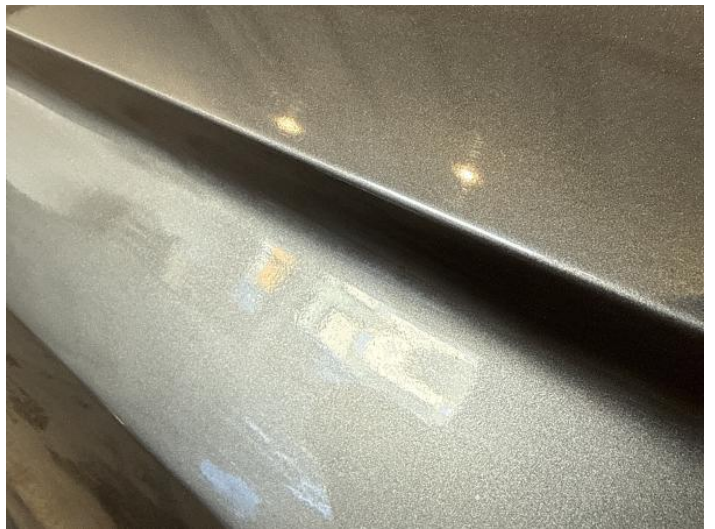
6: Door nsr  
Poor Previous Repair  
Poor Paint

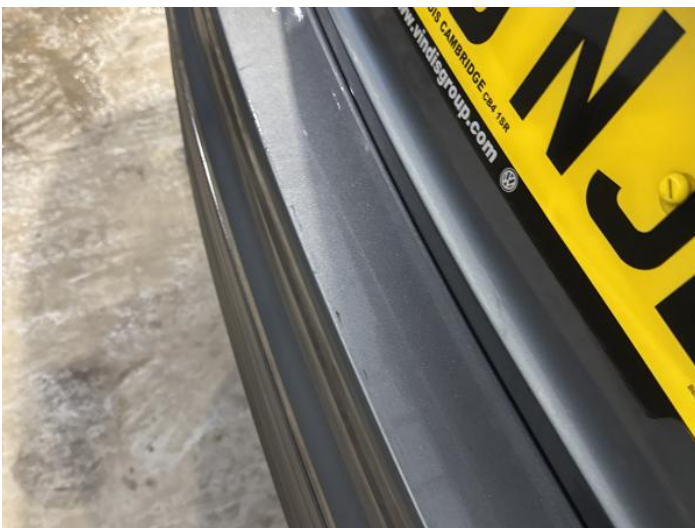
7: Bumper Rear  
Scratched  
25 to 100mm Thru Paint

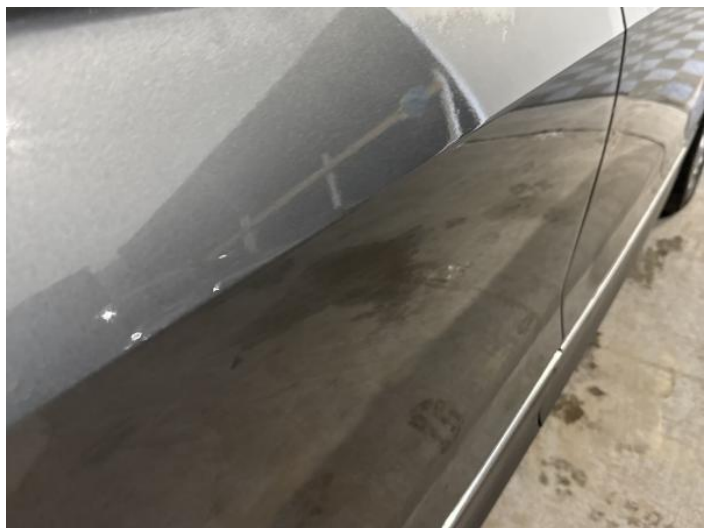
8: Door osr  
Dented  
2 Or Less UpTo 10mm

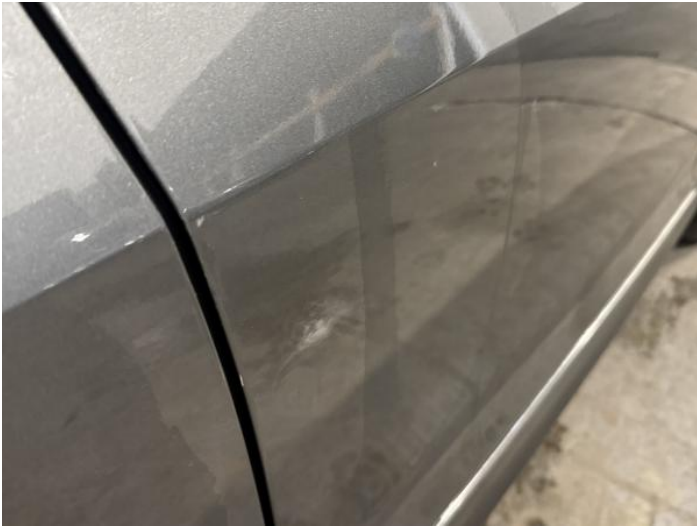
9: Door osf  
Chipped  
Edge Chip

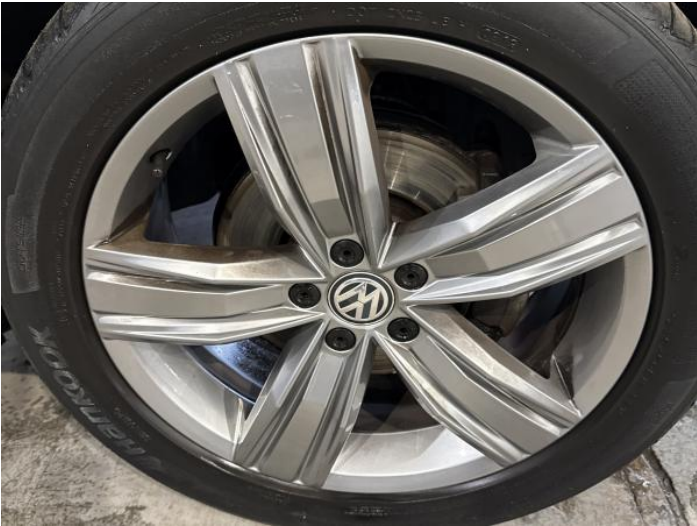
10: Wheel osf  
Scratched  
Up To 50mm

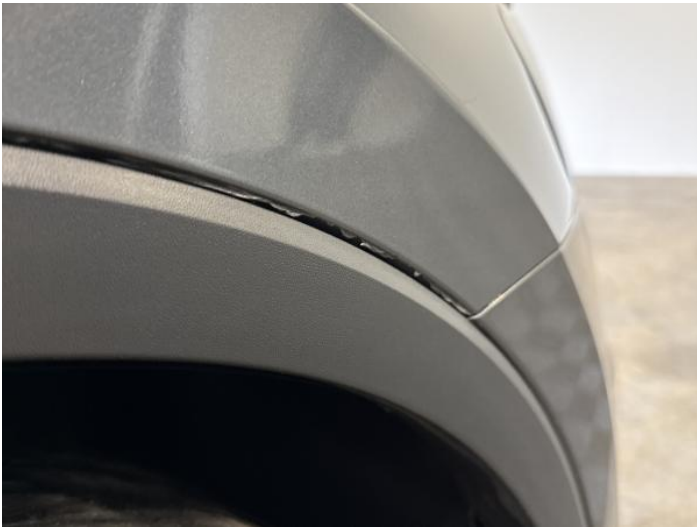
11: Wing osf  
Poor Previous Repair  
Rippled UpTo 30%

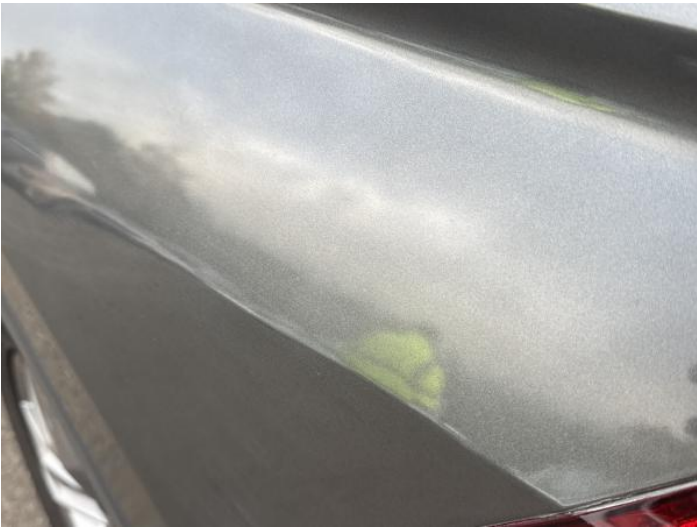
12: Qtr Panel nsr  
Poor Previous Repair  
Rippled UpTo 30%
