# VEHICLE INSPECTION REPORT

**WJ67NHB**

## Peugeot 3008 1.6 BlueHdi 120 GT Line 5dr EAT6

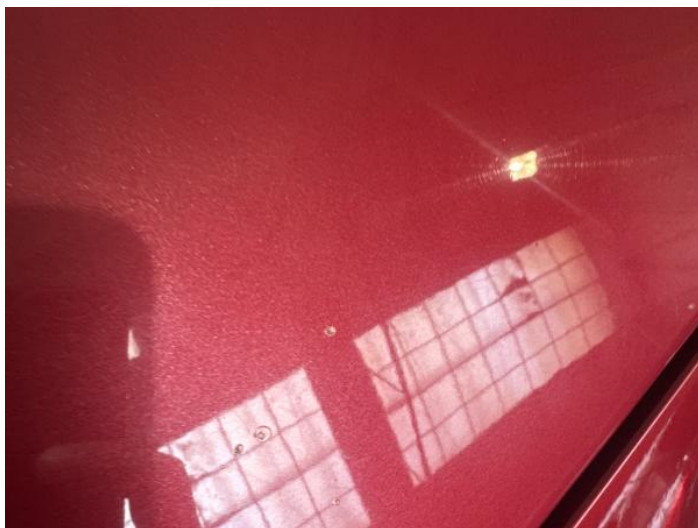
1: Bonnet  
Chipped  
Multiple Chips

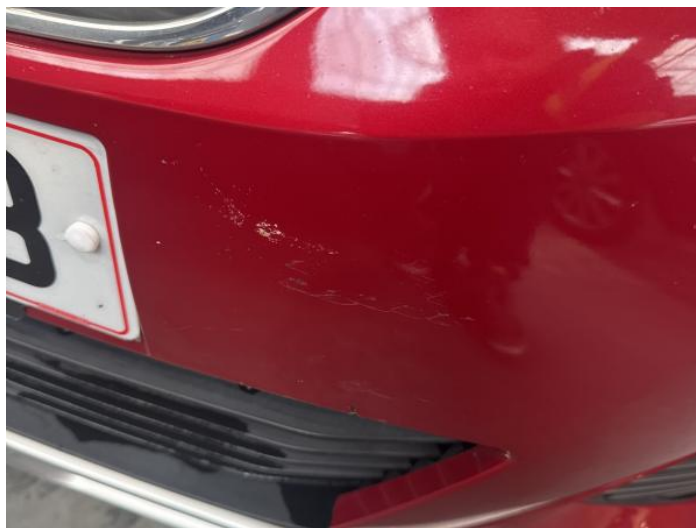
2: Bumper Front  
Scratched  
25 to 100mm Thru Paint

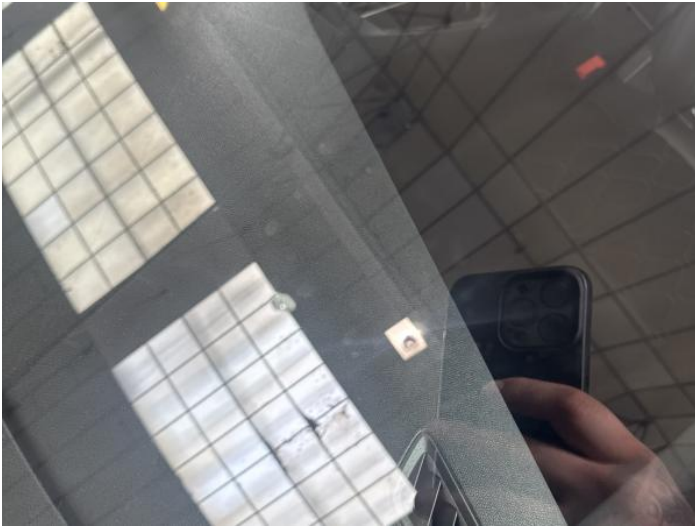
3: Screen Front  
Chipped  
UpTo 10mm

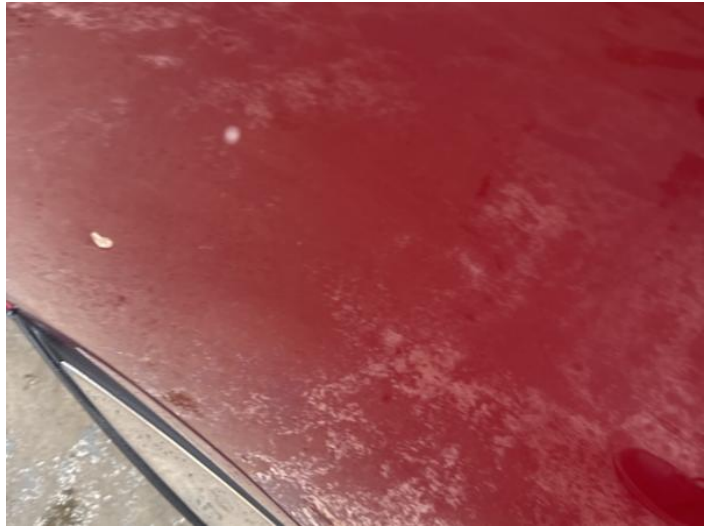
4: Door nsf  
Chipped  
1 To 5

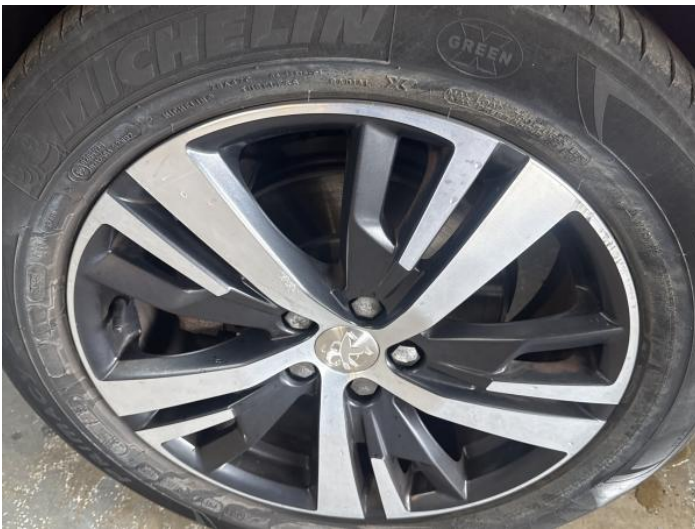
5: Wheel nsf  
Corroded  
Light

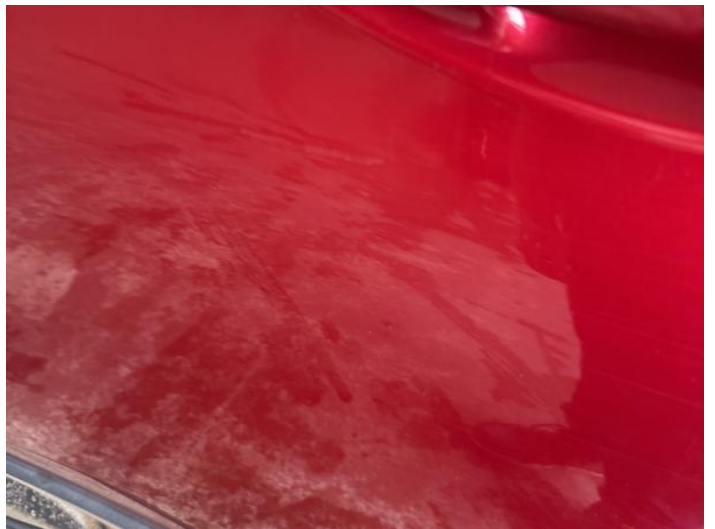
6: Door nsr  
Scratched  
Over 25mm Thru Paint

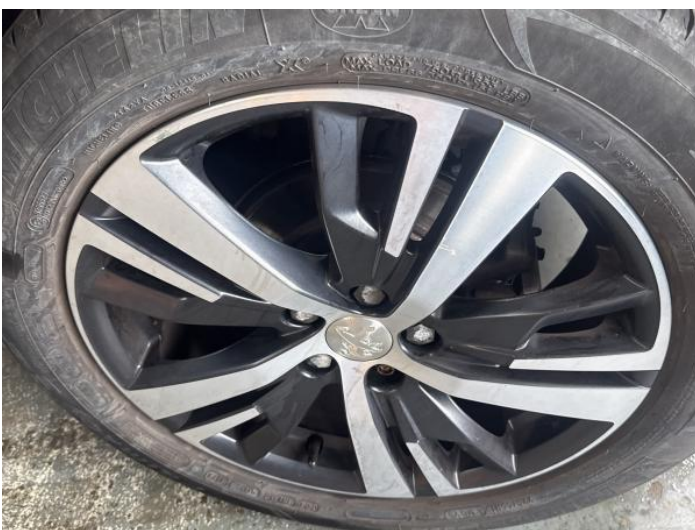
7: Wheel nsr  
Scratched  
Over 50mm

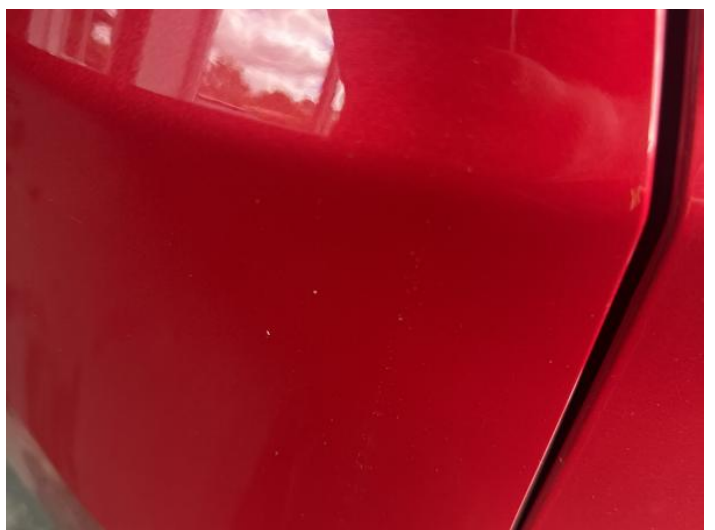
8: Bumper Rear  
Chipped  
Multiple Chips

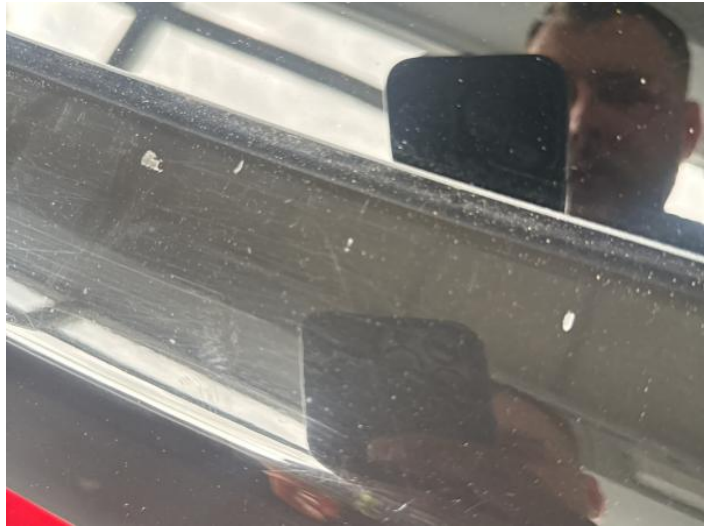
10: Boot Lid  
Chipped  
1 To 5

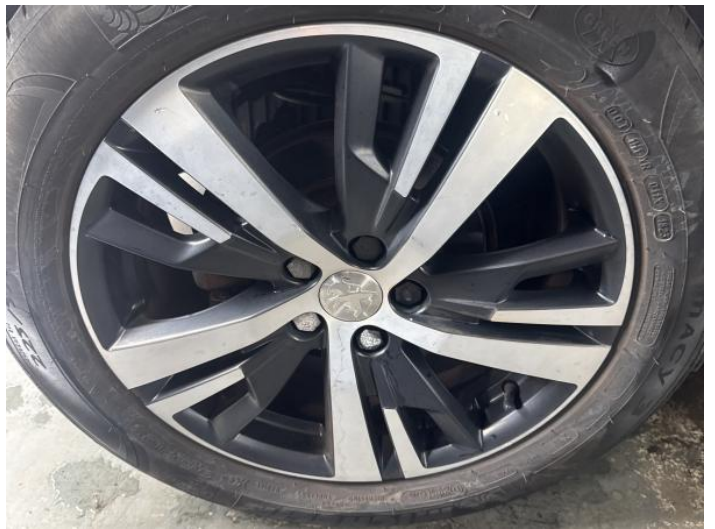
12: Wheel osr  
Corroded  
Light

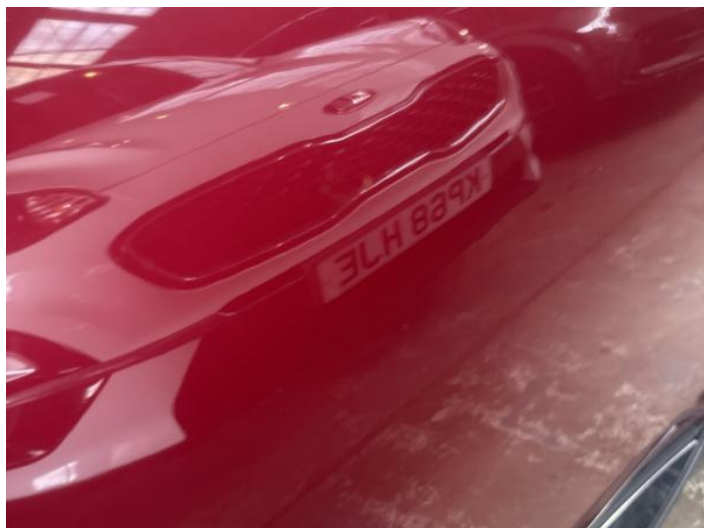
14: Door osf  
Chipped  
1 To 5

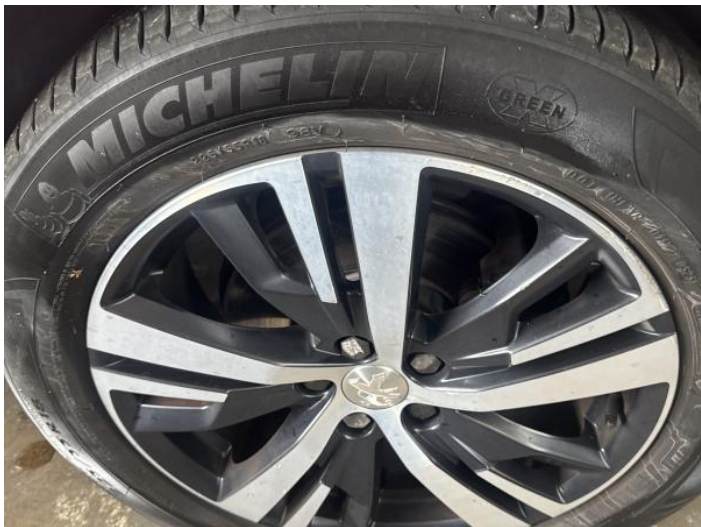
15: Wheel of  
Corroded  
Light
