# VEHICLE INSPECTION REPORT

**HY16ZTM**

## Mazda 6 2.0 Sport Nav 4dr

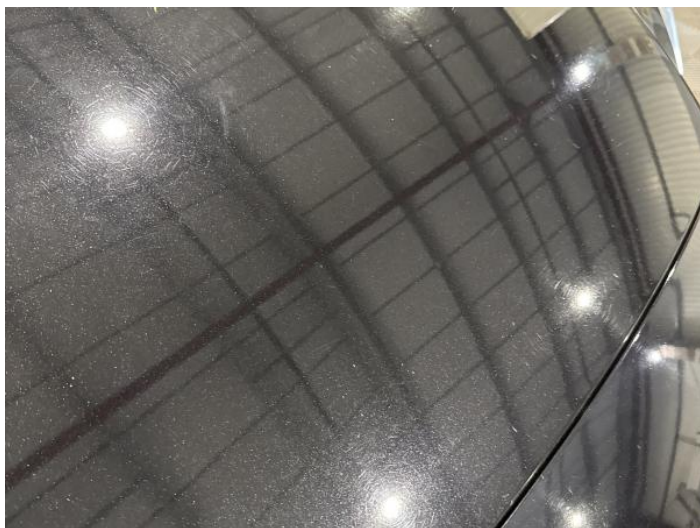
1: Bonnet  
Chipped  
Multiple Chips

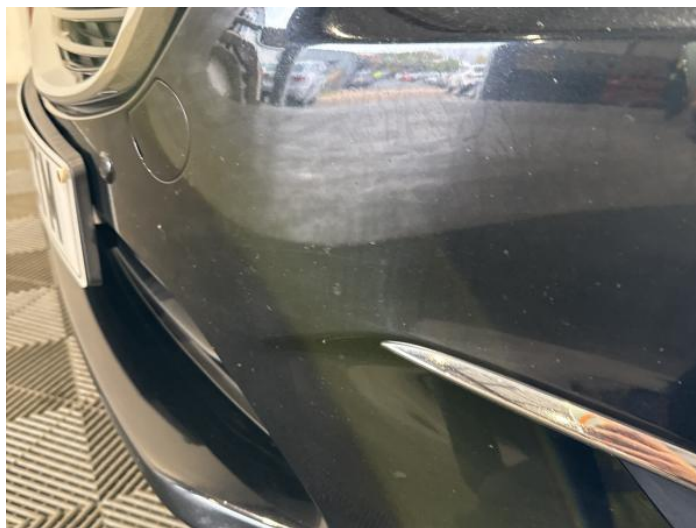
2: Bumper Front  
Chipped  
Multiple Chips

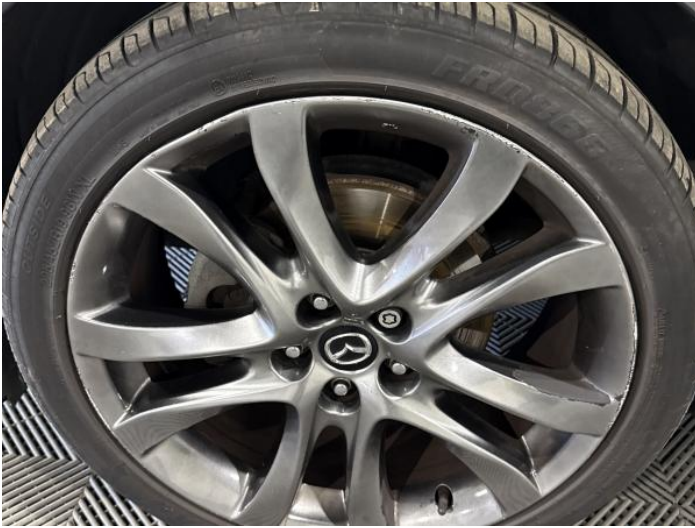
3: Wheel nsf  
Dented  
UpTo 30mm (Alloy)

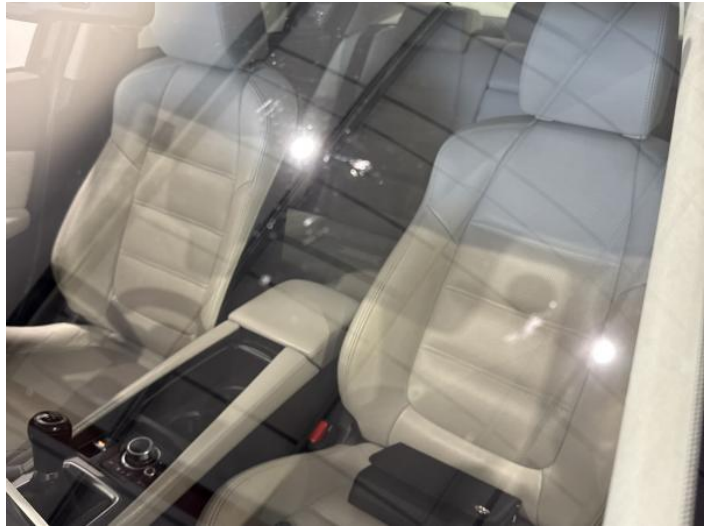
4: Screen Front  
Chipped  
Over 10mm

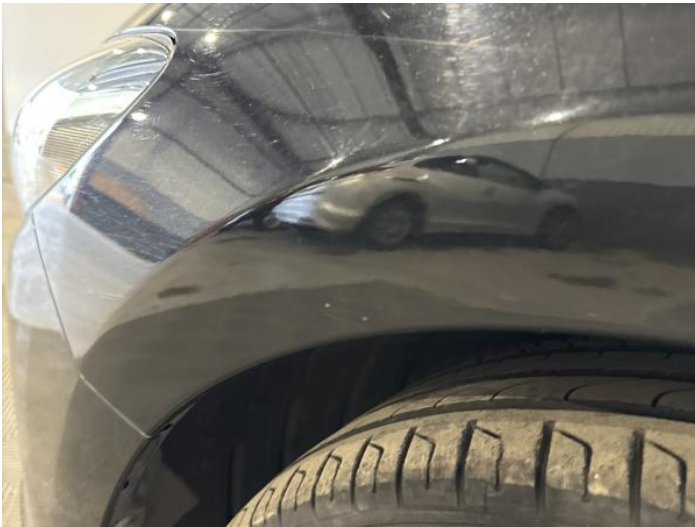
5: Wing nsf  
Chipped  
1 To 5

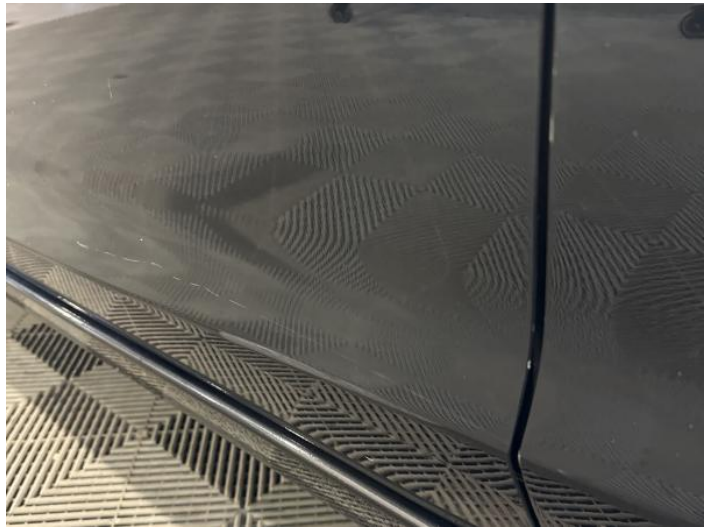
6: Door nsf  
Dented  
Over 30mm

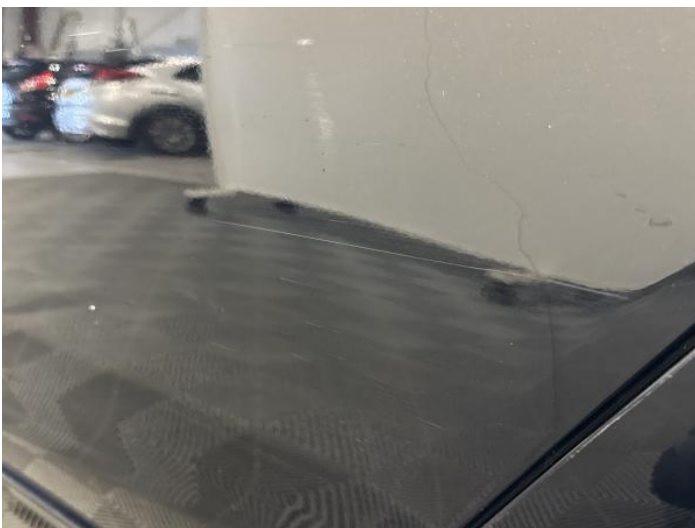
7: Door nsr  
Scratched  
Over 25mm Thru Paint

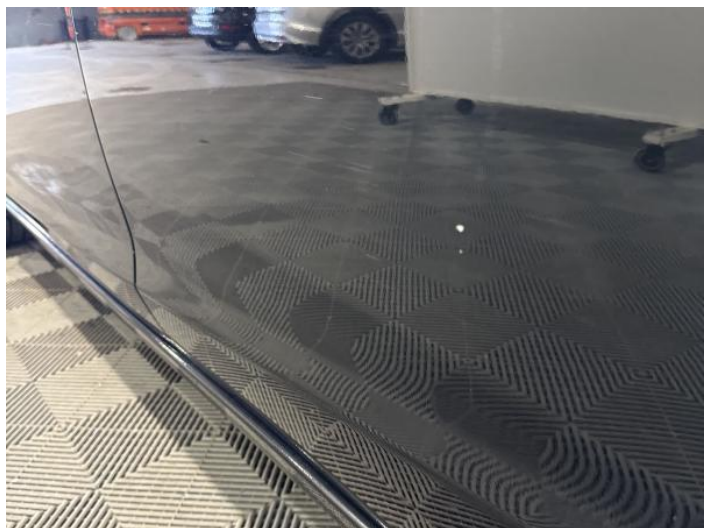
8: Door nsr  
Dented  
Between 10mm + 30mm

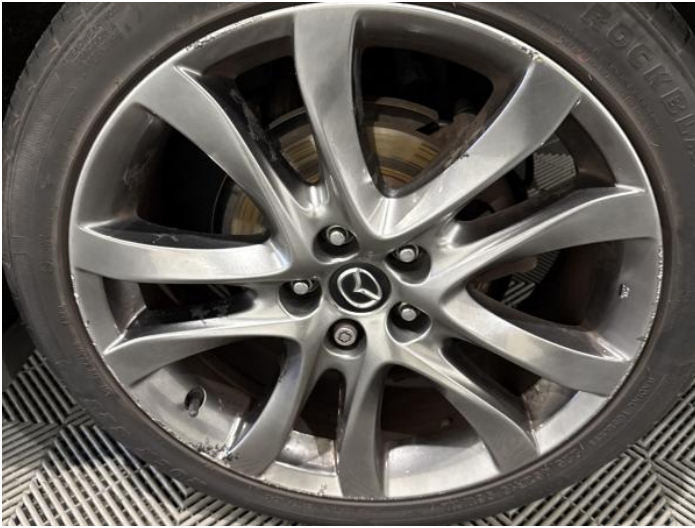
9: Wheel nsr  
Scratched  
Over 50mm

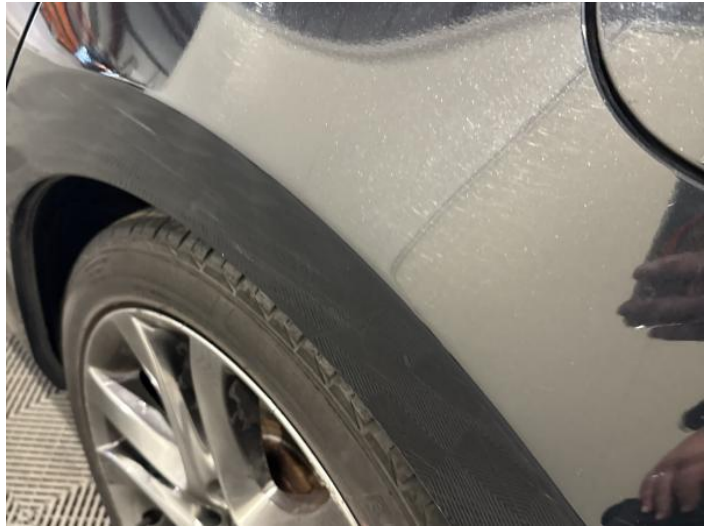
10: Qtr Panel osr  
Scratched  
Over 25mm Thru Paint

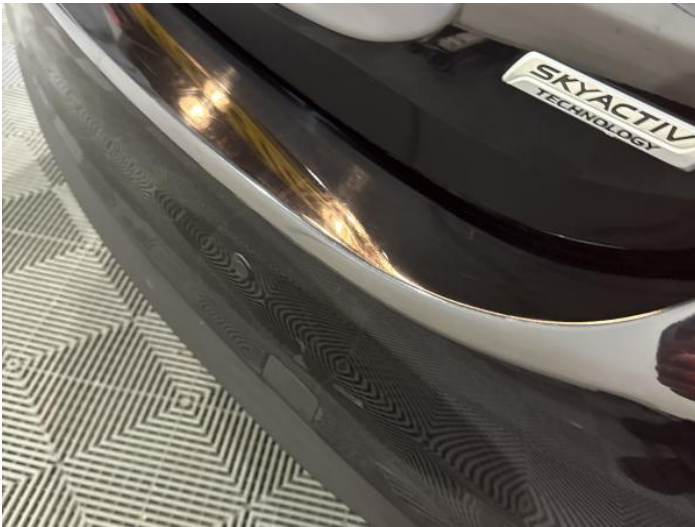
11: Bumper Rear  
Scratched  
25 to 100mm Thru Paint

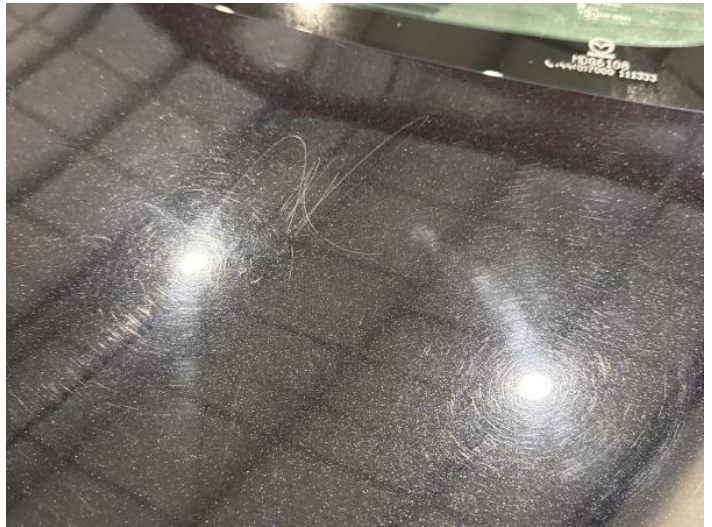
12: Boot Lid  
Scratched  
Over 25mm Thru Paint

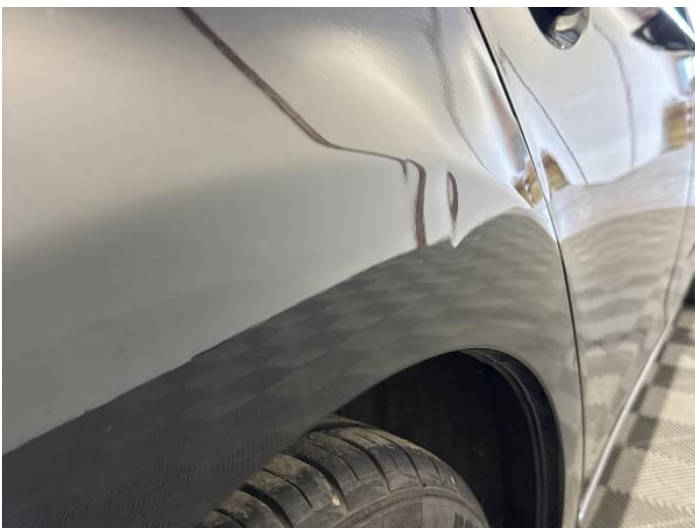
13: Qtr Panel osr  
Dented  
Over 30mm

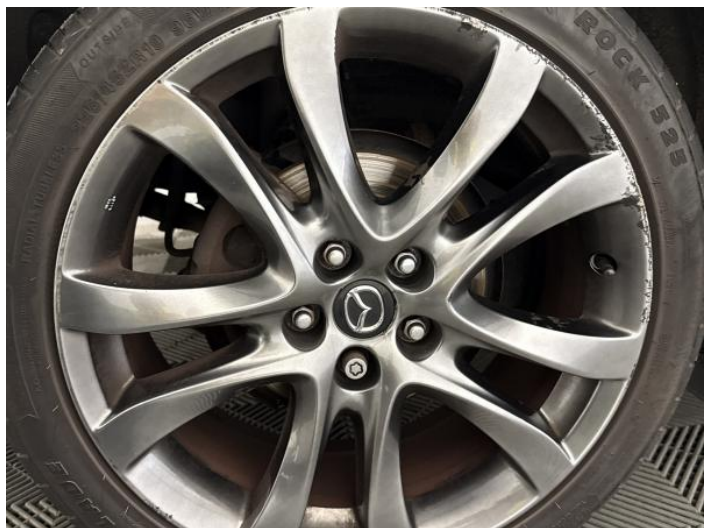
14: Wheel osr  
Scratched  
Over 50mm

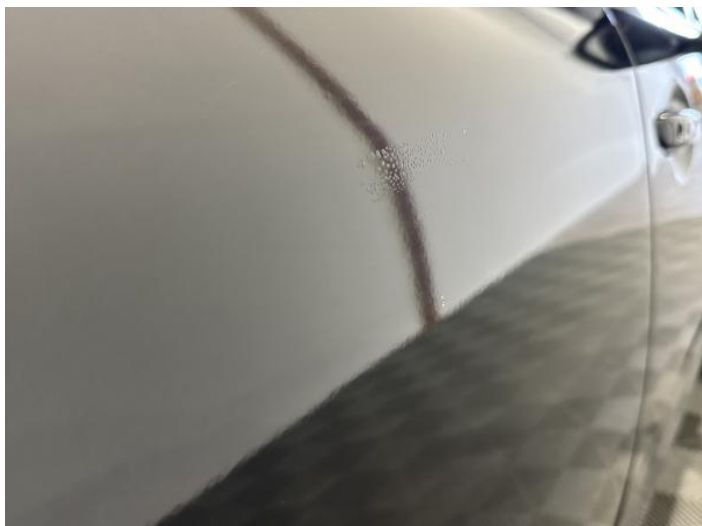
15: Door osr  
Poor Previous Repair  
Poor Paint

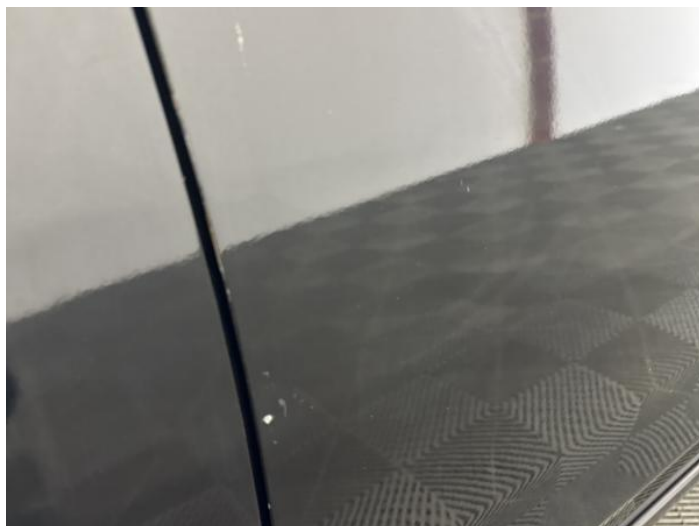
16: Door osf  
Scratched  
UpTo 25mm Thru Paint

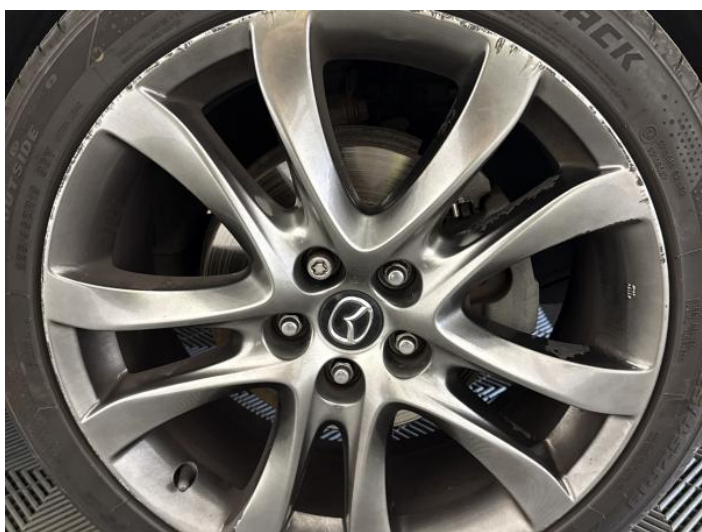
17: Wheel osf  
Scratched  
Over 50mm

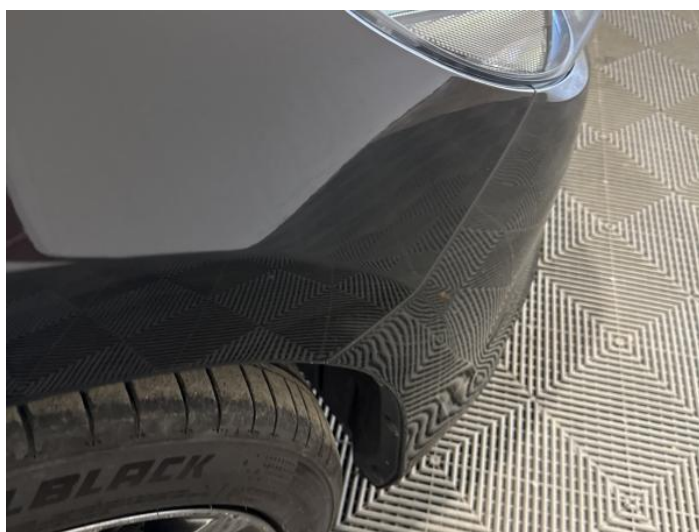
18: Wing osf  
Chipped  
1 To 5

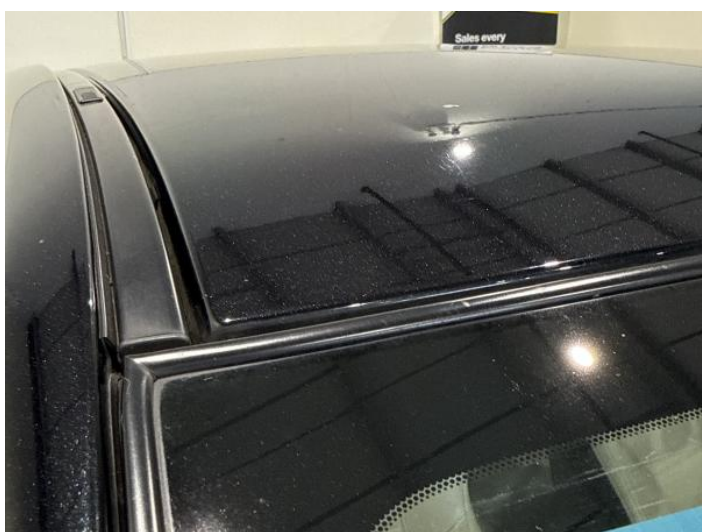
19: Roof  
Dented  
Over 30mm
