# VEHICLE INSPECTION REPORT

**RJ13UVL**

## Honda Civic 1.6 i-DTEC ES 5dr

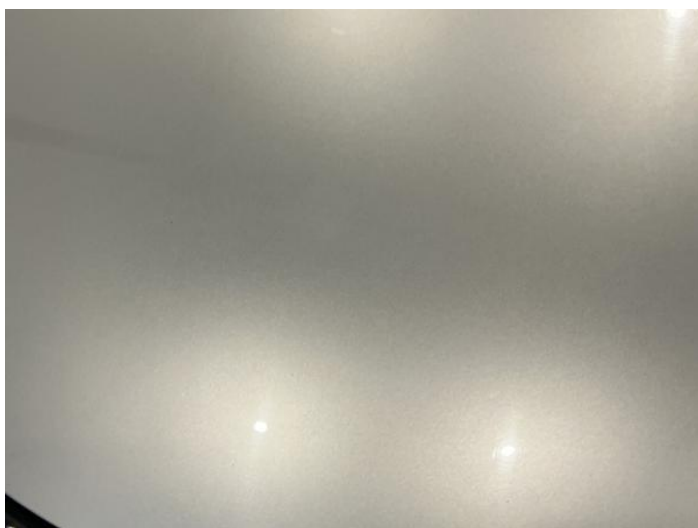
1: Bonnet  
Chipped  
1 To 5

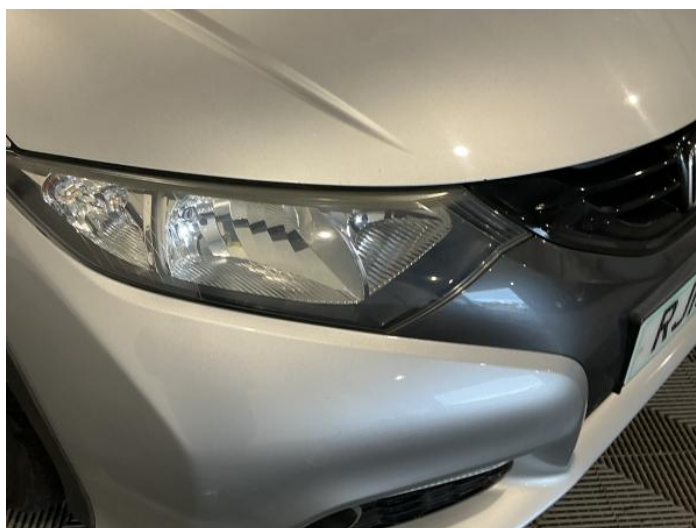
2: Bumper Front  
Poor Previous Repair  
Poor Paint

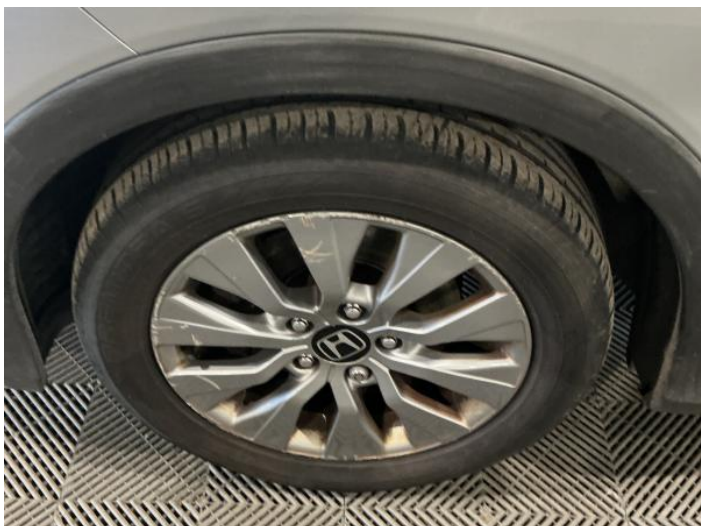
3: Wheel nsf  
Scratched  
Over 50mm

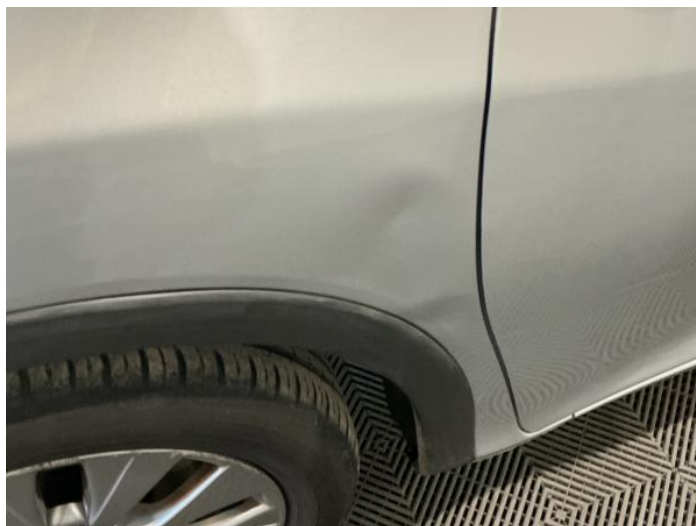
4: Wing nsf  
Dented  
Over 30mm

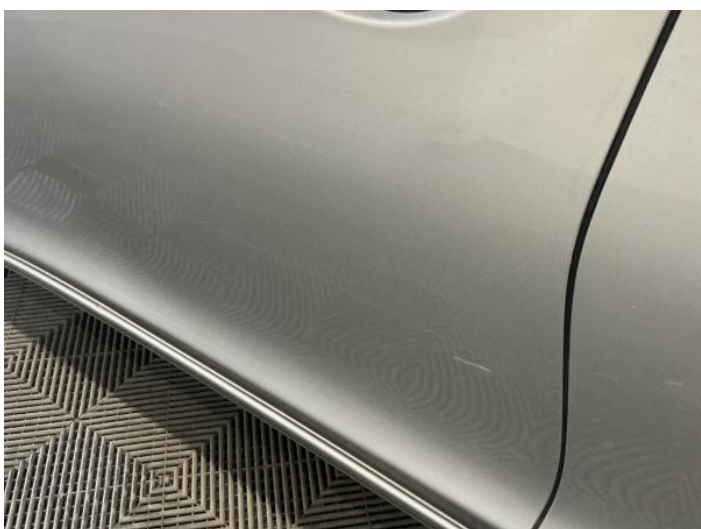
5: Door nsf  
Scratched  
Over 25mm Thru Paint

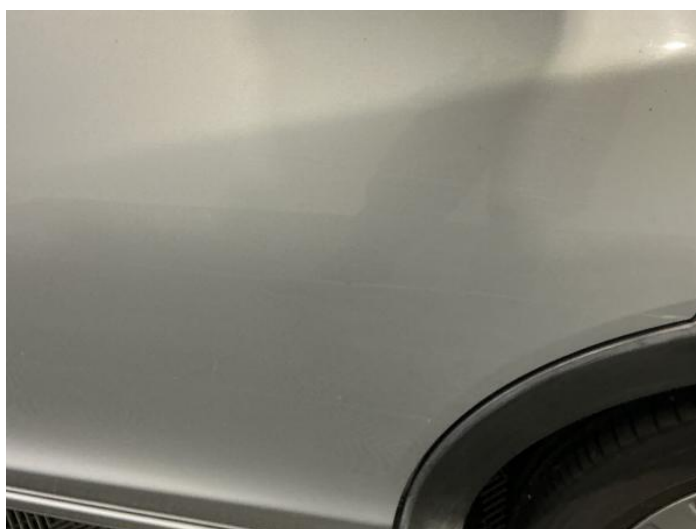
6: Door nsr  
Scratched  
Over 25mm Thru Paint

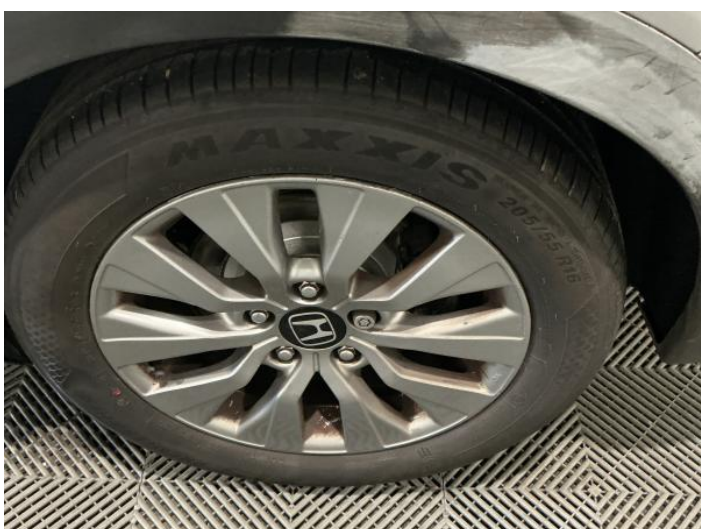
7: Wheel nsr  
Scratched  
Over 50mm

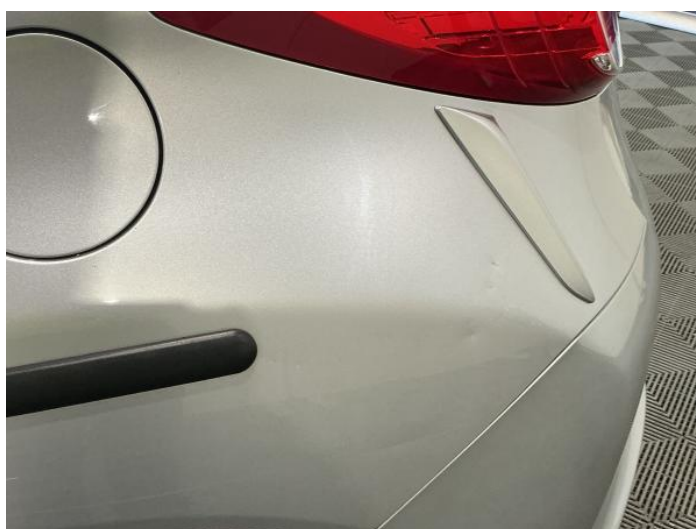
8: Qtr Panel nsr  
Dented  
With Paint Damage

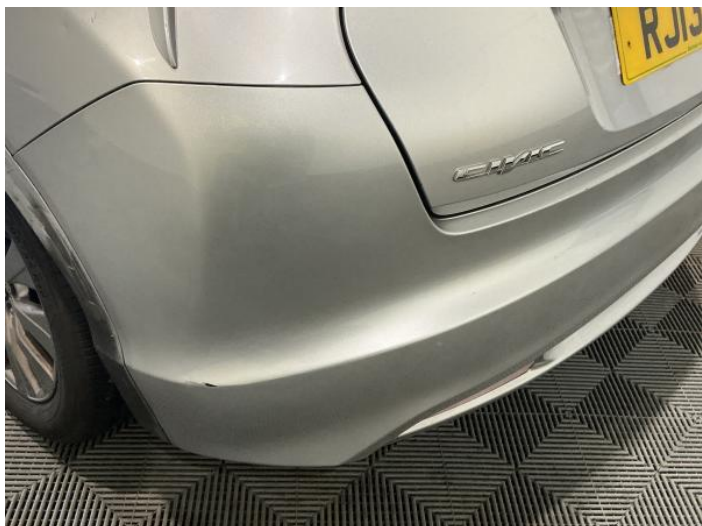
9: Bumper Rear  
Scratched  
Over 100mm Thru Paint

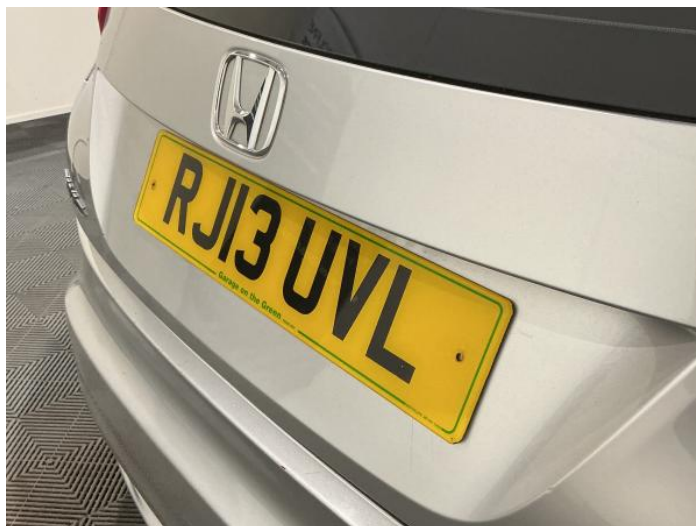
10: Boot Lid  
Chipped  
1 To 5

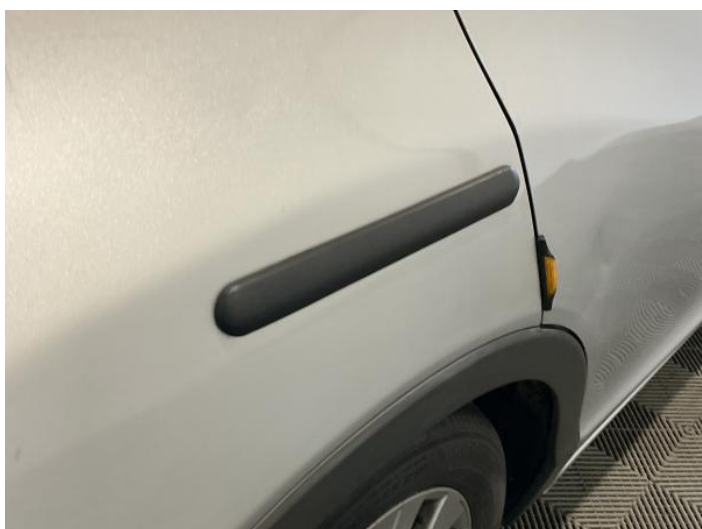
11: Qtr Panel osr  
Scratched  
Over 25mm Thru Paint

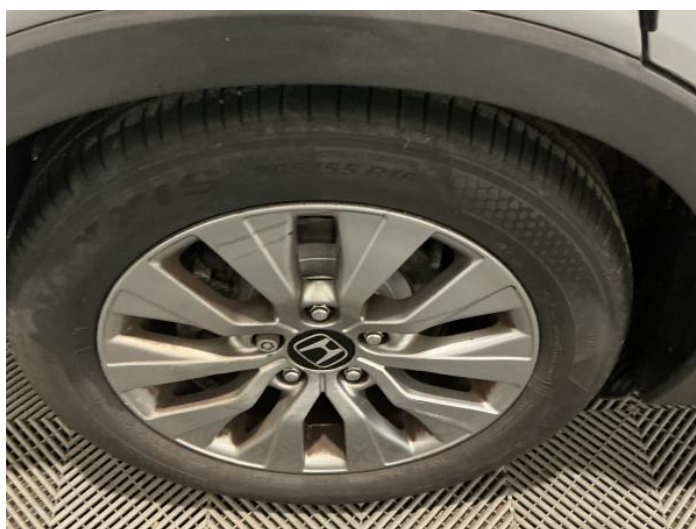
12: Wheel osr  
Scratched  
Up To 50mm

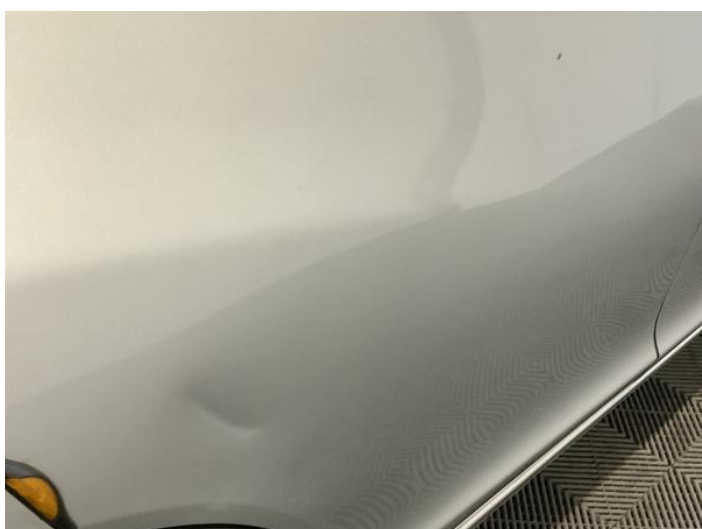
13: Door osr  
Dented  
Over 30mm

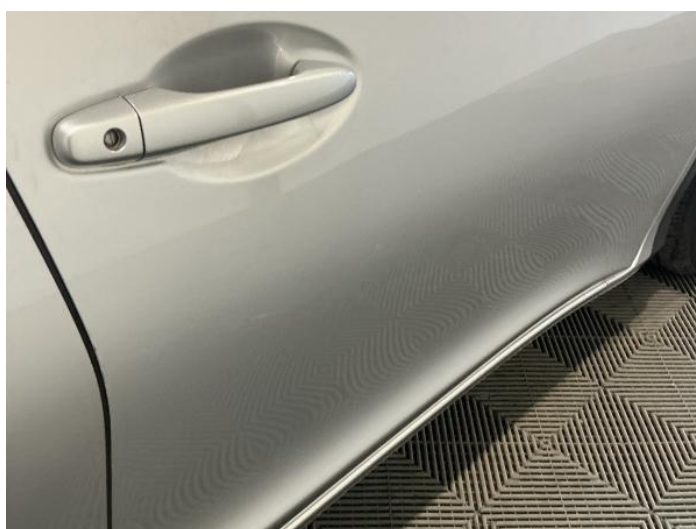
14: Door osf  
Dented  
With Paint Damage

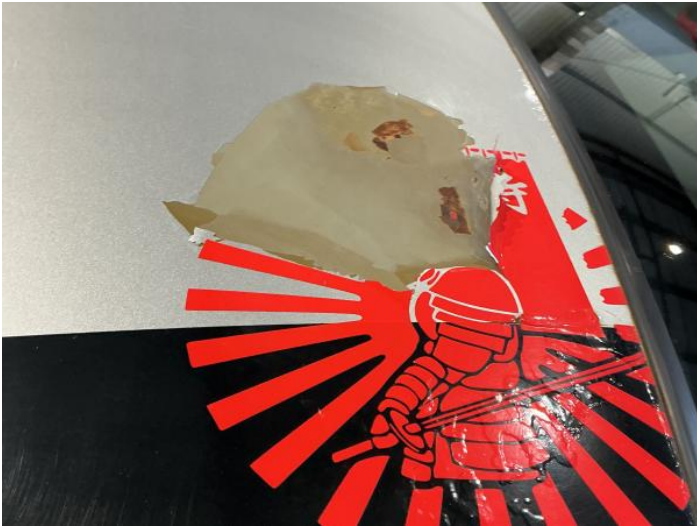
15: Roof  
Poor Previous Repair  
Paint Flake

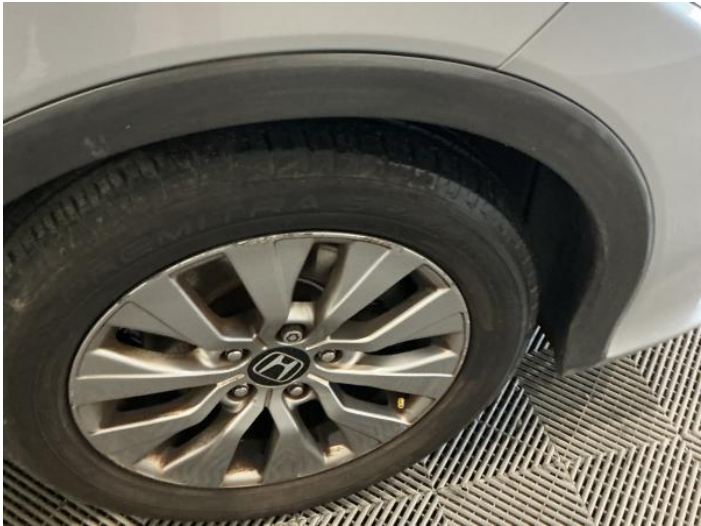
16: Wheel osf  
Scratched  
Over 50mm

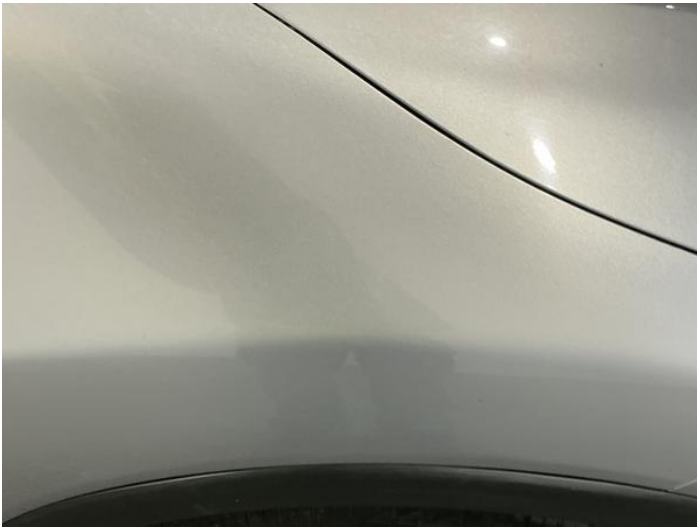
17: Wing osf  
Dented  
Over 2 UpTo 10mm

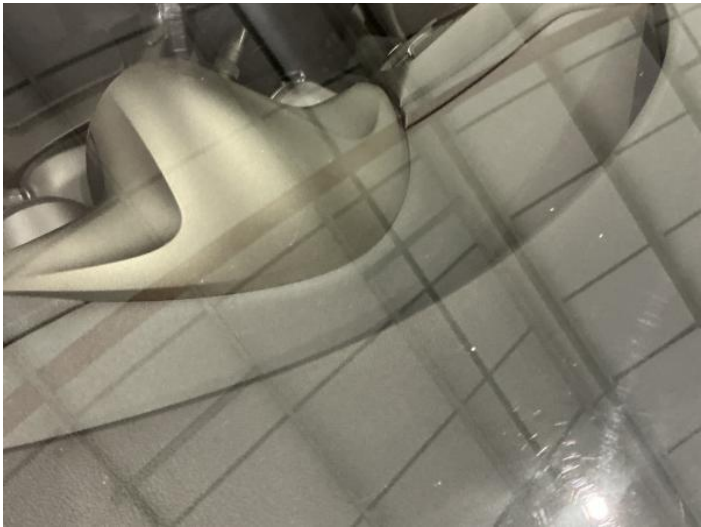
18: Screen Front  
Chipped  
UpTo 10mm
