# VEHICLE INSPECTION REPORT

**GU20YNF**

## Ford Mondeo 2.0 EcoBlue 190 ST-Line Edition 5dr Powershift

nama  
GRADE  
**3**

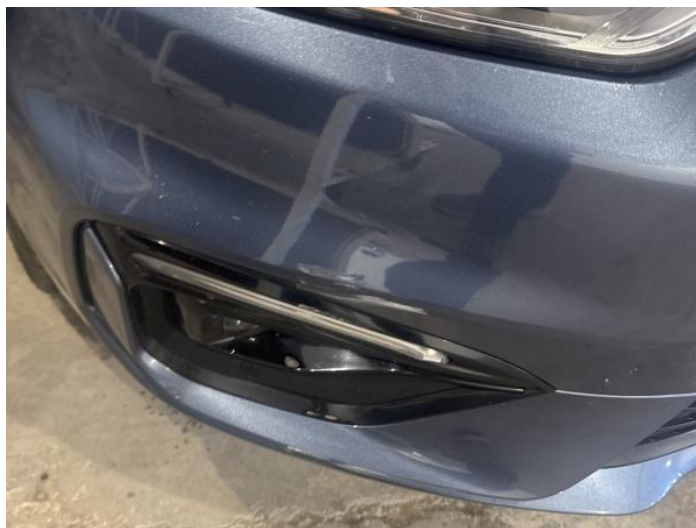
2: Bumper Front  
Scratched  
25 to 100mm Thru Paint

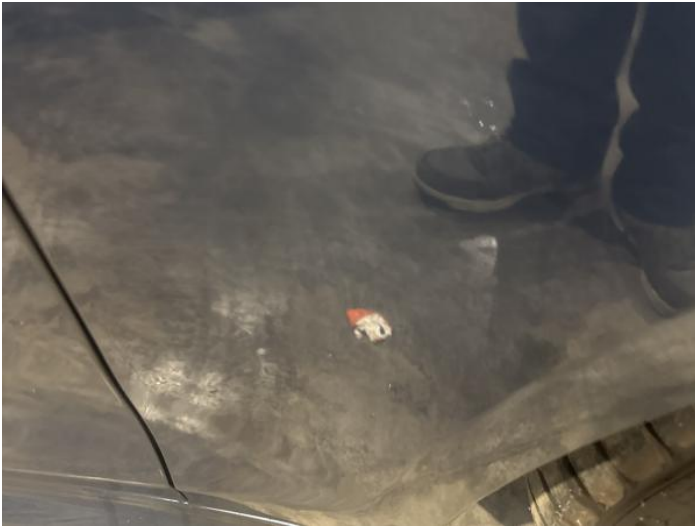
3: Wing osf  
Chipped  
1 To 5

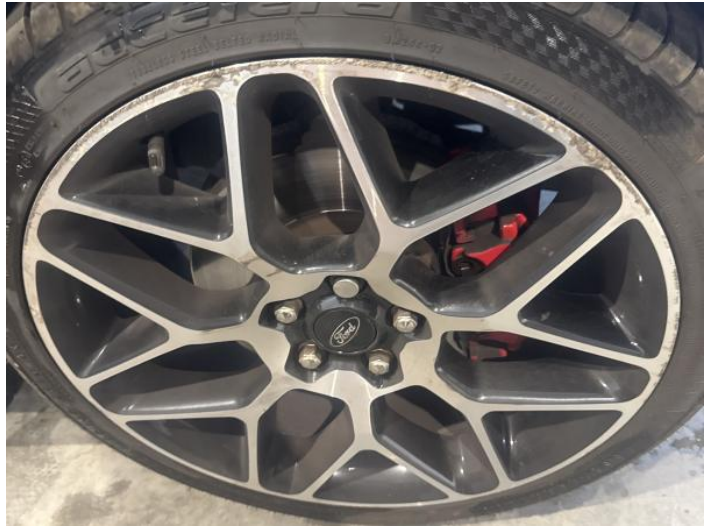
4: Wheel osf  
Scratched  
Over 50mm

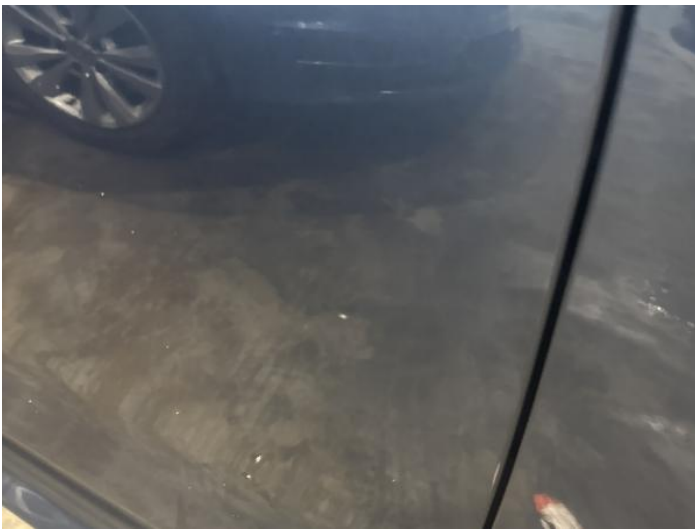
5: Door osf  
Dented  
With Paint Damage

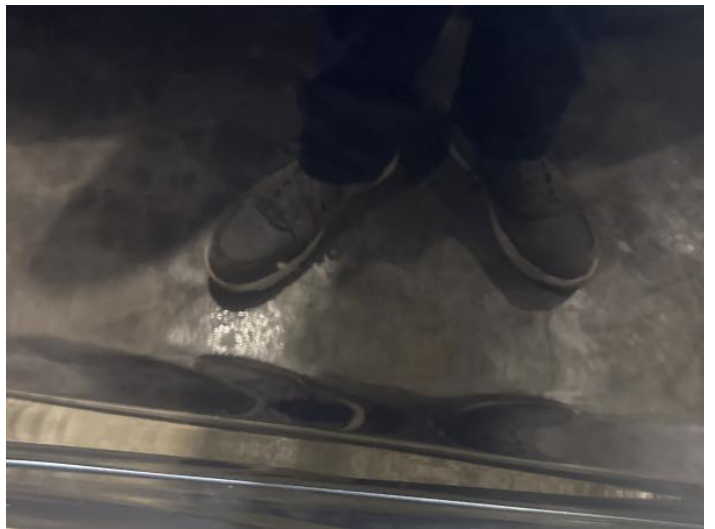
6: Door osr  
Chipped  
1 To 5

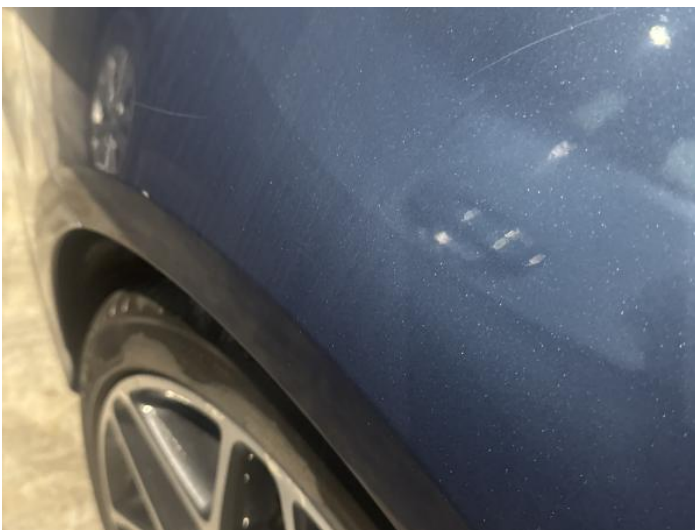
7: Qtr Panel osr  
Scratched  
Over 25mm Thru Paint

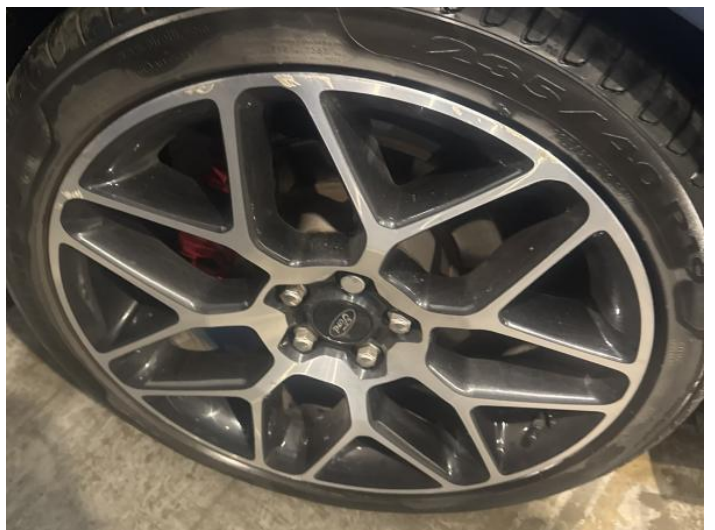
8: Wheel osr  
Scratched  
Up To 50mm

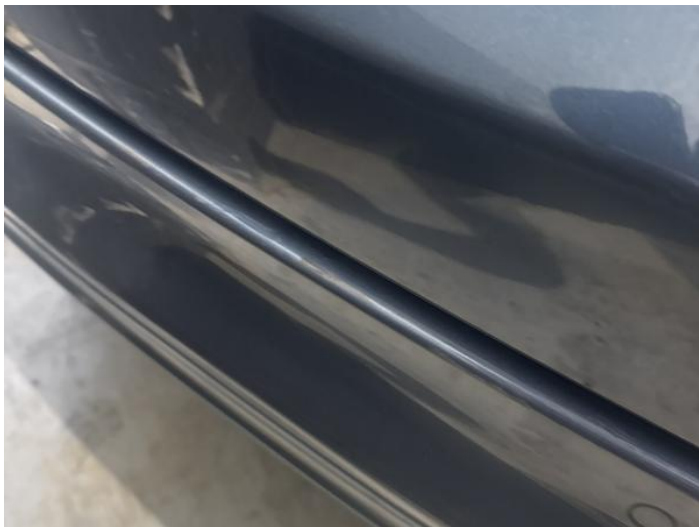
9: Bumper Rear  
Scratched  
25 to 100mm Thru Paint

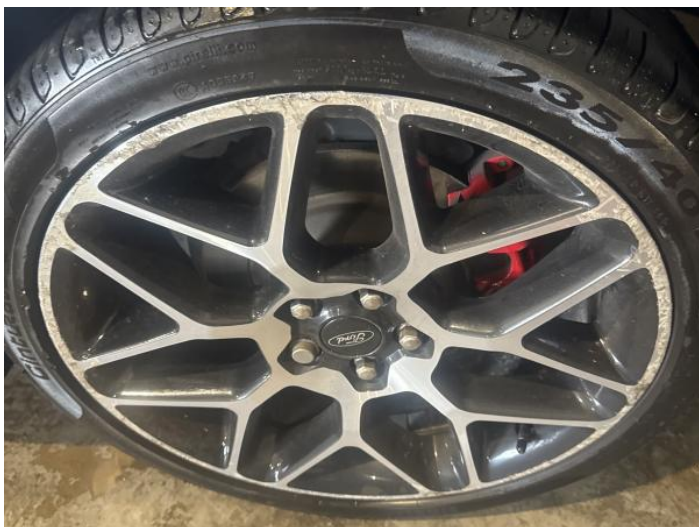
13: Wheel nsr  
Scratched  
Over 50mm

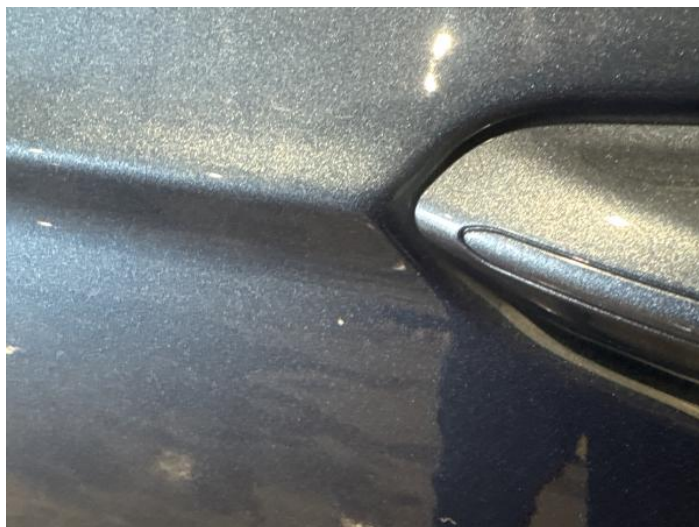
14: Door nsf  
Chipped  
1 To 5

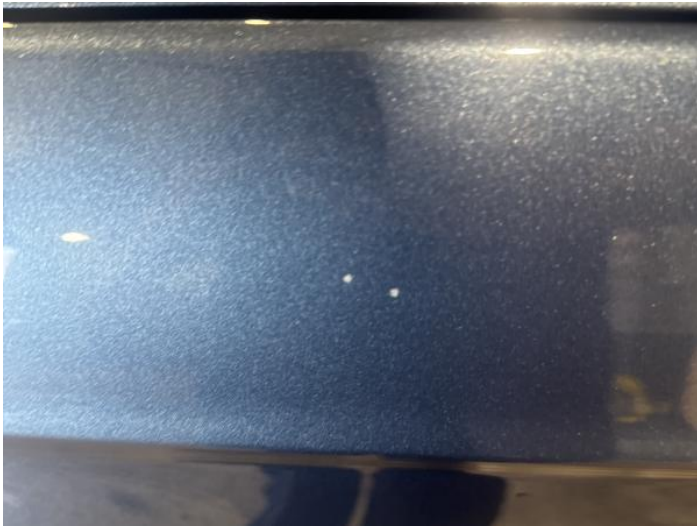
16: Wing nsf  
Chipped  
1 To 5

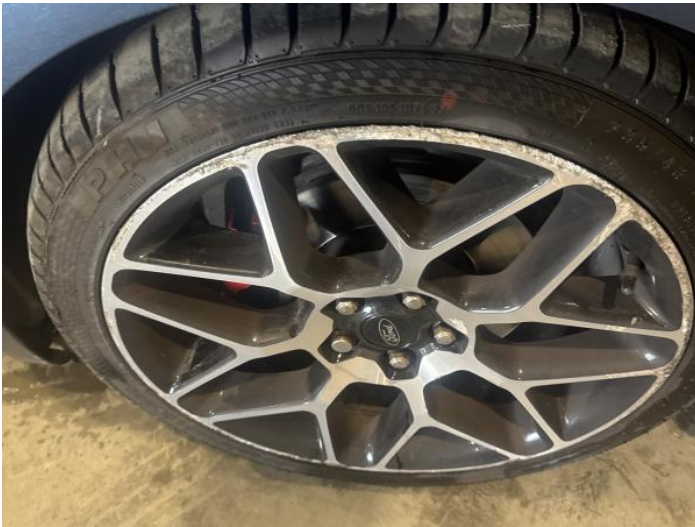
17: Wheel nsf  
Scratched  
Over 50mm
