# VEHICLE INSPECTION REPORT

**GF61RHJ**

## Nissan Qashqai 1.6 dCi Tekna 5dr

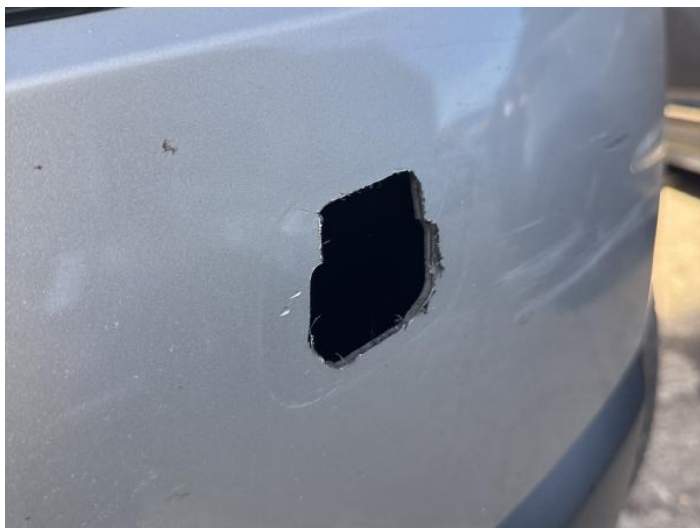
1: Bumper Front  
Hole  
Over 25mm

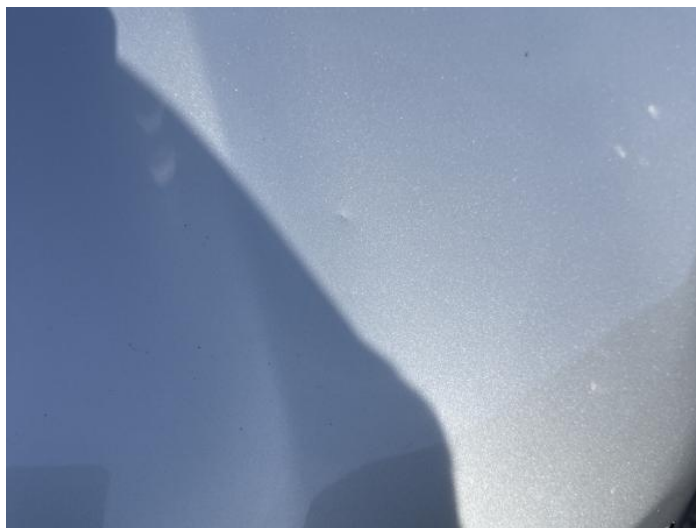
2: Bonnet  
Dented  
With Paint Damage

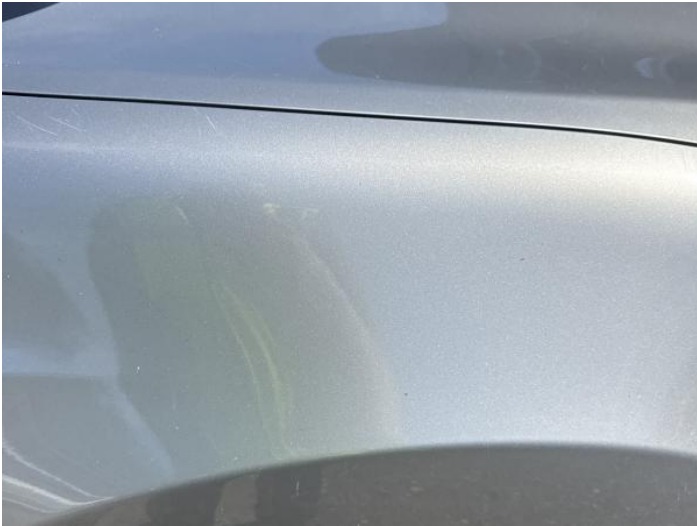
3: Wing osf  
Chipped  
1 To 5

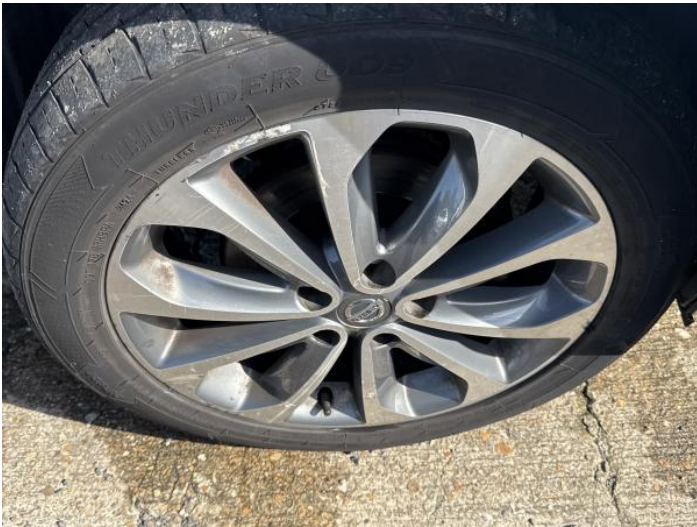
5: Wheel osf  
Scratched  
Over 50mm

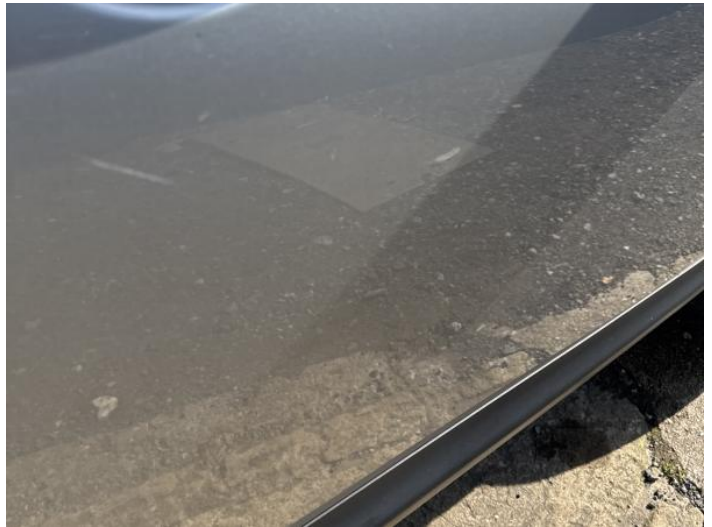
6: Door osf  
Scratched  
Over 25mm Thru Paint

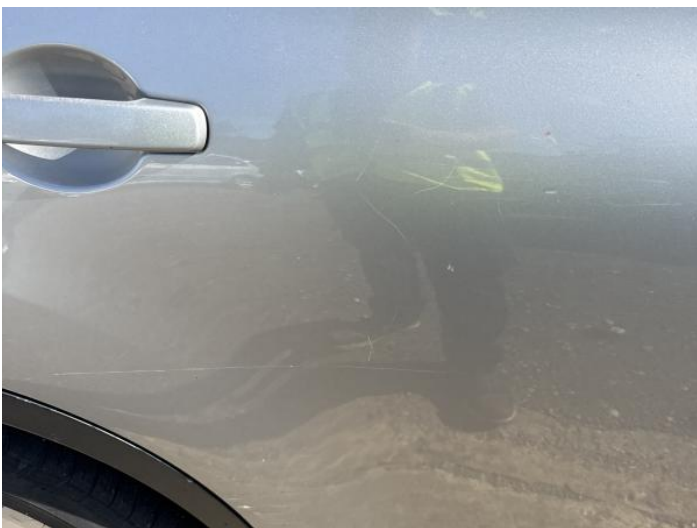
7: Door osr  
Dented  
With Paint Damage

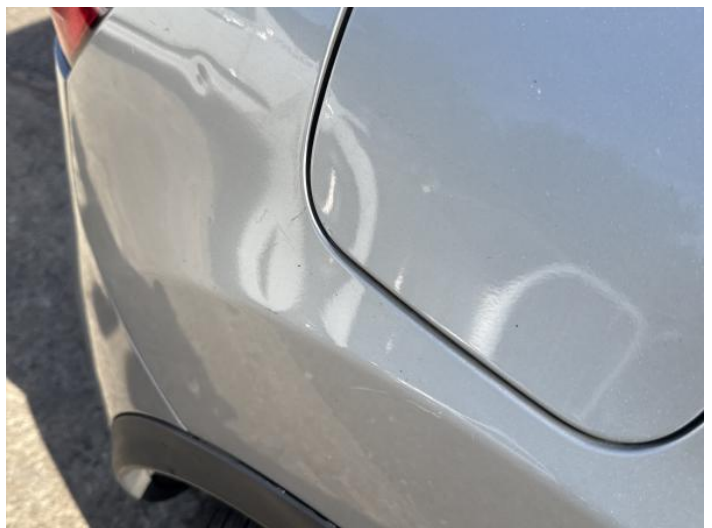
8: Qtr Panel osr  
Dented  
Between 10mm + 30mm

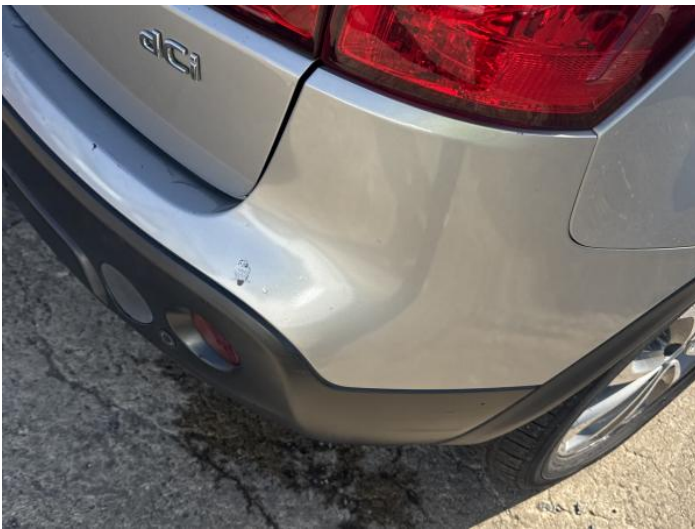
11: Bumper Rear  
Poor Previous Repair  
Poor Paint

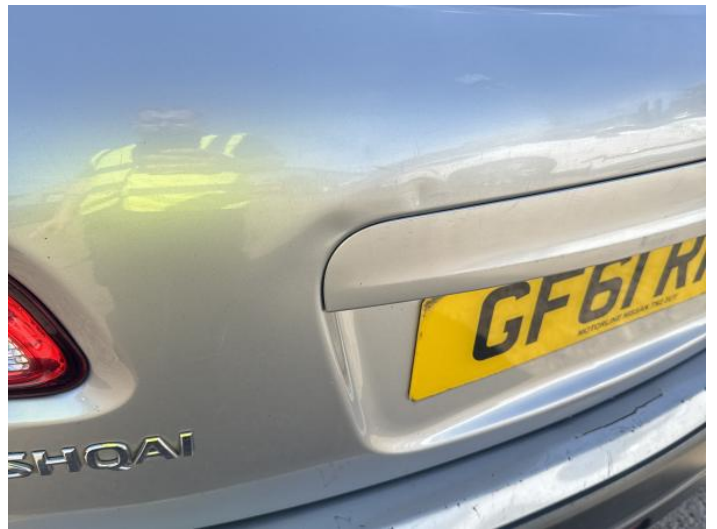
12: Boot Lid  
Dented  
Over 30mm

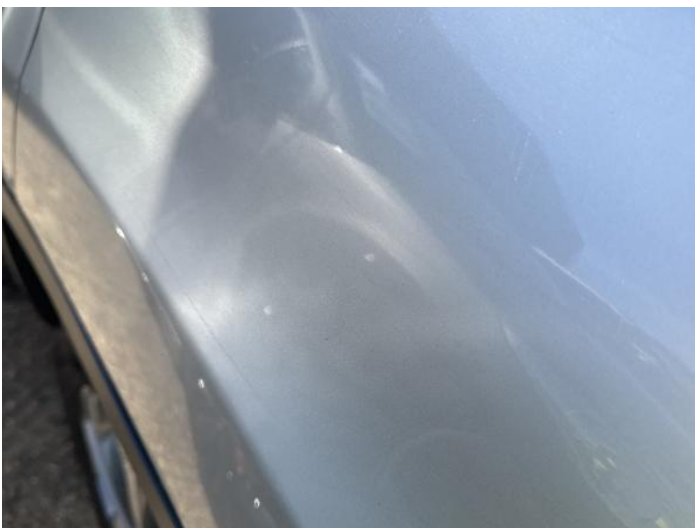
13: Qtr Panel nsr  
Chipped  
1 To 5

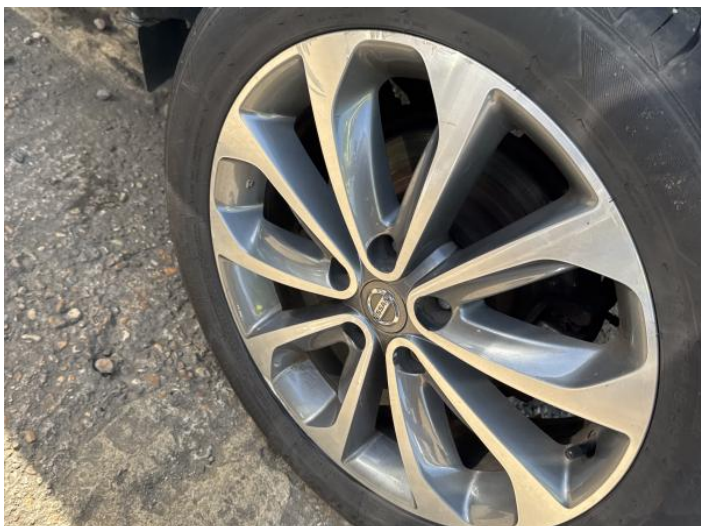
15: Wheel nsr  
Scratched  
Over 50mm

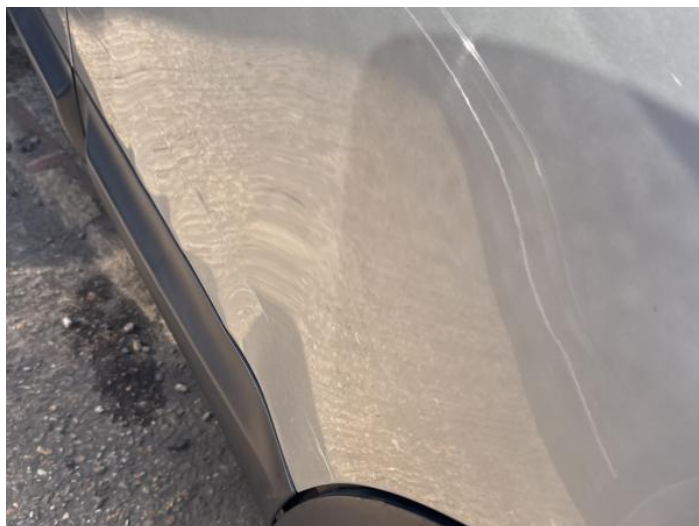
16: Door nsr  
Dented  
With Paint Damage

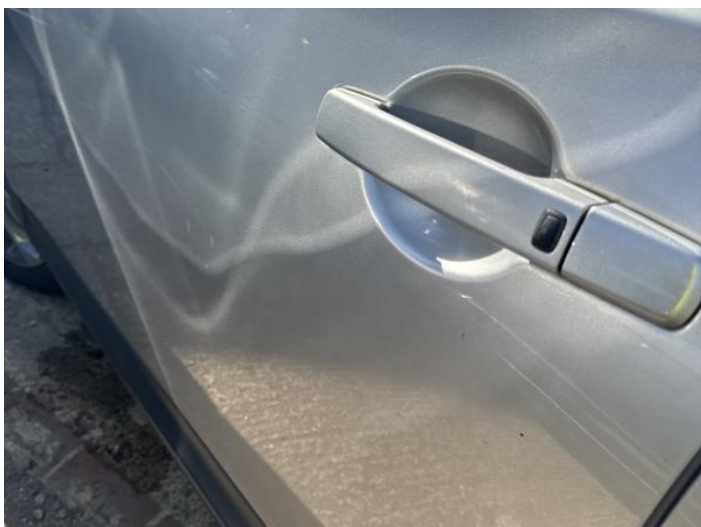
17: Door nsf  
Chipped  
1 To 5

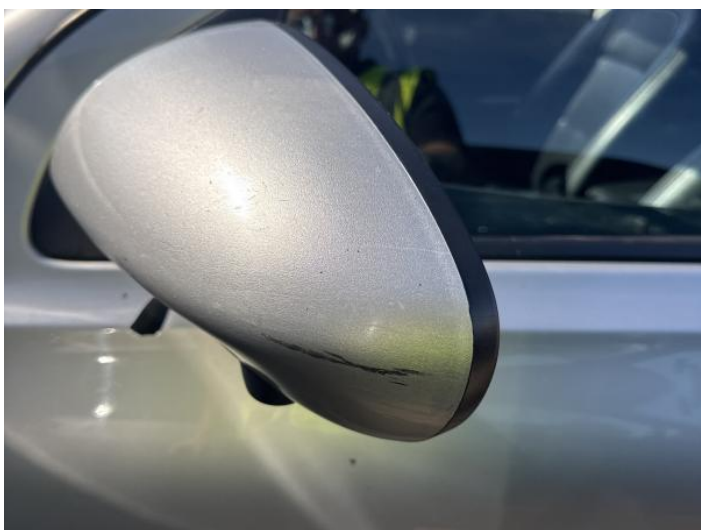
19: Door Mirror Assy nsf  
Scratched (Painted)  
Over 25mm Thru Paint

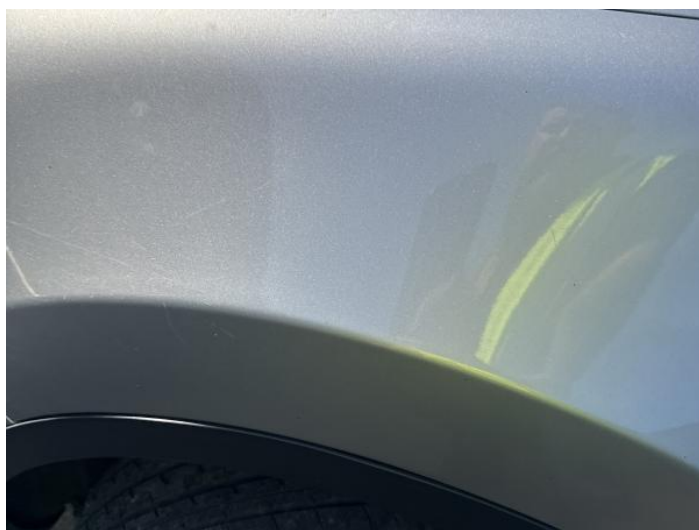
20: Wing nsf  
Chipped  
1 To 5
