# VEHICLE INSPECTION REPORT

**SE12JYF**

## Nissan Qashqai 1.6 [117] N-Tec+ 5dr [Start Stop]

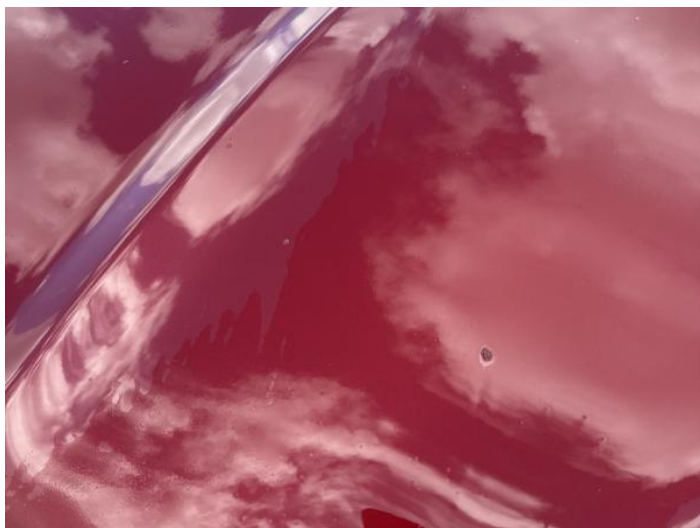
1: Bonnet  
Chipped  
Multiple Chips

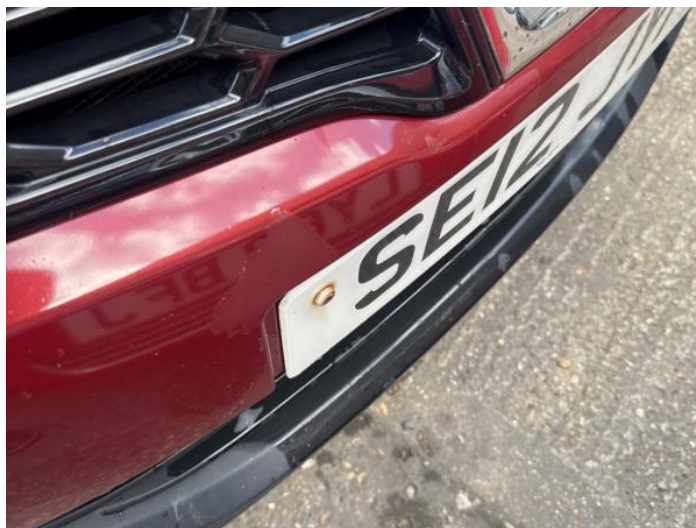
2: Bumper Front  
Poor Previous Repair  
Paint Flake

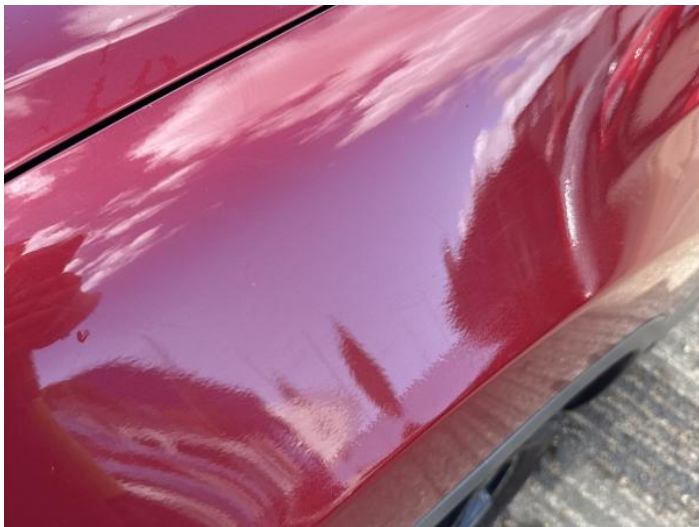
3: Wing nsf  
Chipped  
Multiple Chips

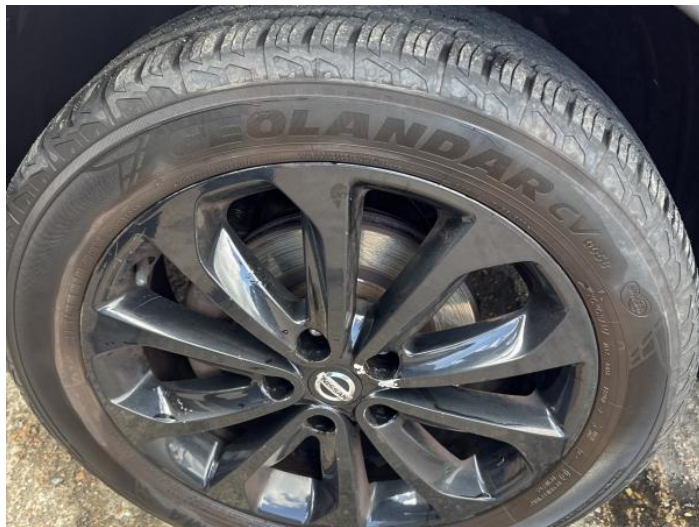
4: Wheel nsf  
Scratched  
Over 50mm

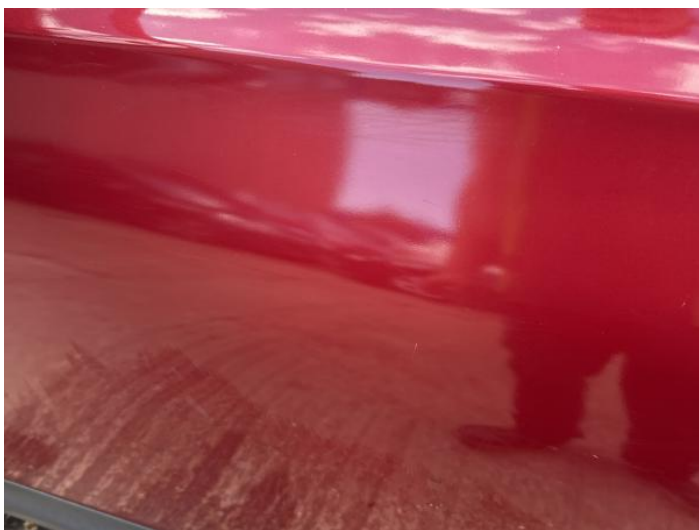
5: Door nsf  
Poor Previous Repair  
Poor Paint

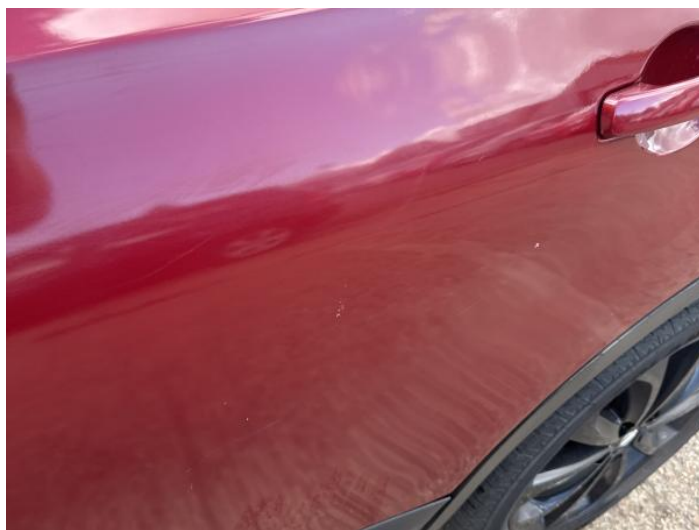
6: Door nsr  
Poor Previous Repair  
Poor Paint

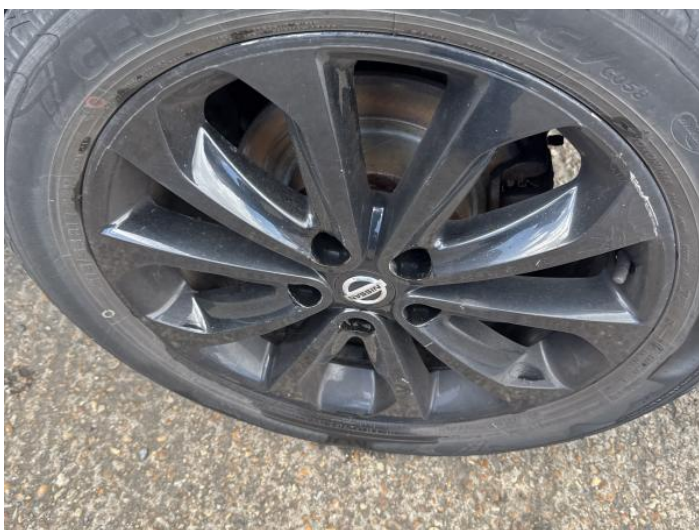
7: Wheel nsr  
Scratched  
Over 50mm

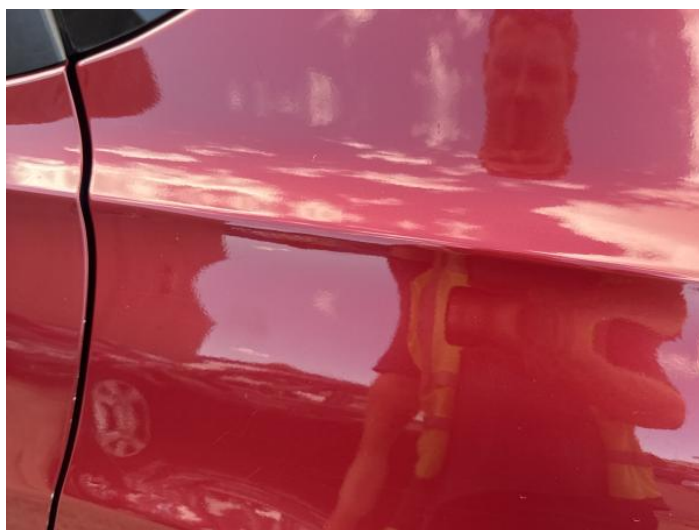
8: Qtr Panel nsr  
Chipped  
1 To 5

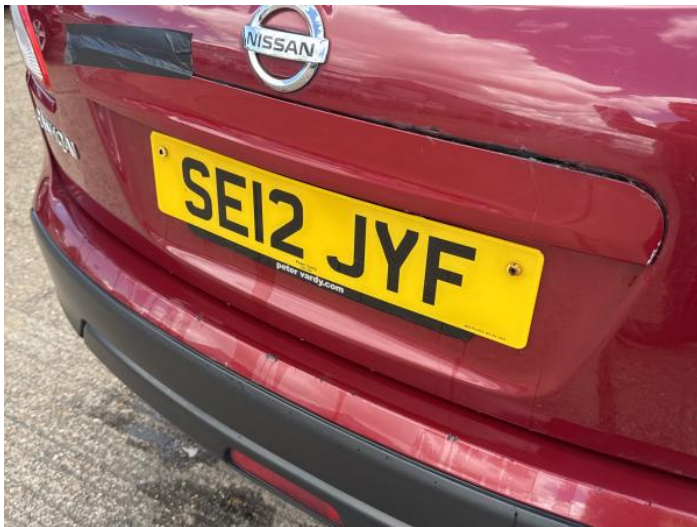
9: Bumper Rear  
Scratched  
25 to 100mm Thru Paint

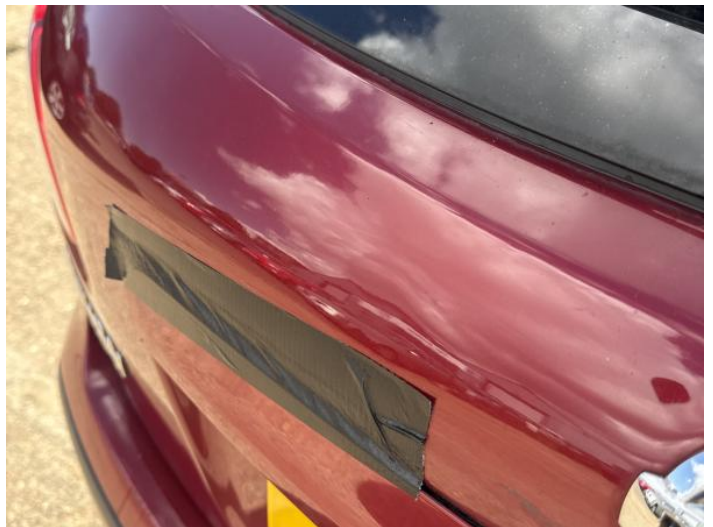
12: Boot Lid  
Dented  
Over 30mm

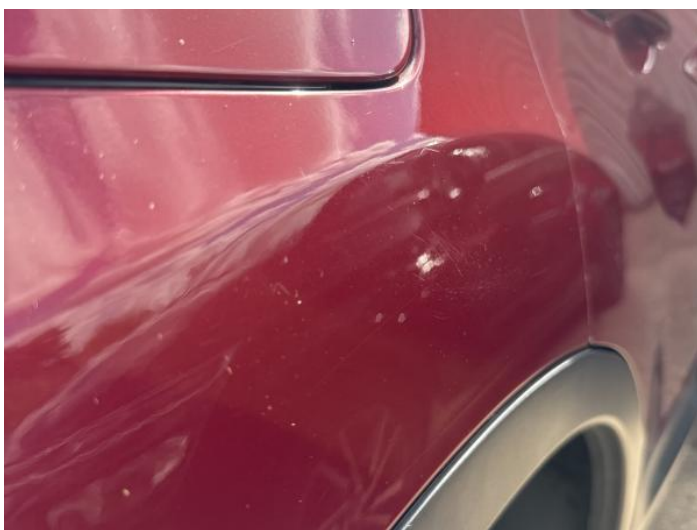
13: Qtr Panel osr  
Chipped  
1 To 5

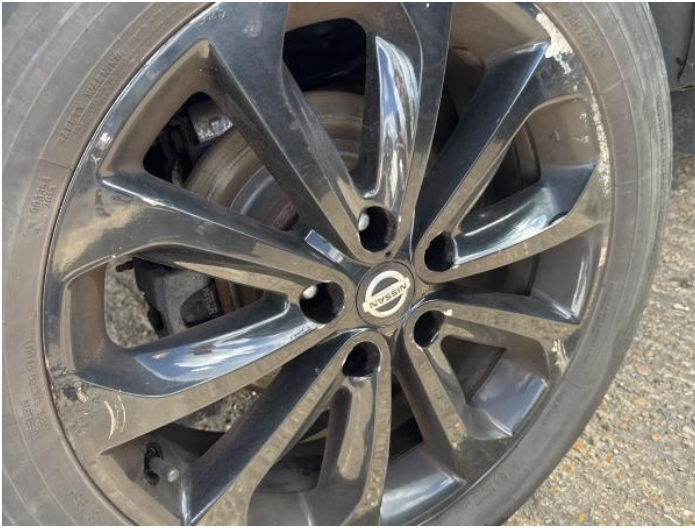
15: Wheel osf  
Scratched  
Over 50mm

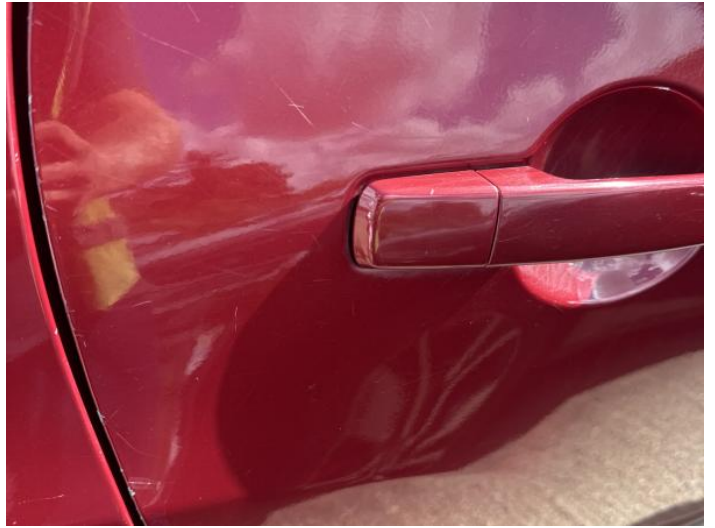
16: Door osf  
Chipped  
Multiple Chips

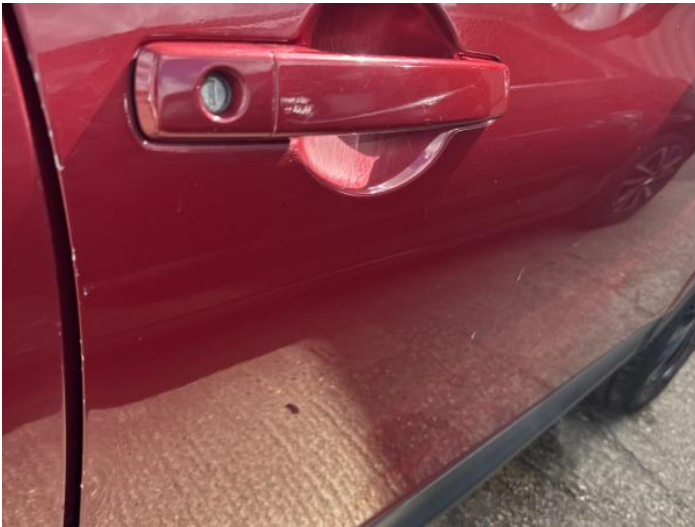
17: Door osf  
Dented  
With Paint Damage

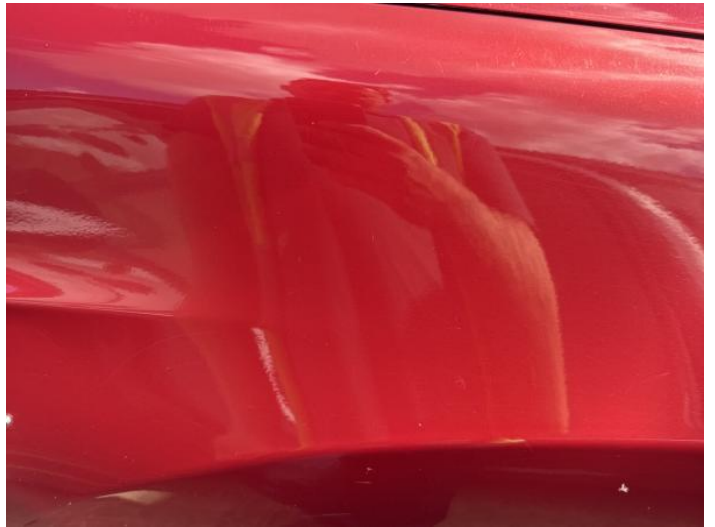
18: Wing osf  
Chipped  
1 To 5

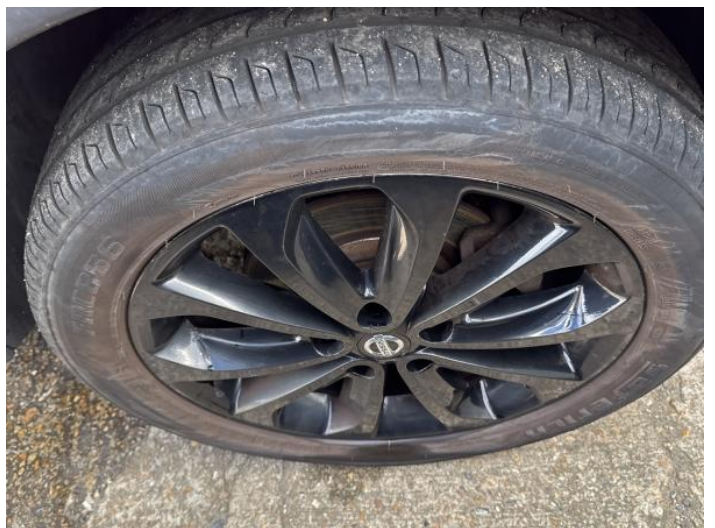
20: Wheel osf  
Scratched  
Over 50mm

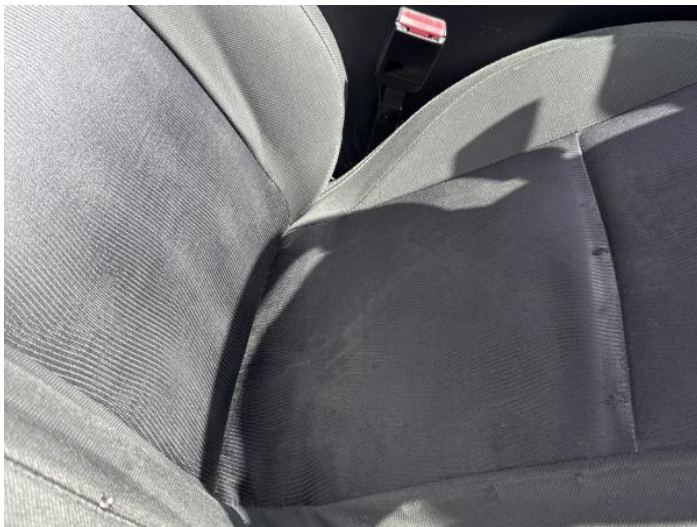
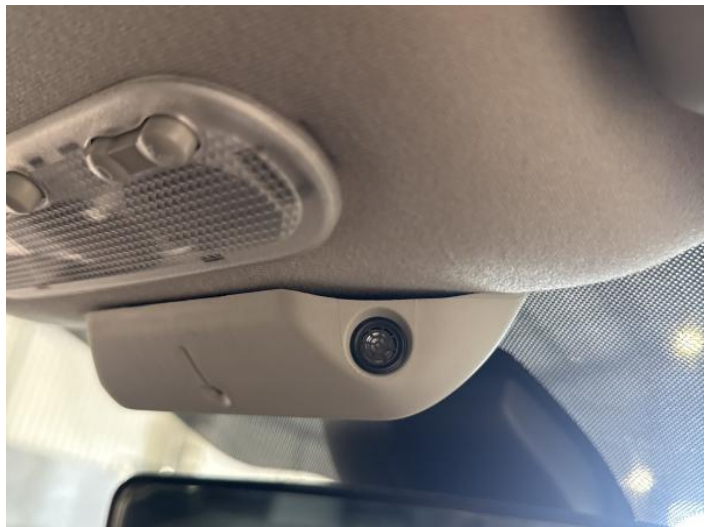
21: Seat Base Cover osf  
Torn  
Over 3mm
