# VEHICLE INSPECTION REPORT

**YH11EZG**

## Mini Hatchback 1.6 Cooper D 3dr

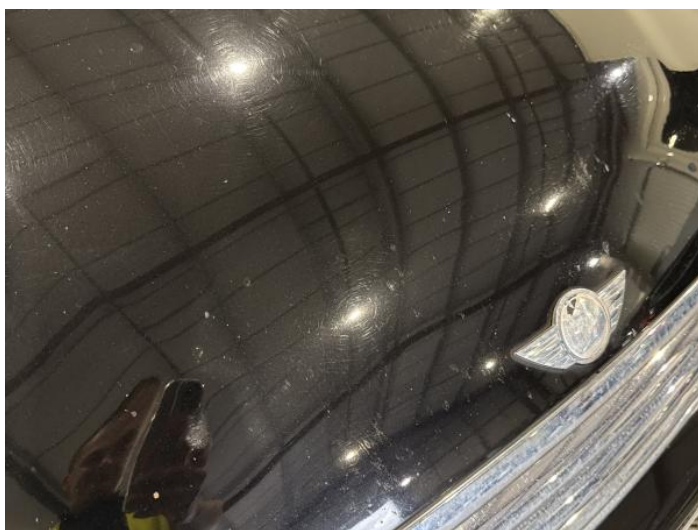
1: Bonnet  
Chipped  
Multiple Chips

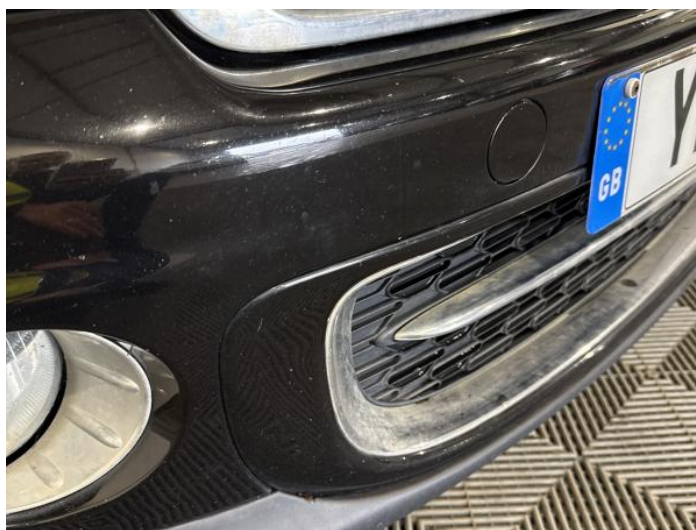
2: Bumper Front  
Chipped  
Multiple Chips

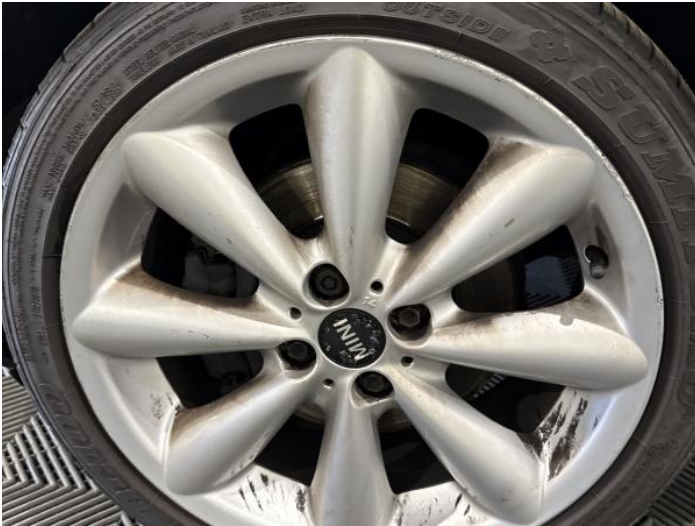
3: Wheel nsf  
Scratched  
Over 50mm

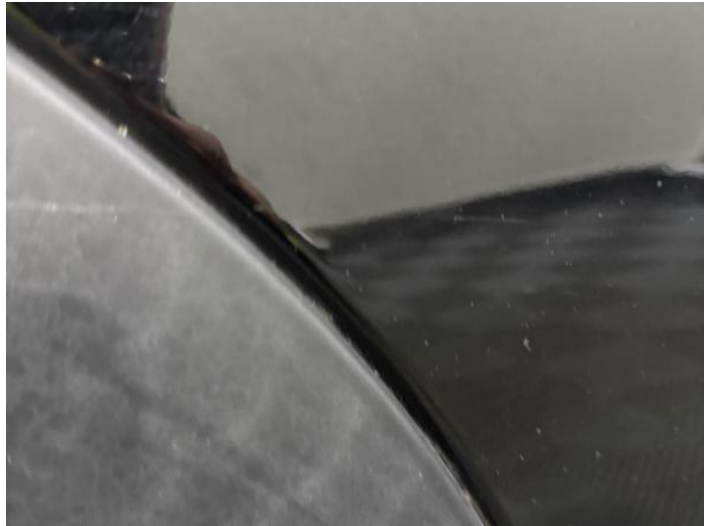
4: Wing nsf  
Scratched  
UpTo 25mm Thru Paint

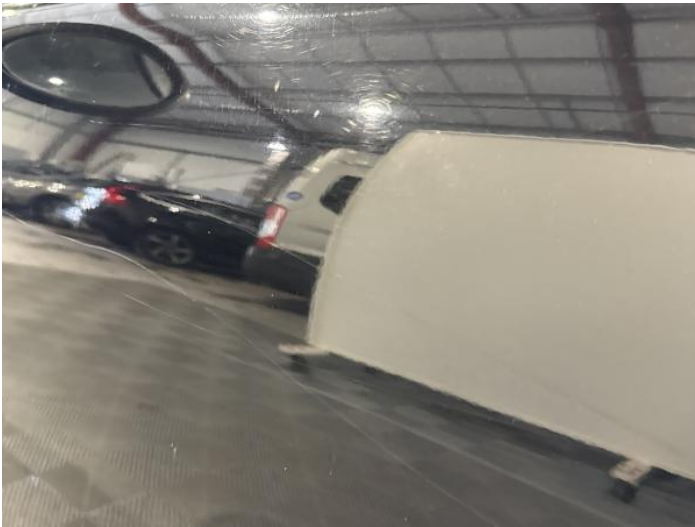
5: Door nsf  
Dented  
2 Or Less UpTo 10mm

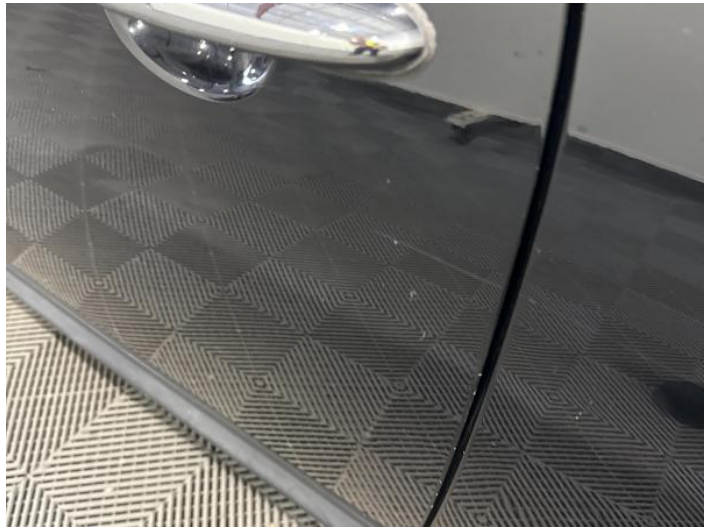
6: Door nsf  
Chipped  
1 To 5

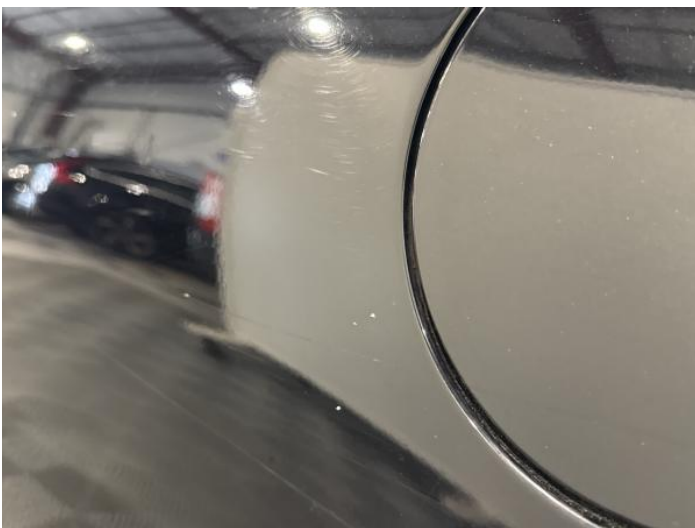
7: Qtr Panel nsr  
Dented  
Between 10mm + 30mm

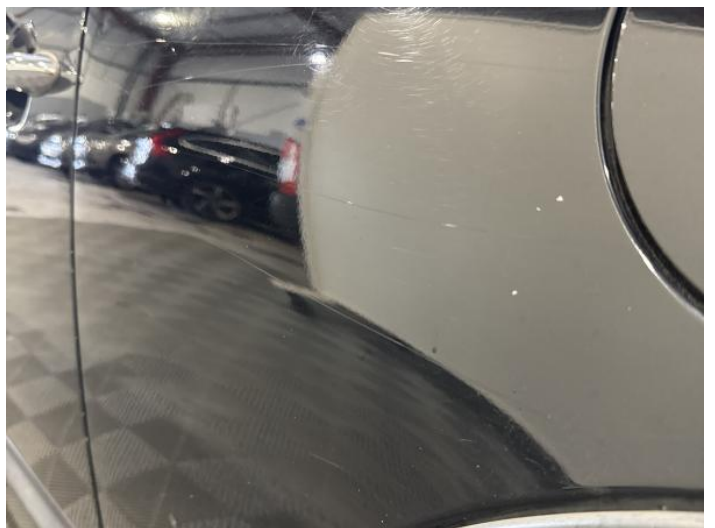
8: Qtr Panel nsr  
Chipped  
1 To 5

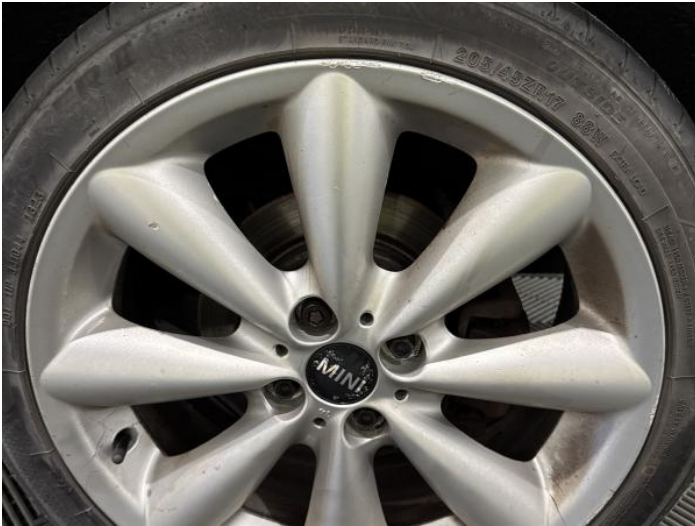
9: Wheel nsr  
Scratched  
Over 50mm

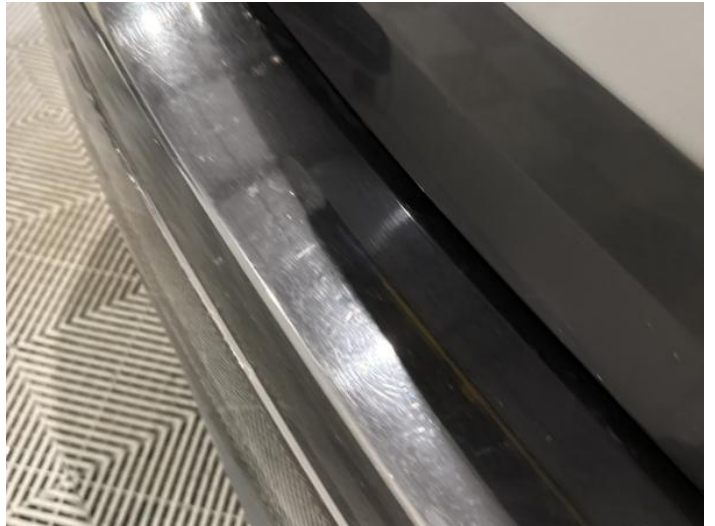
10: Bumper Rear  
Scratched  
Up To 25mm Thru Paint

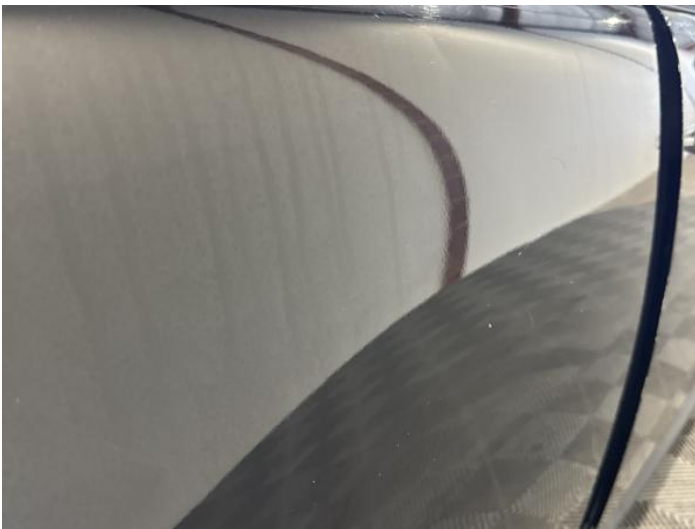
11: Qtr Panel osr  
Dented  
Over 30mm

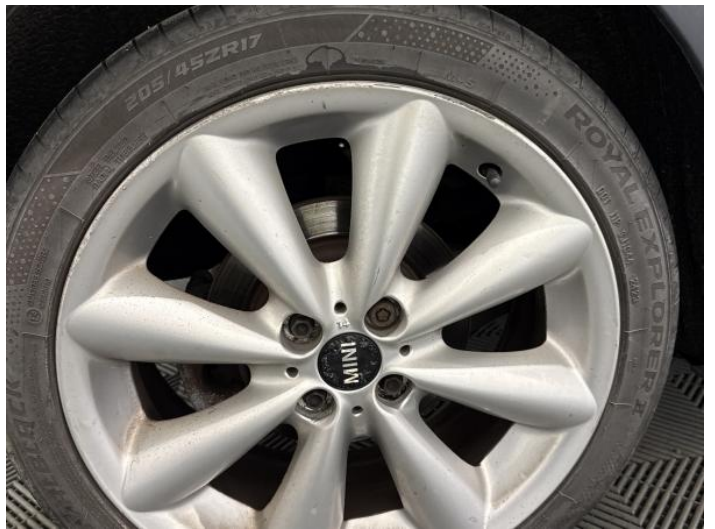
12: Wheel osr  
Scratched  
Over 50mm

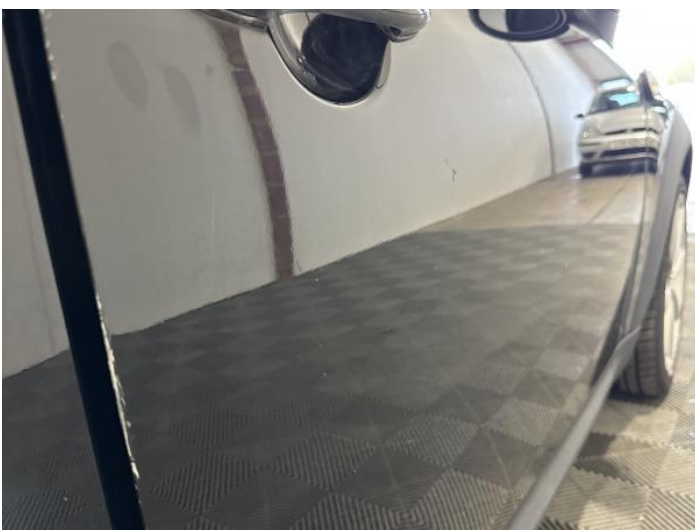
13: Door osf  
Poor Previous Repair  
Rippled UpTo 30%

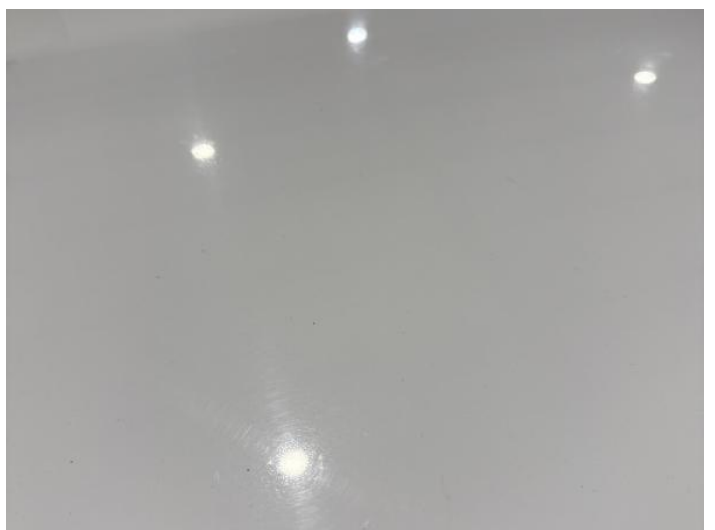
14: Roof  
Dented  
2 Or Less UpTo 10mm

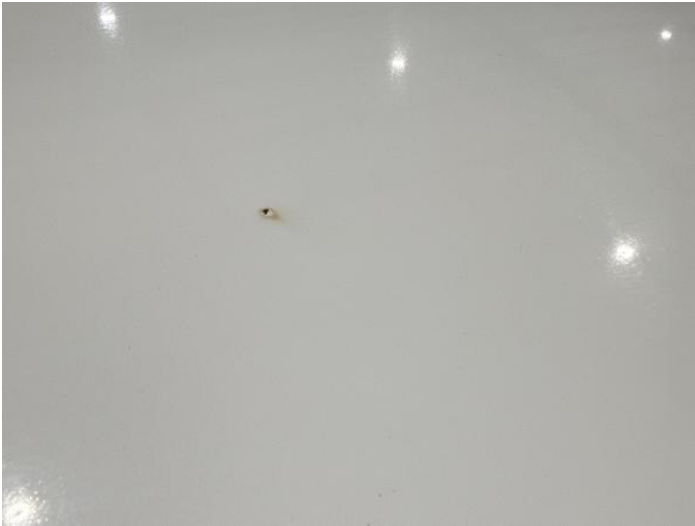
15: Roof  
Chipped  
1 To 5

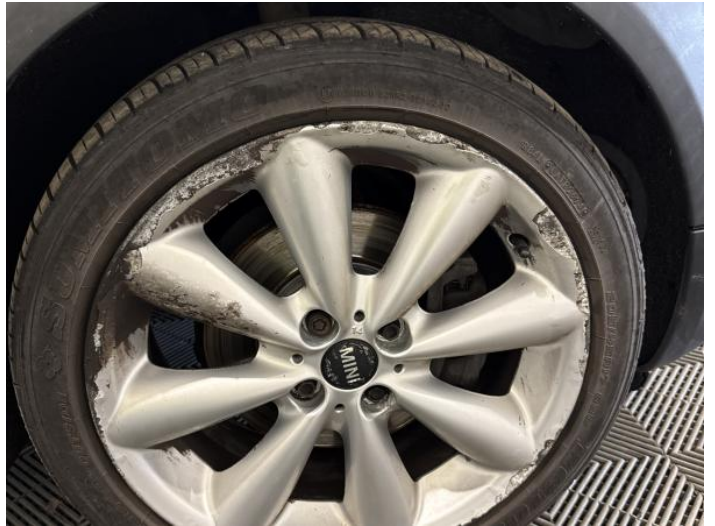
16: Wheel osf  
Scratched  
Over 50mm

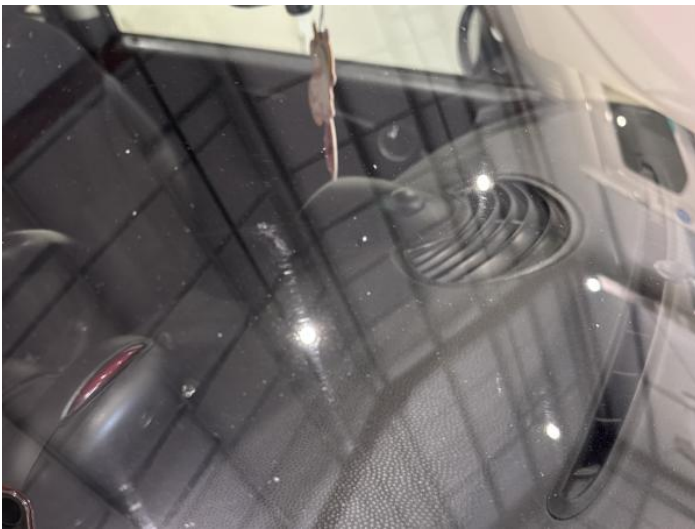
17: Screen Front  
Chipped  
UpTo 10mm

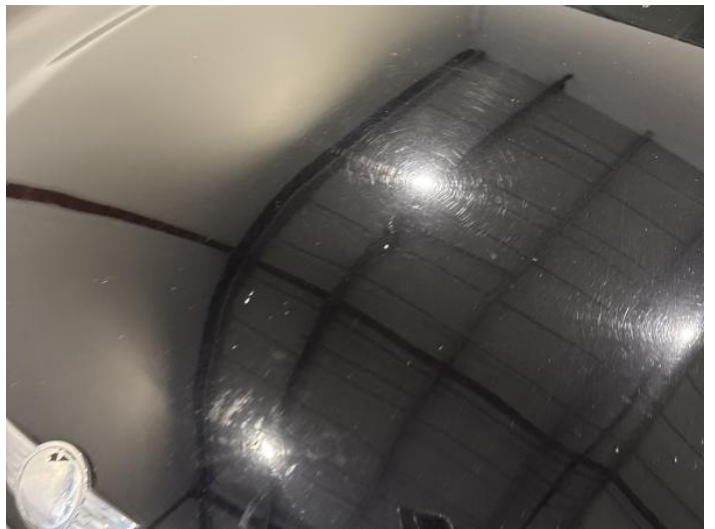
18: Bonnet  
Dented  
Between 10mm + 30mm

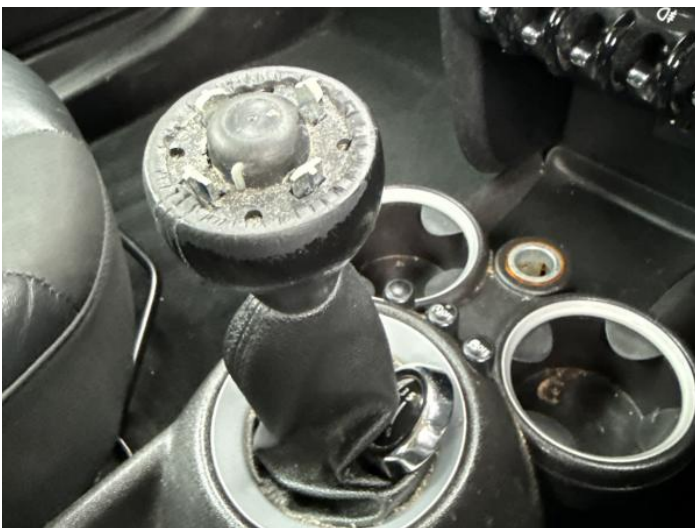
19: Switches And Controls  
Broken  
Replace

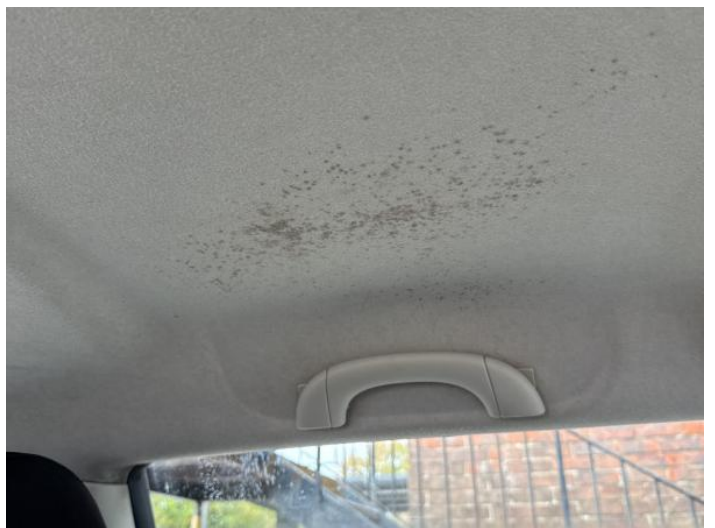
20: Roof Lining  
Soiled  
Light
