# VEHICLE INSPECTION REPORT

RO18MVD

## Land Rover Discovery Sport 2.0 TD4 180 HSE Black 5dr Auto

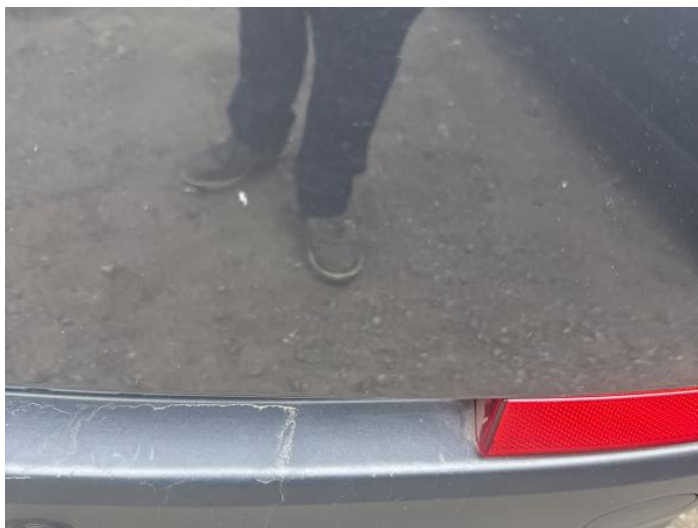
1: Boot Lid  
Chipped  
1 To 5

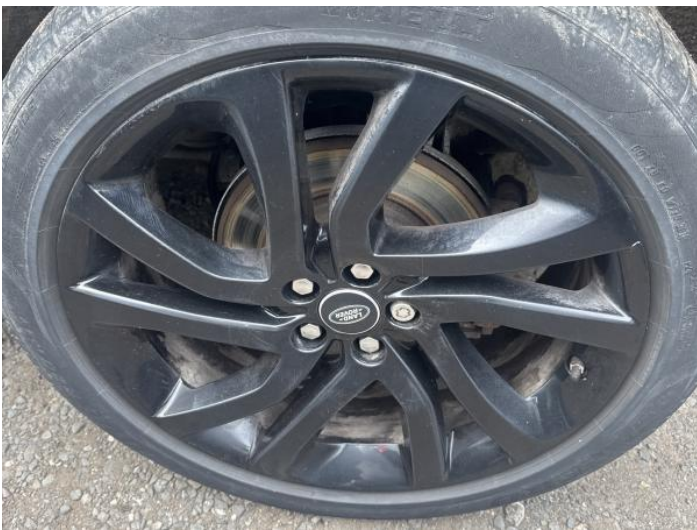
5: Wheel nsr  
Scratched  
Up To 50mm

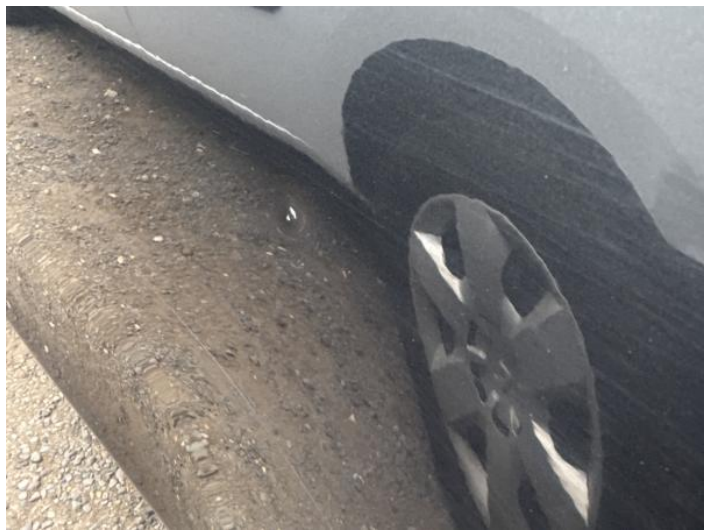
6: Door nsr  
Dented  
2 Or Less UpTo 10mm

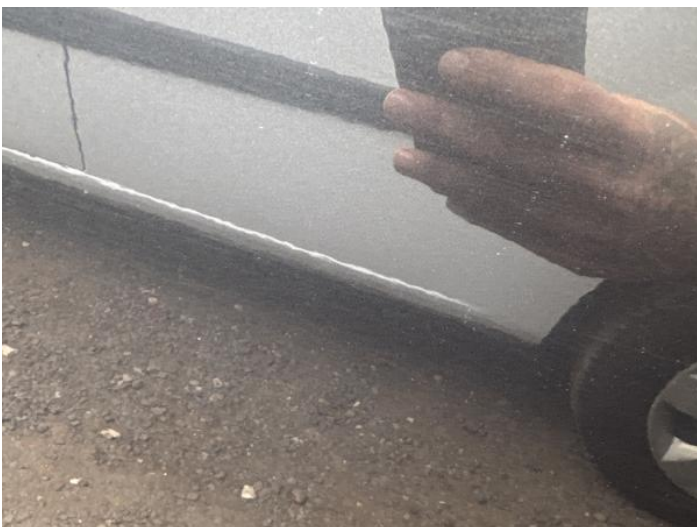
7: Door nsf  
Chipped  
1 To 5

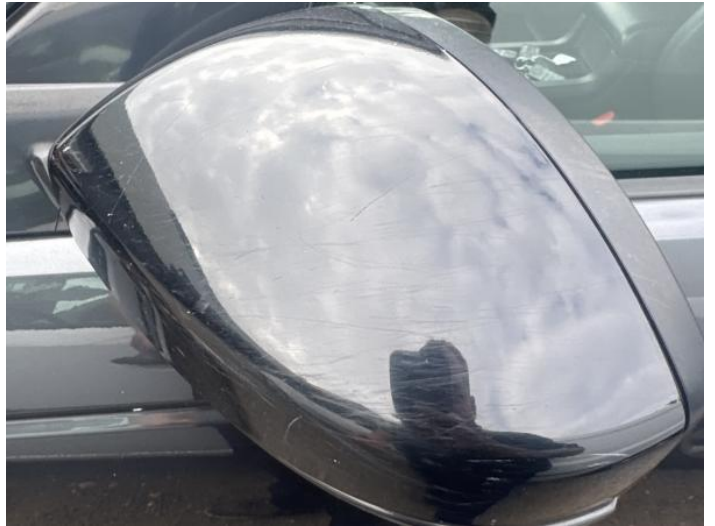
9: Door nsf  
Scratched  
Over 25mm Not Thru Paint

10: Door Mirror Assy nsf  
Scratched (Painted)  
Over 25mm Not Thru Paint

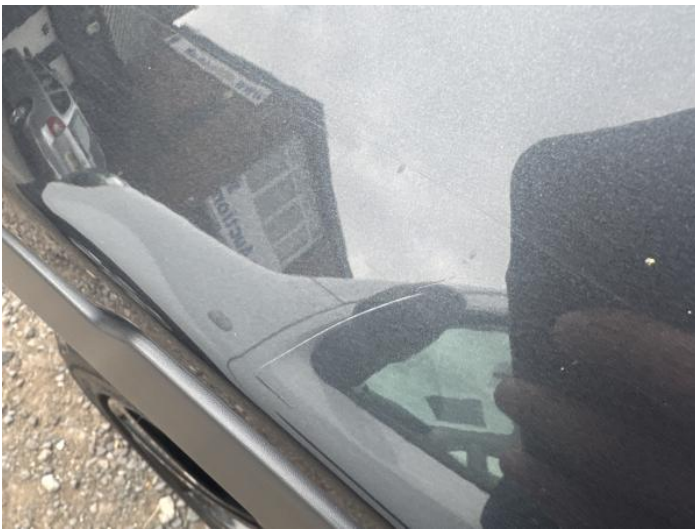
11: Wing nsf  
Scratched  
Over 25mm Thru Paint

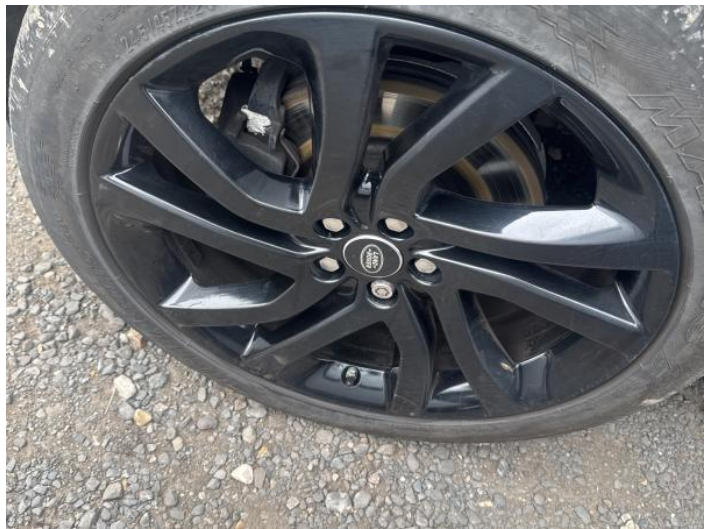
12: Wheel nsf  
Scratched  
Up To 50mm

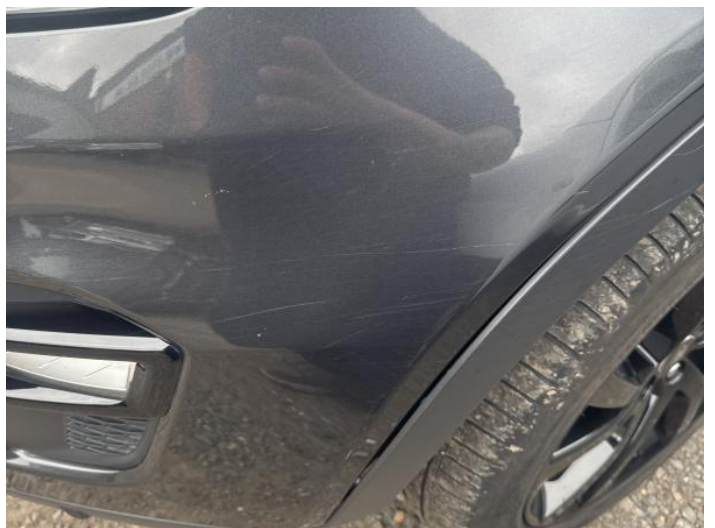
14: Bumper Front  
Scratched  
Over 100mm Thru Paint

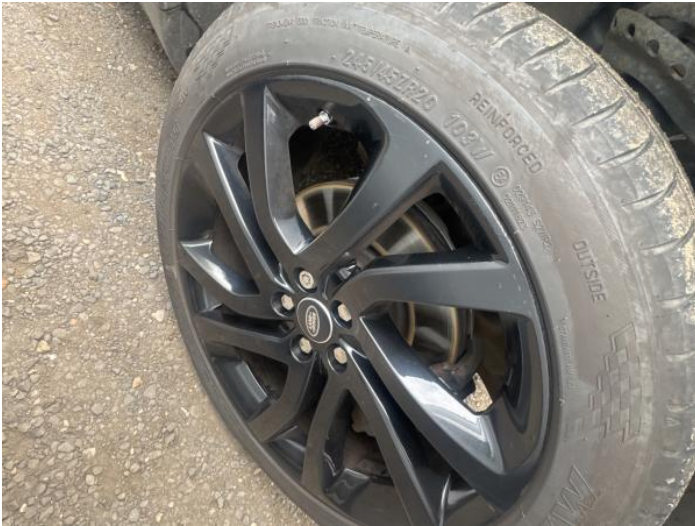
15: Wheel osf  
Scratched  
Up To 50mm

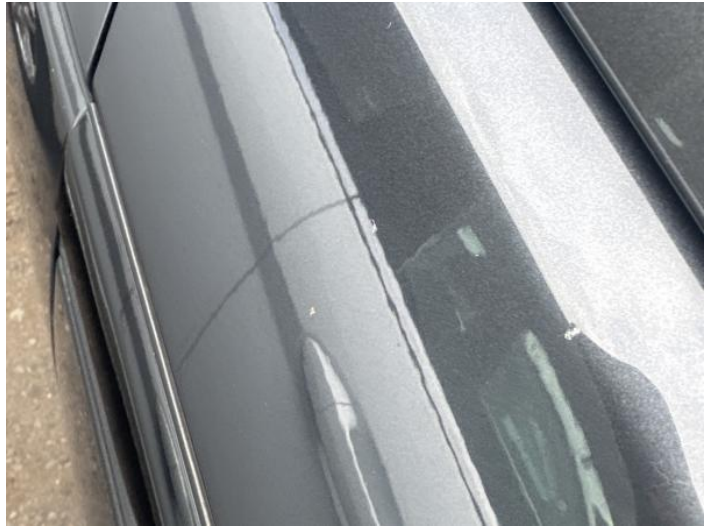
16: Wing osf  
Chipped  
1 To 5

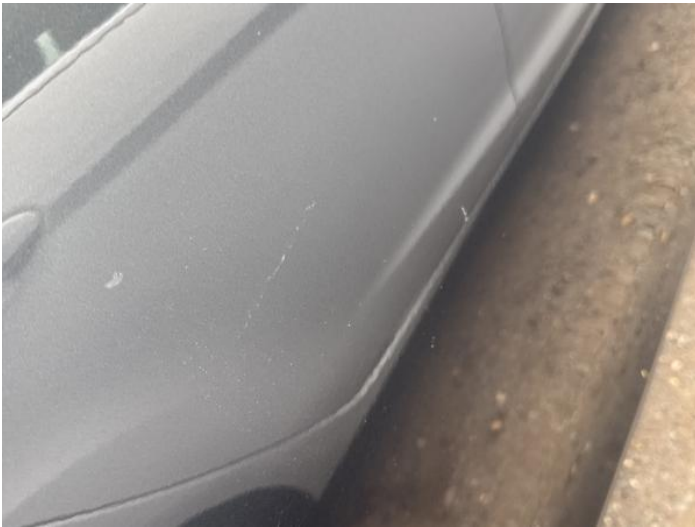
17: Door osf  
Chipped  
Multiple Chips

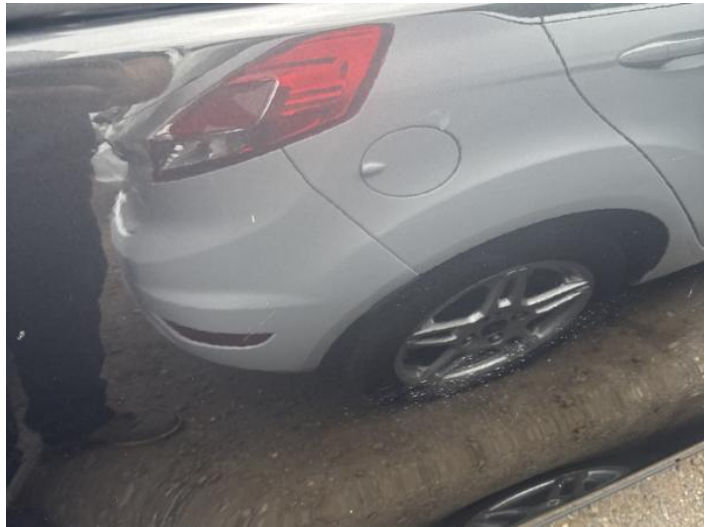
18: Door osr  
Chipped  
1 To 5

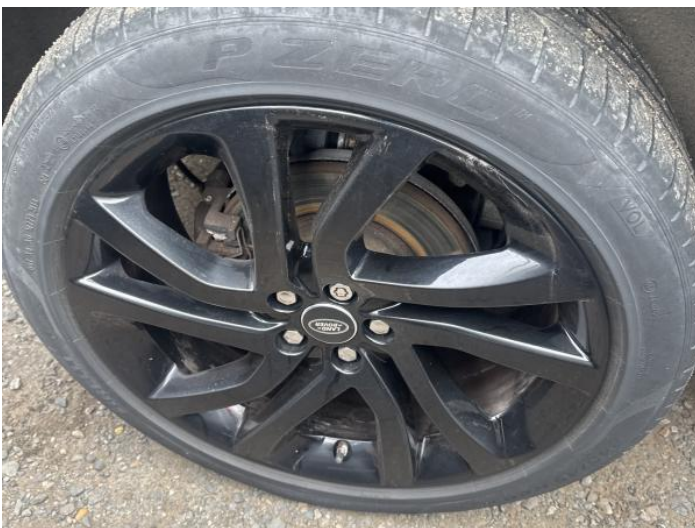
19: Wheel osr  
Scratched  
Up To 50mm
