VEHICLE INSPECTION REPORT

Audi A1 1.4 TFSI Sport 5dr S Tronic

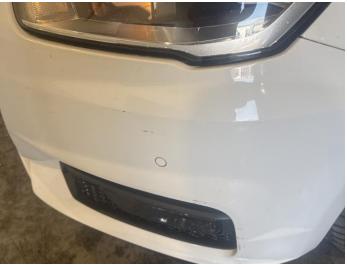
2: Bumper Front Scratched Over 100mm Thru Paint

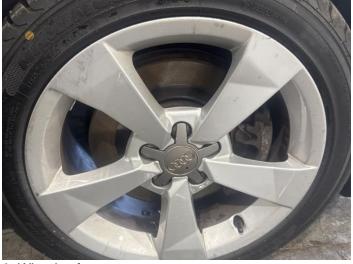
3: Wheel osf Scratched Over 50mm

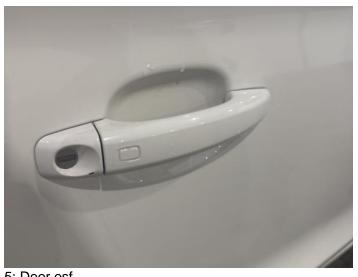
5: Door osf Chipped 1 To 5

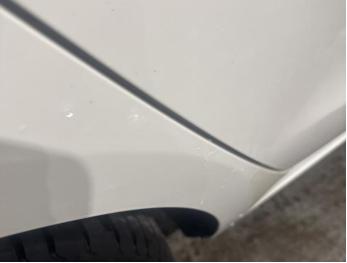
6: Qtr Panel osr Dented 2 Or Less UpTo 10mm

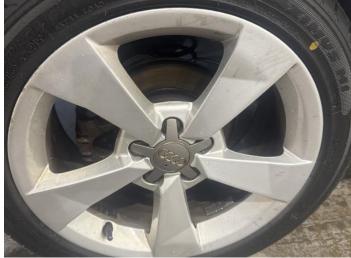
7: Wheel osr Scratched Over 50mm

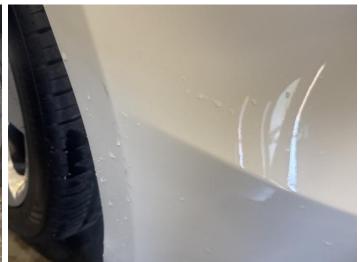
8: Bumper Rear Scratched 25 to 100mm Thru Paint

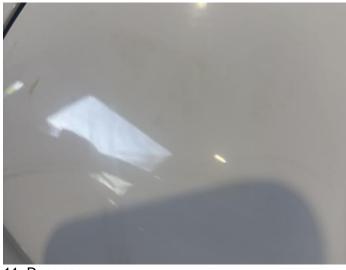
11: Door nsr Scratched Over 25mm Not Thru Paint

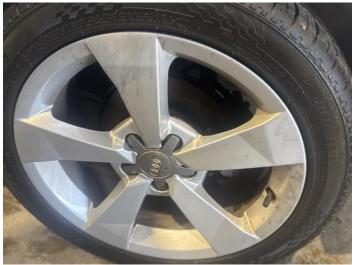
12: Wheel nsr Scratched Up To 50mm

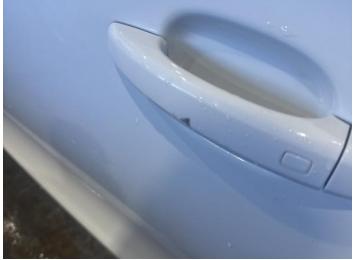
13: Door nsf Chipped 1 To 5
