VEHICLE INSPECTION REPORT

GJ19UYT

Kia Ceed 1.0T GDi ISG GT-Line 5dr

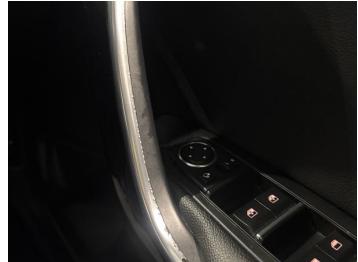
1: Handle Inner osf Damaged Replace

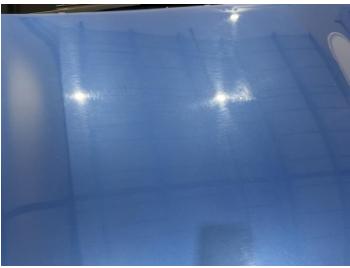
2: Bonnet Chipped 1 To 5

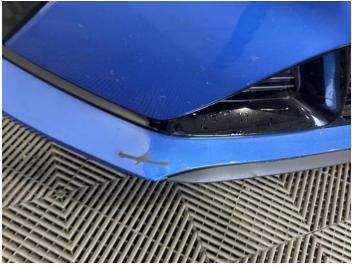
3: Bumper Front Cracked UpTo 25mm

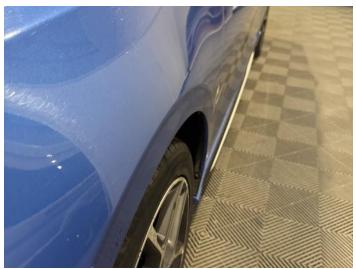
4: Wing nsf Chipped 1 To 5

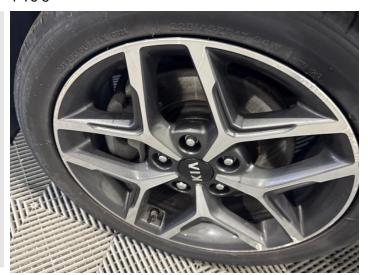
6: Wheel nsf Scratched Over 50mm

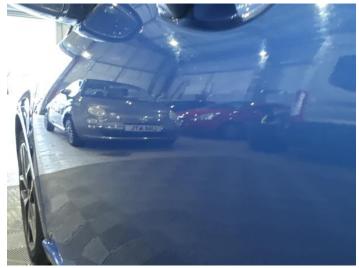
7: Door nsf Dented Over 30mm

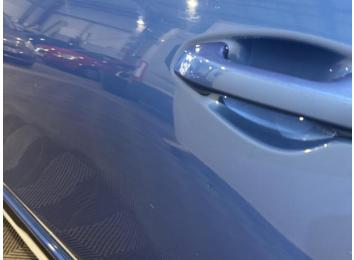
8: Door nsr Chipped 1 To 5

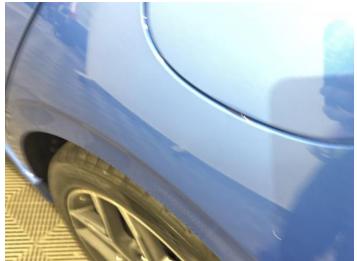
11: Qtr Panel nsr Chipped 1 To 5

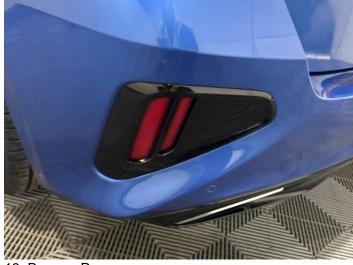
13: Bumper Rear Scratched 25 to 100mm Thru Paint

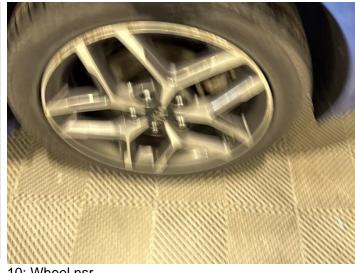
10: Wheel nsr Scratched Over 50mm

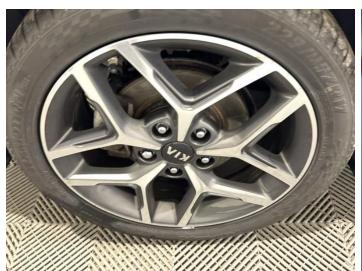
17: Wheel osr Scratched Over 50mm

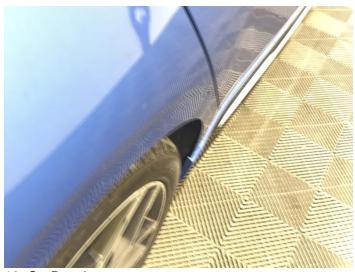
16: Qtr Panel osr Dented Over 30mm

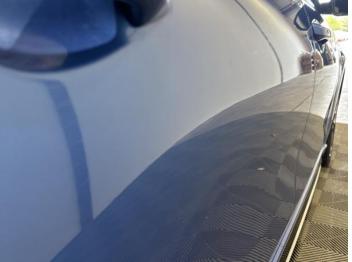
18: Door osr Dented Over 2 UpTo 10mm

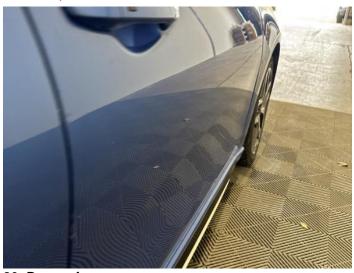
20: Door osf Dented 2 Or Less UpTo 10mm

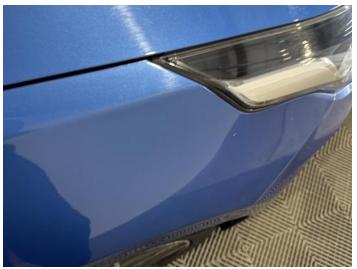
21: Wing osf Chipped 1 To 5

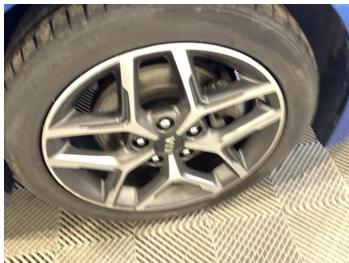
22: Wheel osf Scratched Over 50mm
