# VEHICLE INSPECTION REPORT

**GU14BZT**

## Peugeot 2008 1.6 e-HDi Allure 5dr EGC

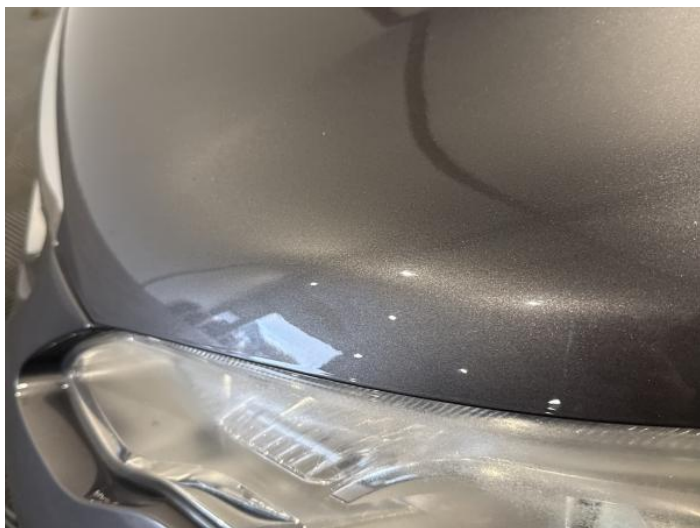
1: Bonnet  
Dented  
Between 10mm + 30mm

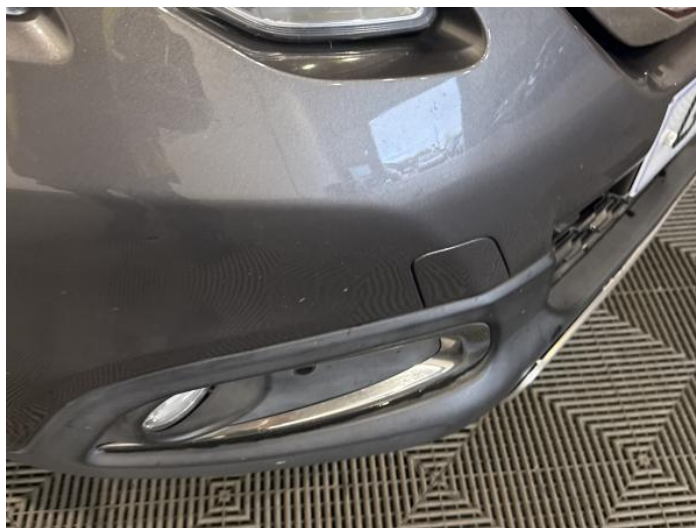
2: Bumper Front  
Chipped  
1 To 5

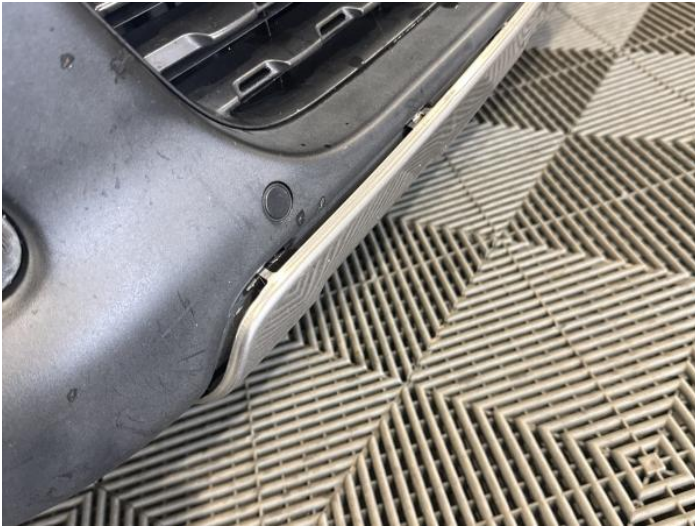
3: Bumper Front Moulding  
Broken  
Replace

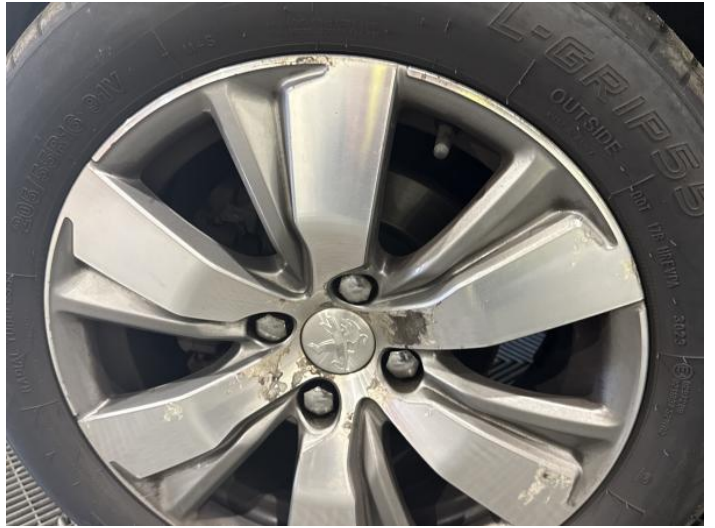
4: Wheel nsf  
Scratched  
Over 50mm

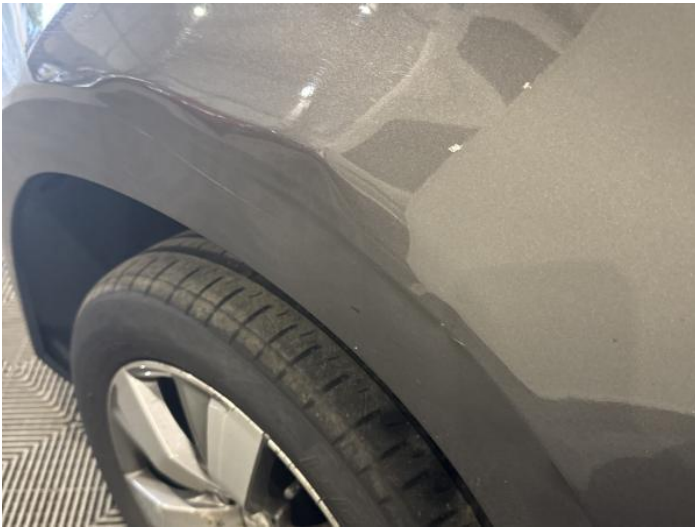
5: Wing nsf  
Dented  
Over 30mm

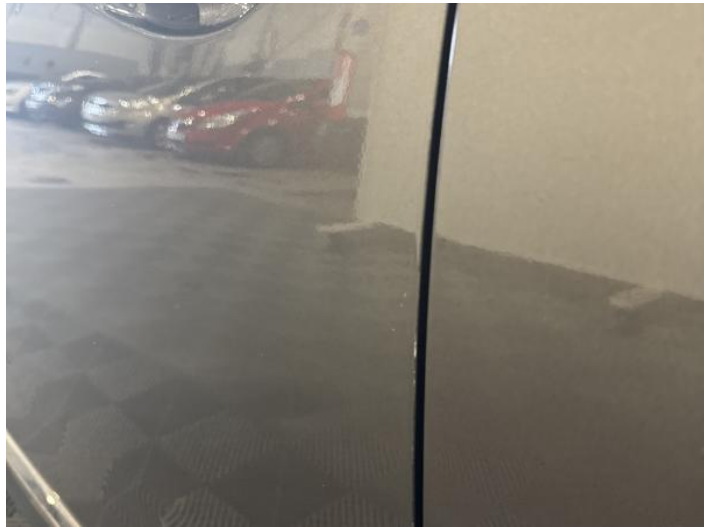
6: Door nsf  
Chipped  
Edge Chip

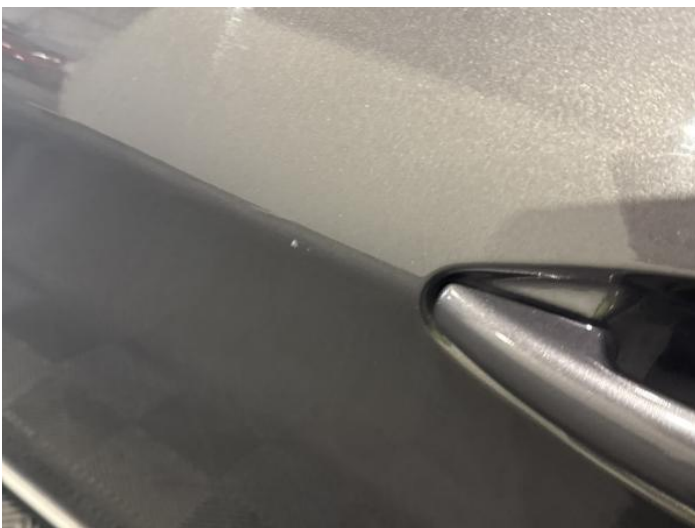
7: Door nsr  
Chipped  
1 To 5

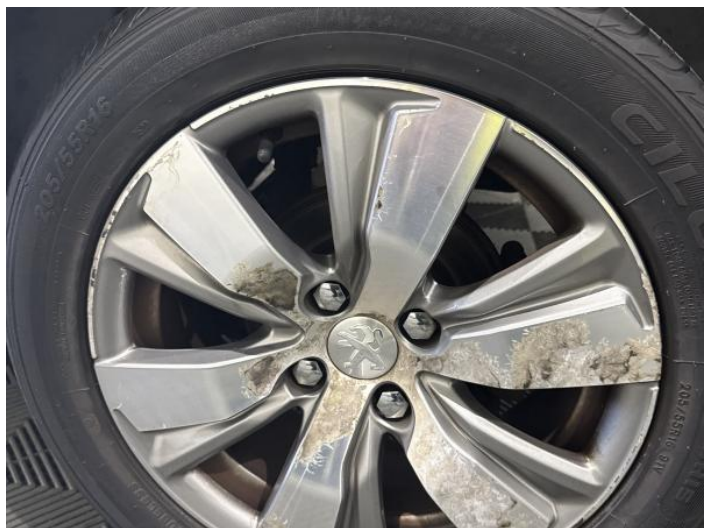
8: Wheel nsr  
Scratched  
Over 50mm

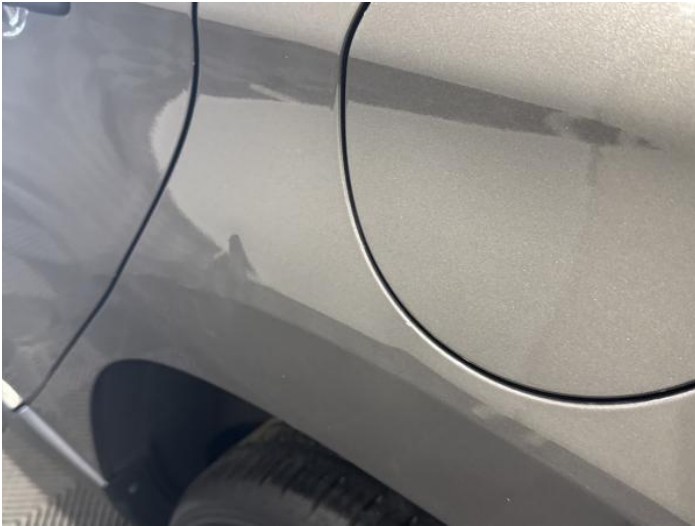
9: Qtr Panel nsr  
Dented  
Over 30mm

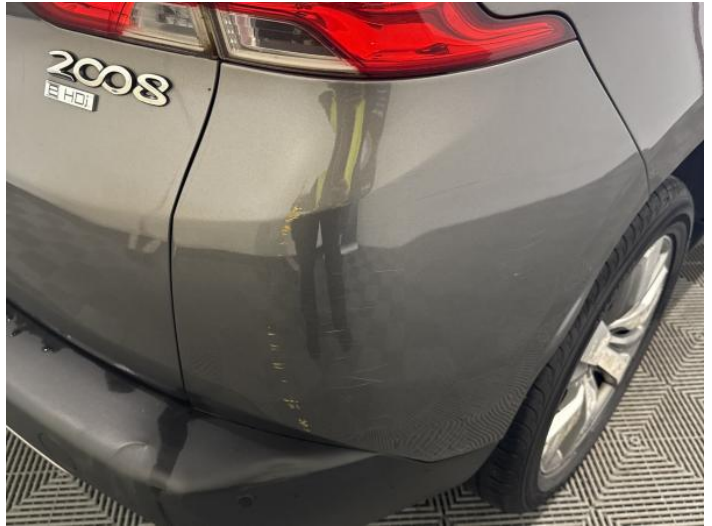
10: Bumper Rear  
Scratched  
Over 100mm Thru Paint

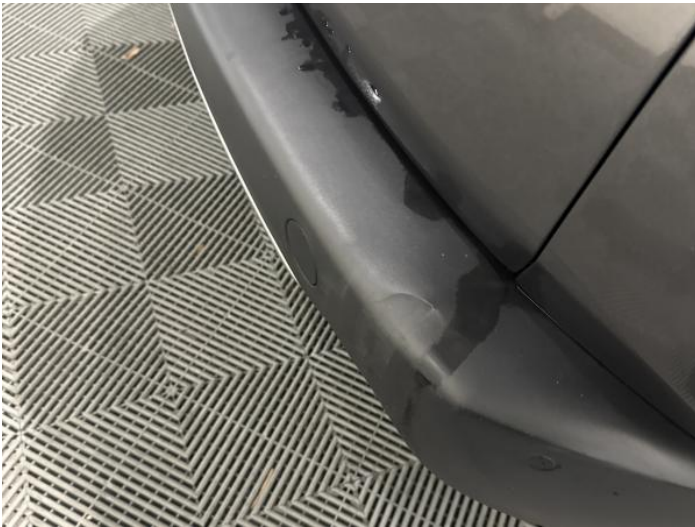
11: Bumper Rear Moulding  
Scuffed (Unpainted)  
UpTo 100mm

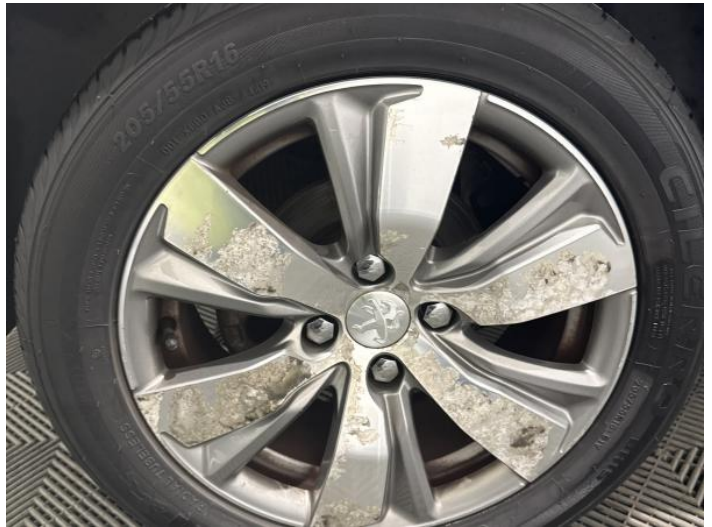
12: Wheel osr  
Scratched  
Over 50mm

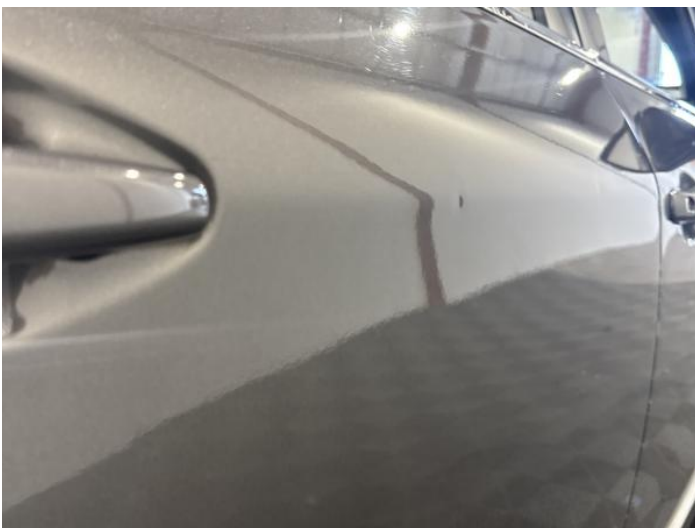
13: Door osr  
Dented  
Between 10mm + 30mm

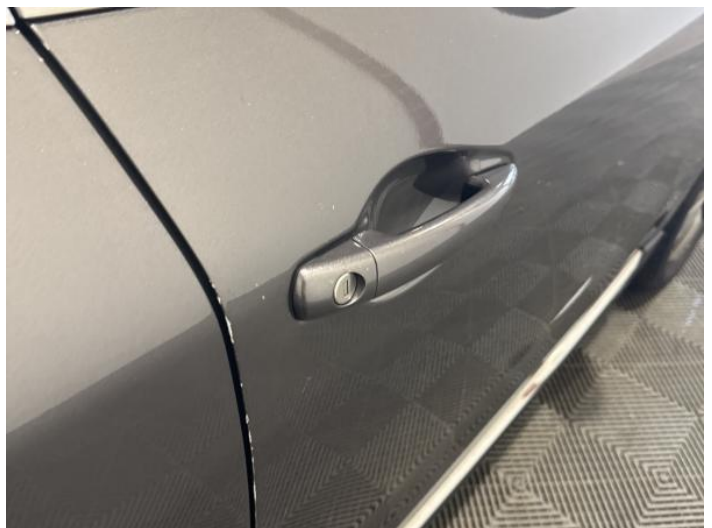
14: Door osf  
Dented  
Between 10mm + 30mm

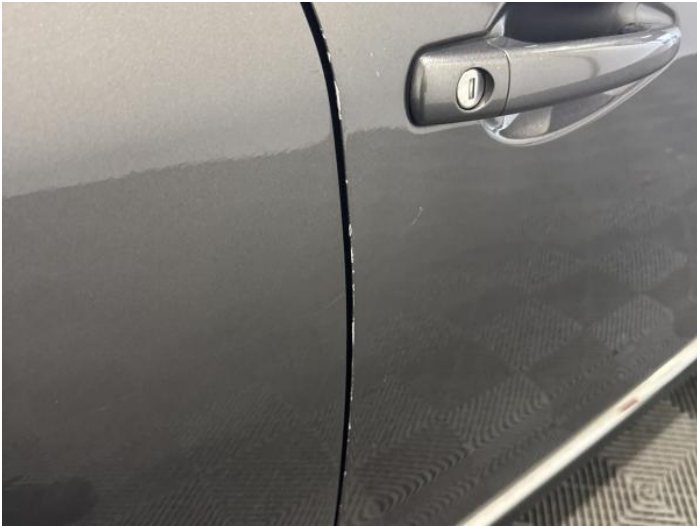
15: Door osf  
Chipped  
Edge Chip

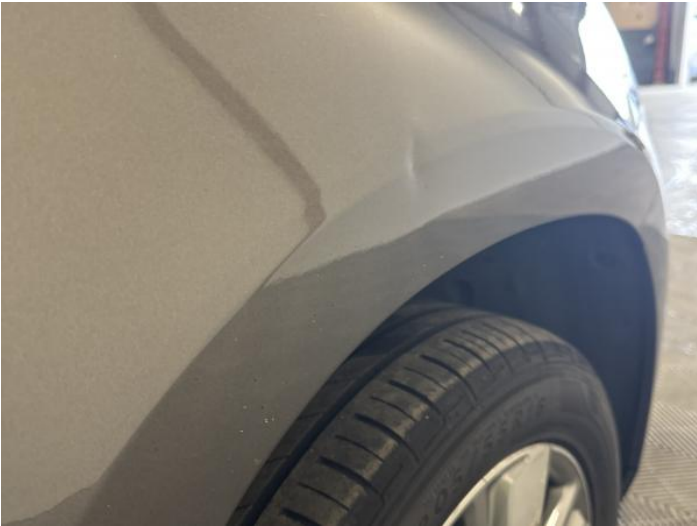
16: Wing osf  
Dented  
Between 10mm + 30mm

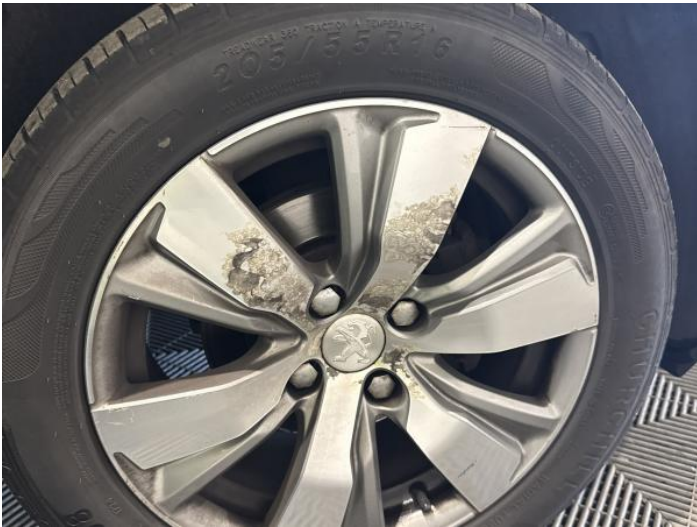
17: Wheel osf  
Scratched  
Over 50mm

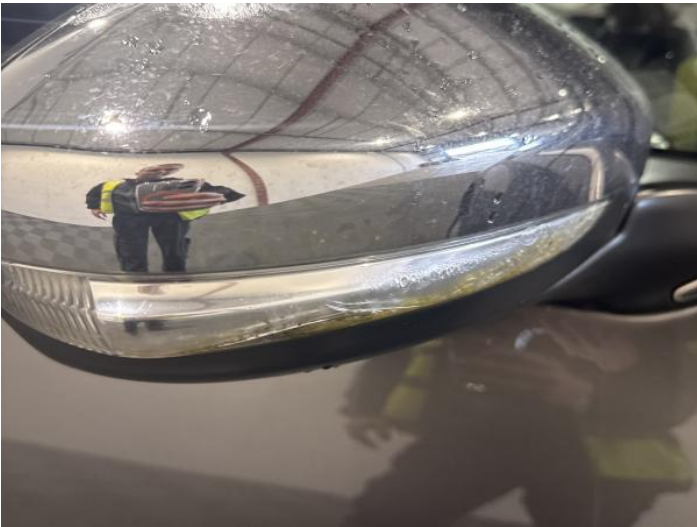
18: Flasher Side Repeater os  
Broken  
Replace
