## VEHICLE INSPECTION REPORT

**NX69UZU**

### Skoda Kodiaq 2.0 TDI 190 Sport Line 4x4 5dr DSG [7 Seat]

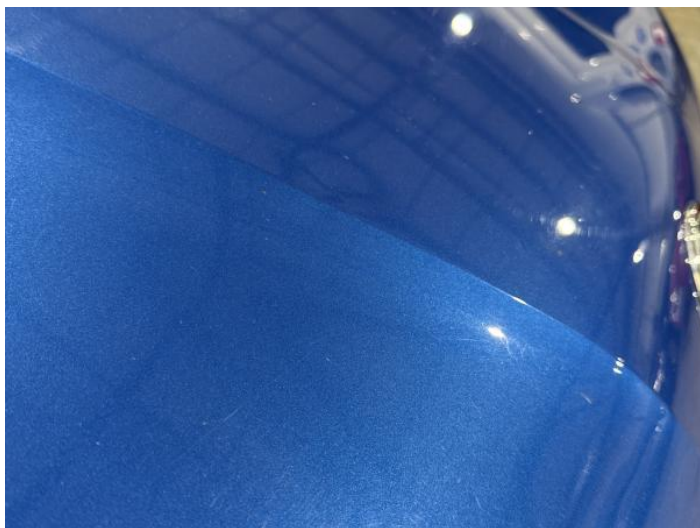
1: Bonnet  
Dented  
Between 10mm + 30mm

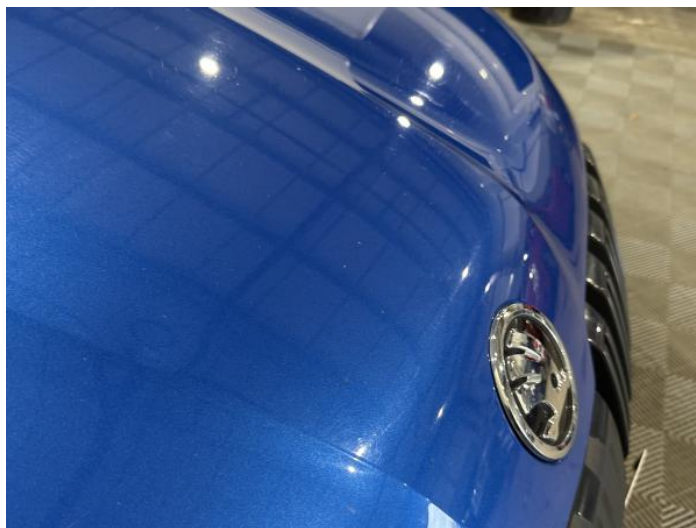
2: Bonnet  
Chipped  
1 To 5

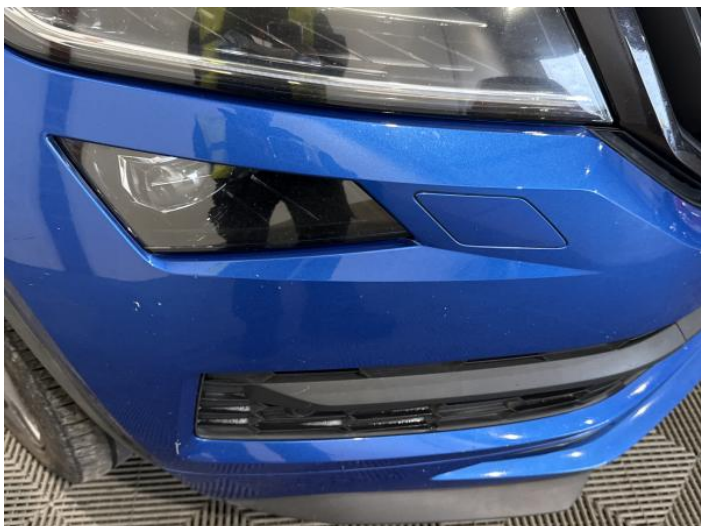
3: Bumper Front  
Chipped  
Multiple Chips

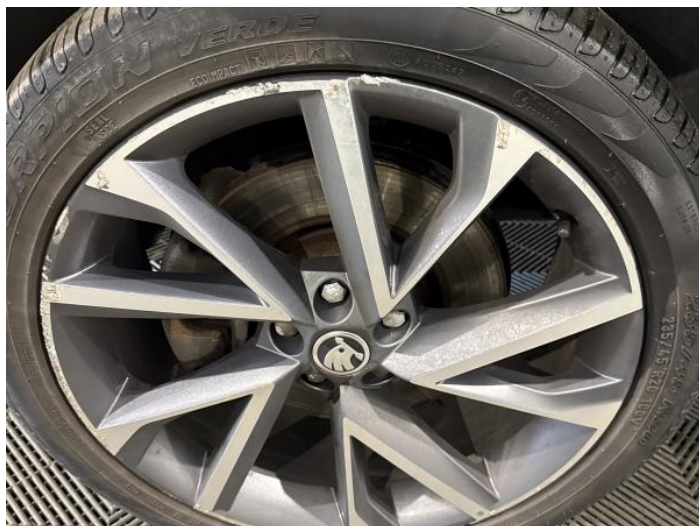
4: Wheel nsf  
Scratched  
Over 50mm

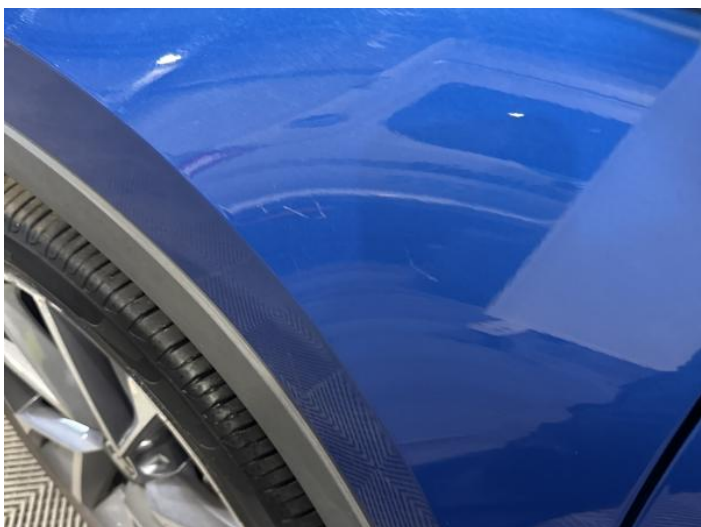
5: Wing nsf  
Scratched  
UpTo 25mm Thru Paint

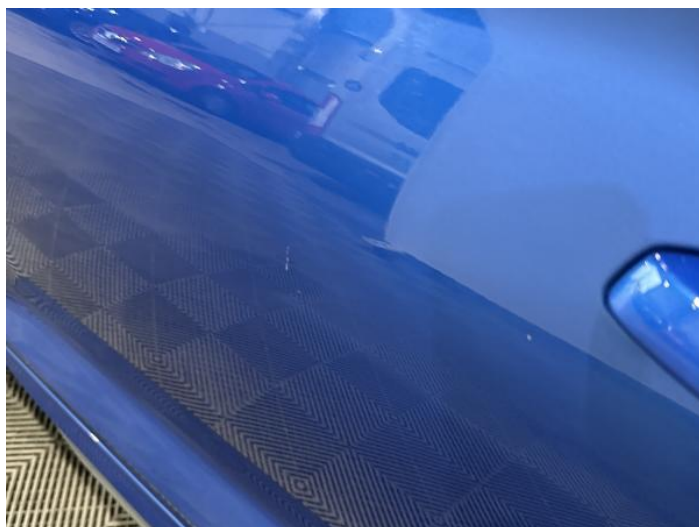
6: Door nsf  
Scratched  
UpTo 25mm Thru Paint

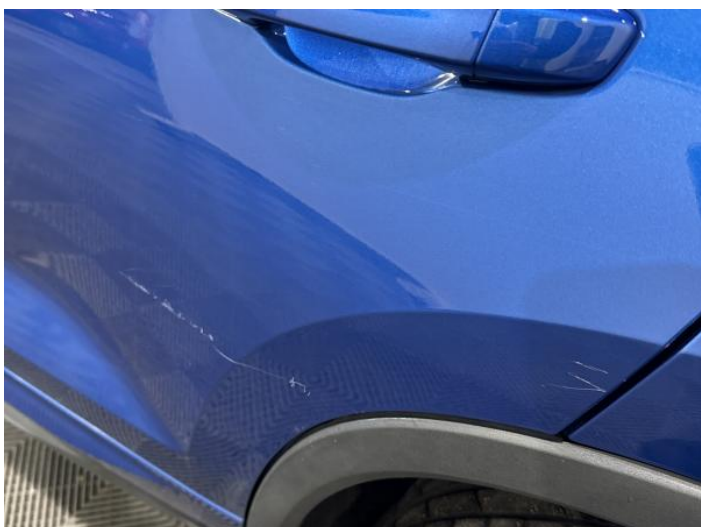
7: Door nsr  
Scratched  
Over 25mm Thru Paint

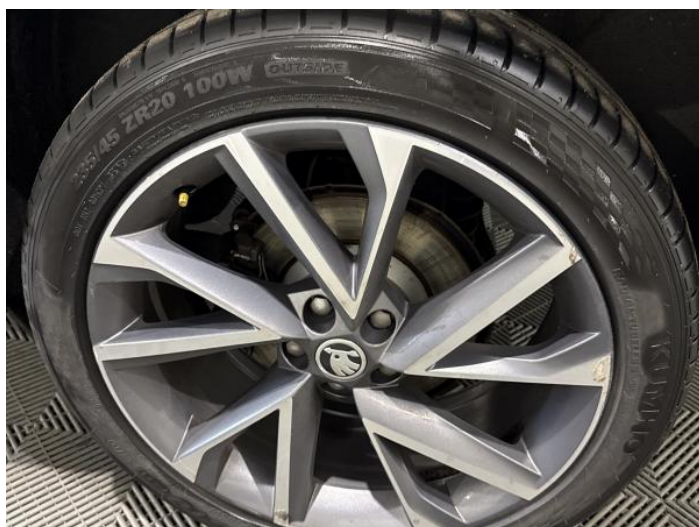
8: Wheel nsr  
Scratched  
Over 50mm

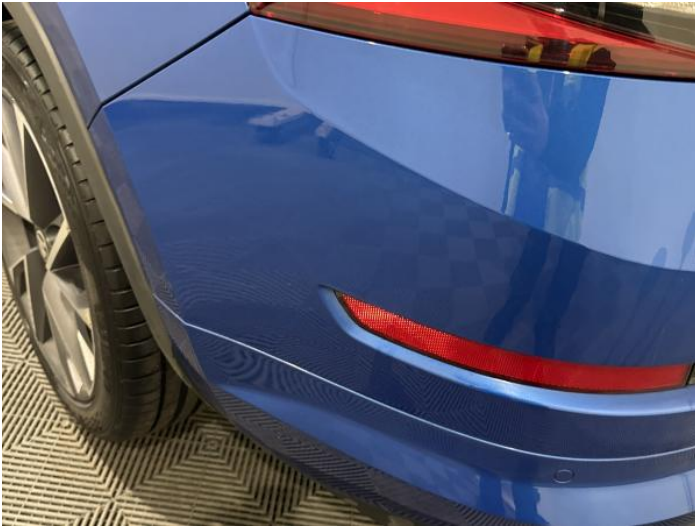
9: Bumper Rear  
Scratched  
25 to 100mm Thru Paint

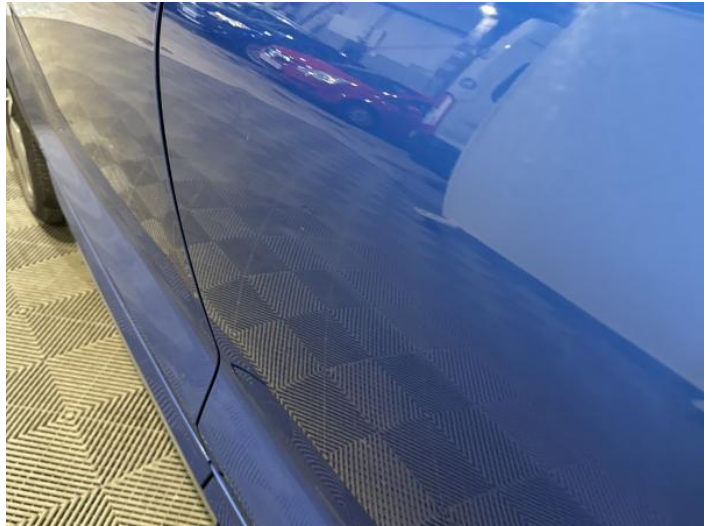
10: Door nsr  
Dented  
Between 10mm + 30mm

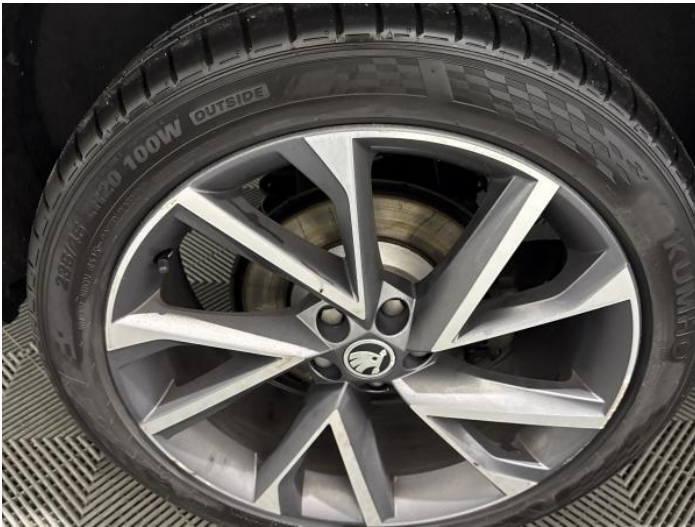
11: Wheel nsr  
Scratched  
Over 50mm

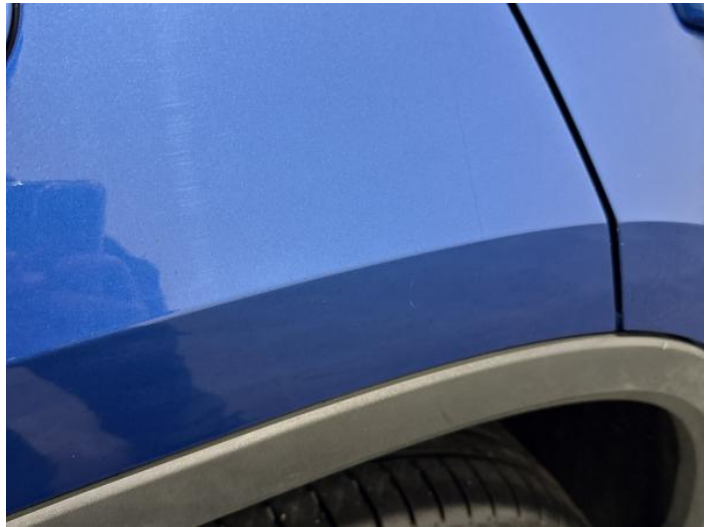
12: Qtr Panel osr  
Scratched  
UpTo 25mm Thru Paint

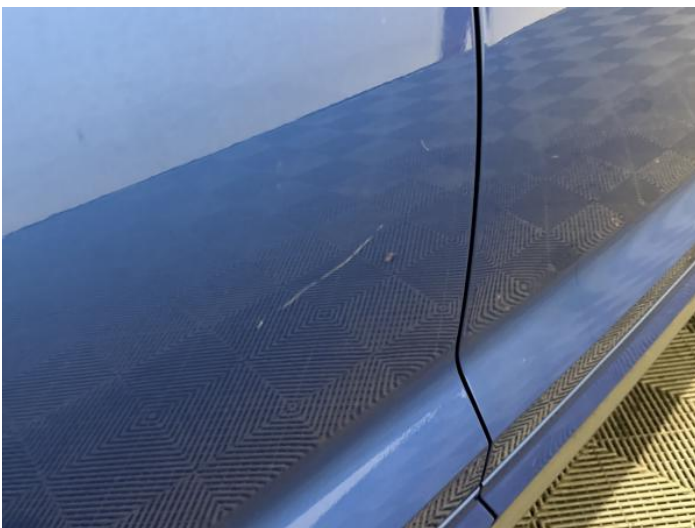
13: Door osr  
Scratched  
Over 25mm Thru Paint

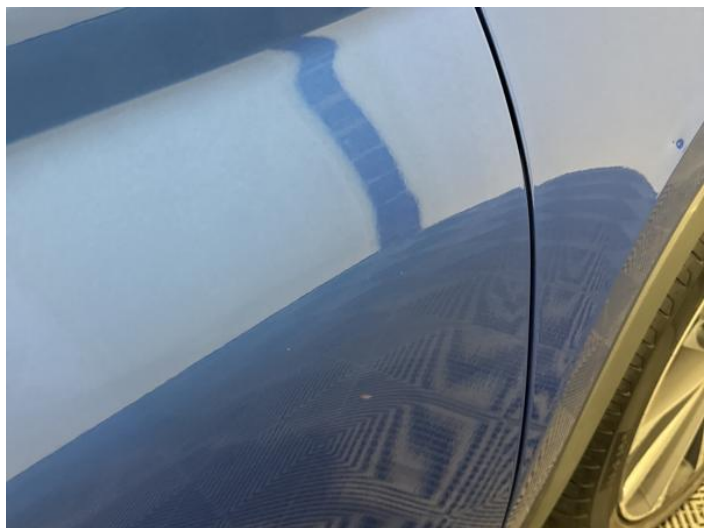
14: Door osf  
Dented  
Between 10mm + 30mm

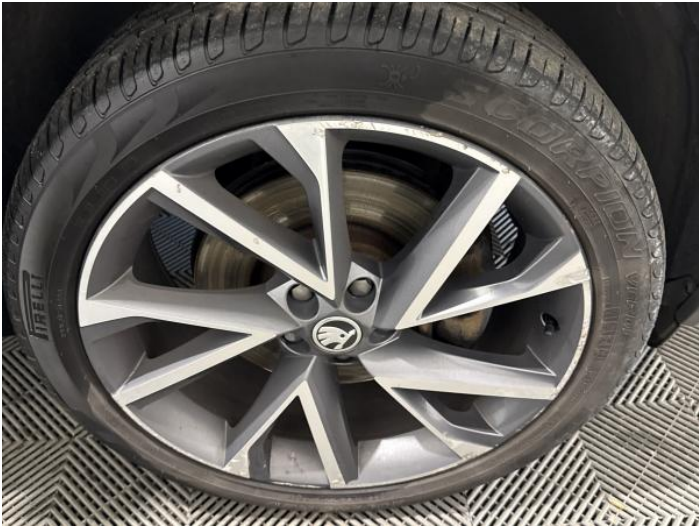
15: Wheel osf  
Scratched  
Over 50mm

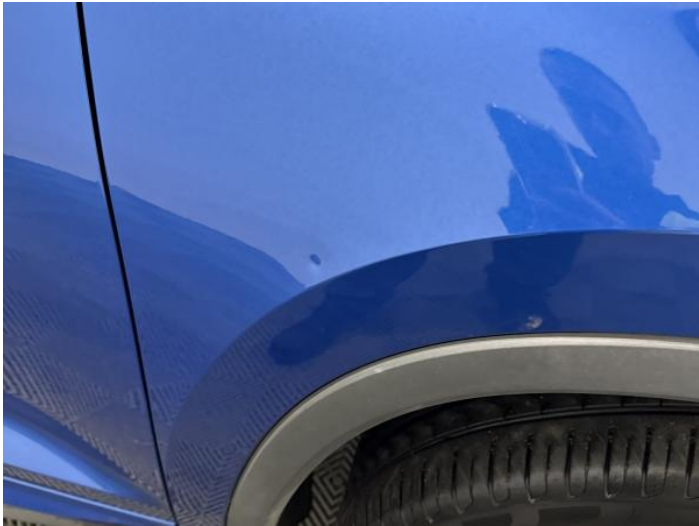
16: Wing osf  
Dented  
Between 10mm + 30mm

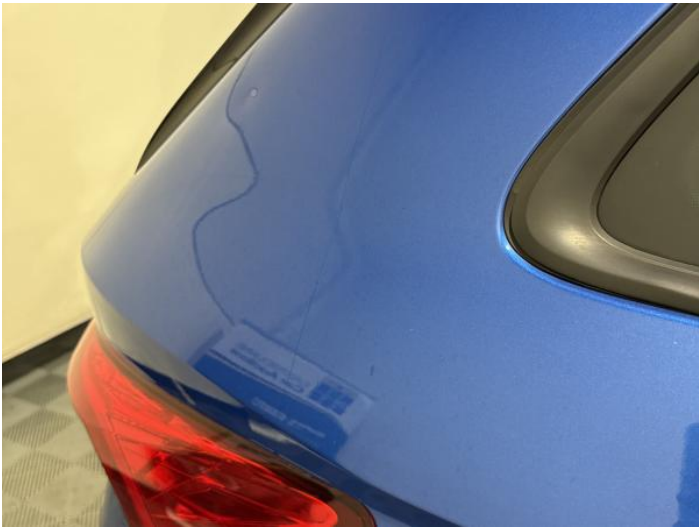
17: Qtr Panel osr  
Dented  
Between 10mm + 30mm
