# VEHICLE INSPECTION REPORT

**GP10DNF**

## Peugeot 5008 2.0 HDi 163 Exclusive 5dr Auto

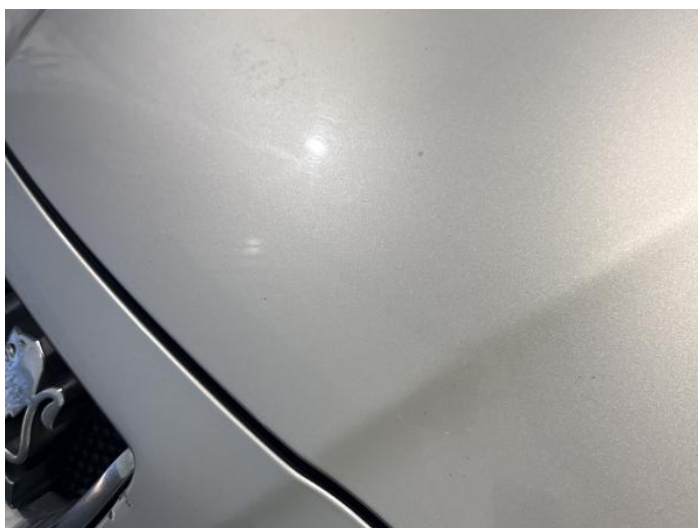
1: Bonnet  
Chipped  
1 To 5

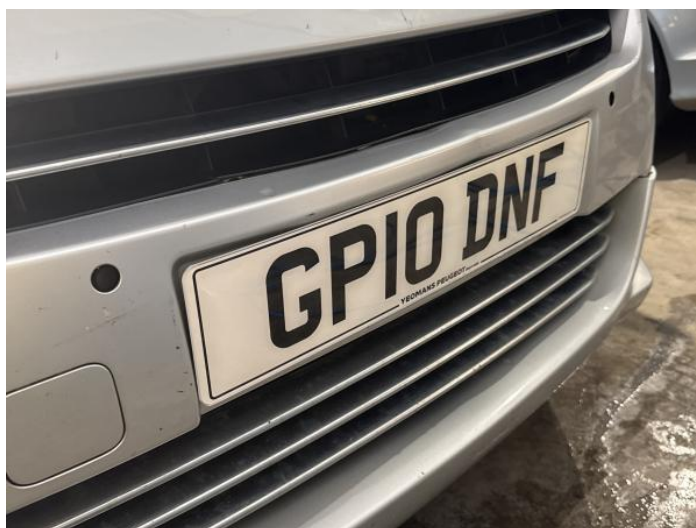
2: Parking Sensor Front  
Missing  
Replace

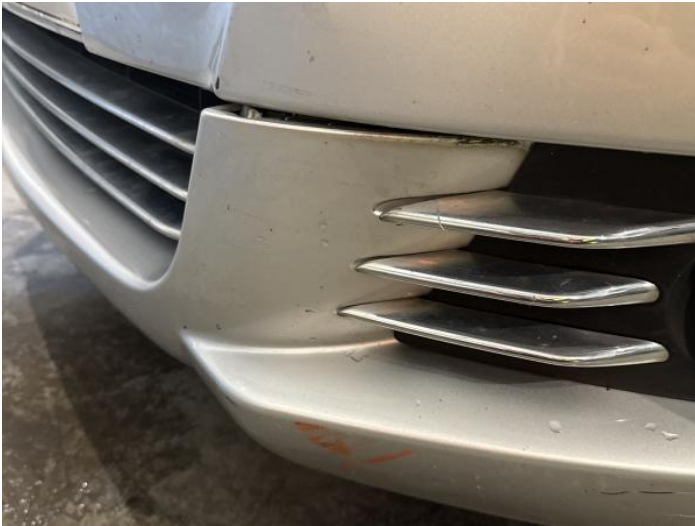
3: Bumper Front Moulding  
Broken  
Replace

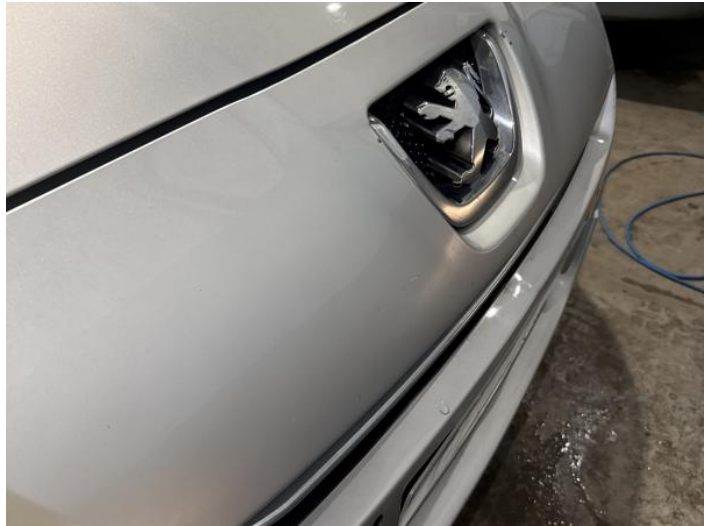
4: Bumper Front  
Dented  
With Paint Damage

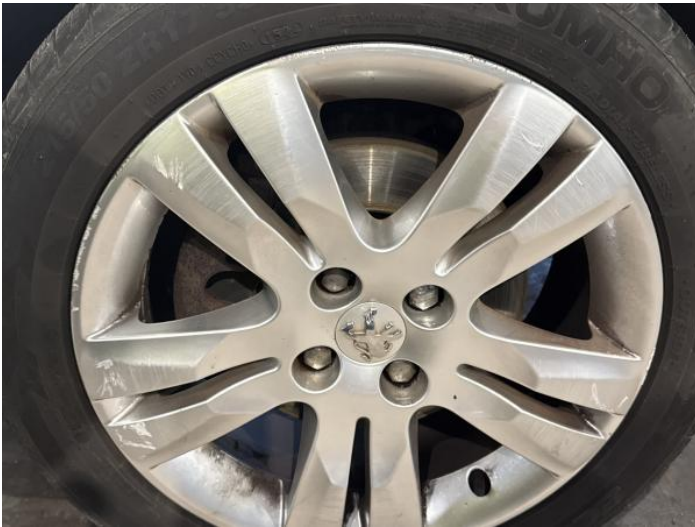
5: Wheel nsf  
Scratched  
Over 50mm

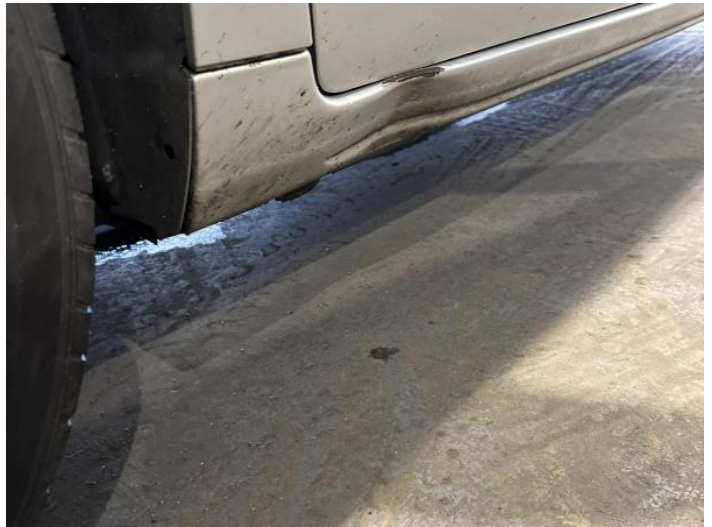
6: Sill ns  
Dented  
Over 30mm

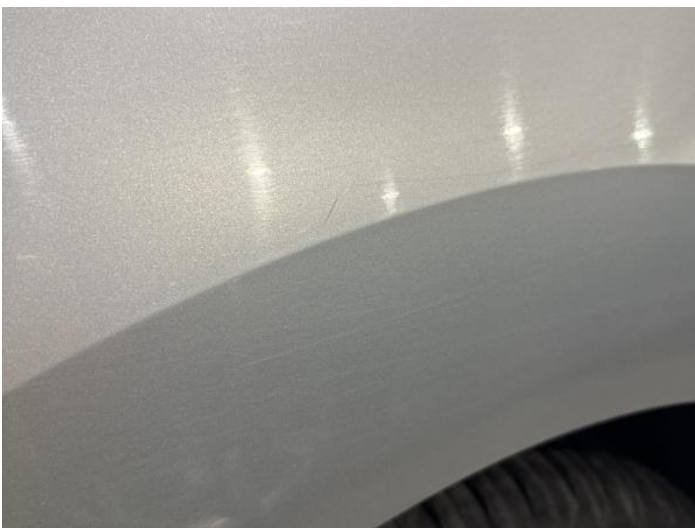
7: Wing nsf  
Scratched  
UpTo 25mm Thru Paint

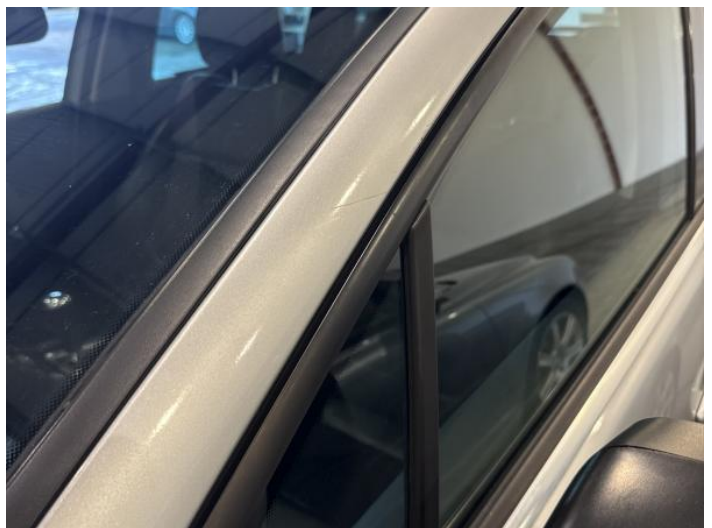
8: B Post ns  
Scratched  
UpTo 25mm Thru Paint

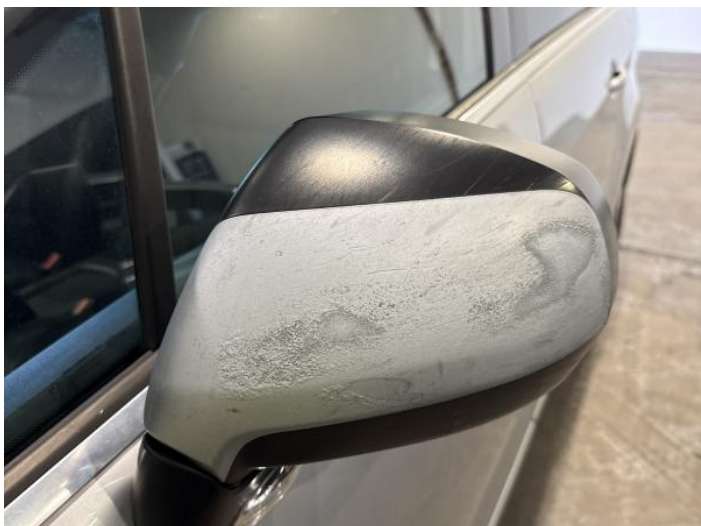
9: Door Mirror Assy nsf  
Scratched (Painted)  
Over 25mm Thru Paint

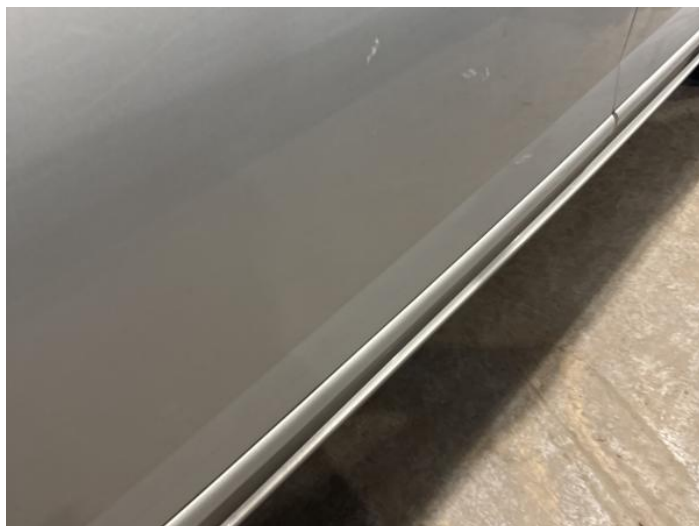
10: Door nsf  
Dented  
Over 30mm

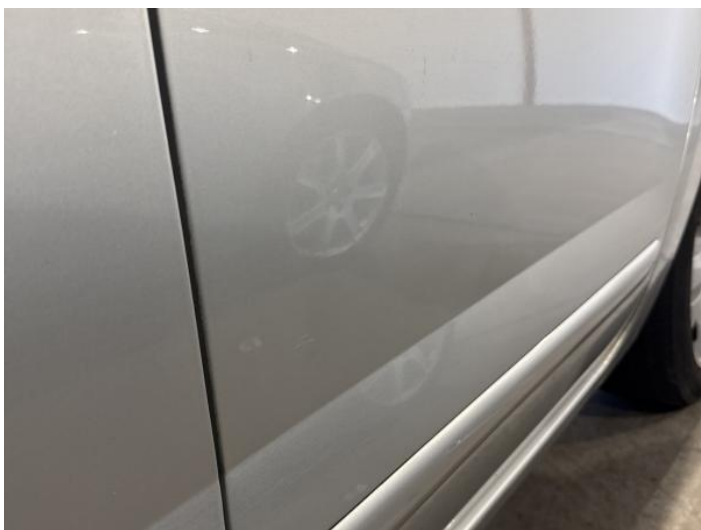
11: Door nsr  
Dented  
Over 30mm

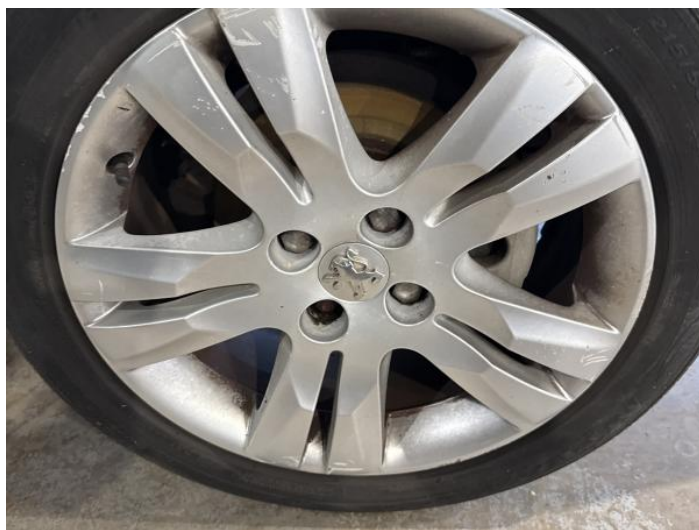
12: Wheel nsr  
Scratched  
Over 50mm

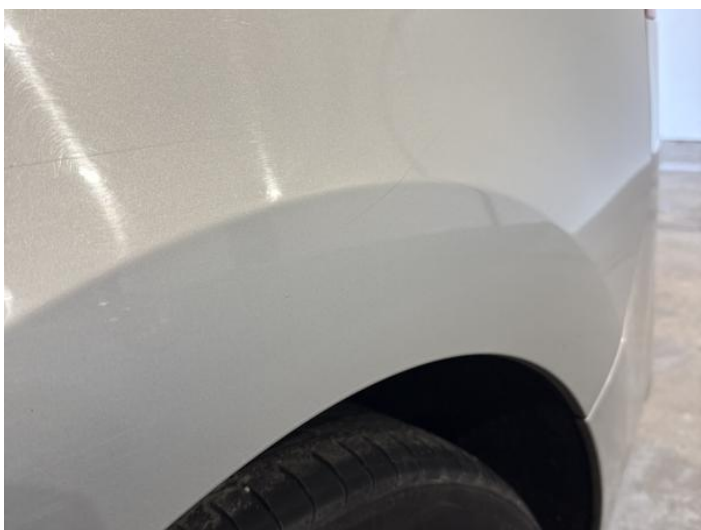
13: Qtr Panel nsr  
Scratched  
Over 25mm Thru Paint

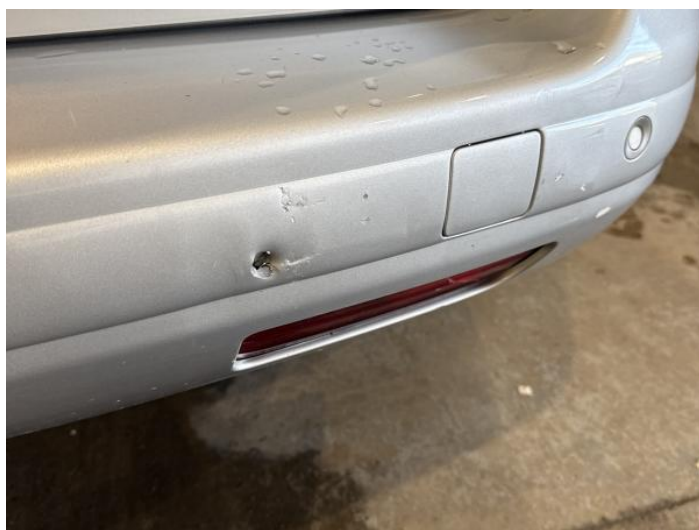
14: Bumper Rear  
Hole  
Over 25mm

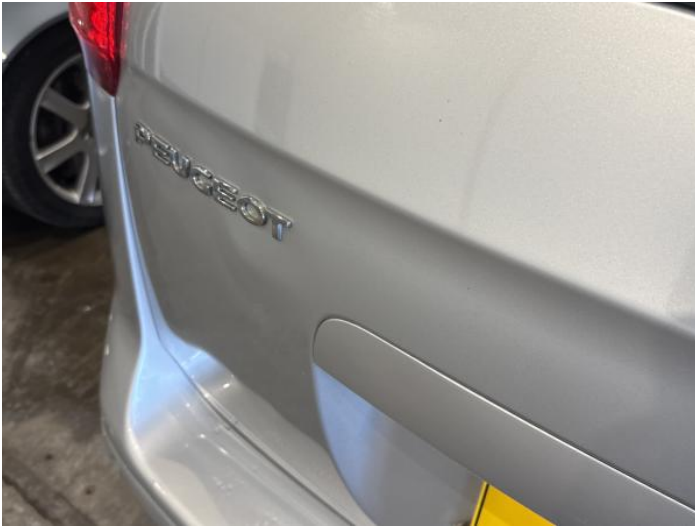
15: Tailgate  
Dented  
Over 30mm

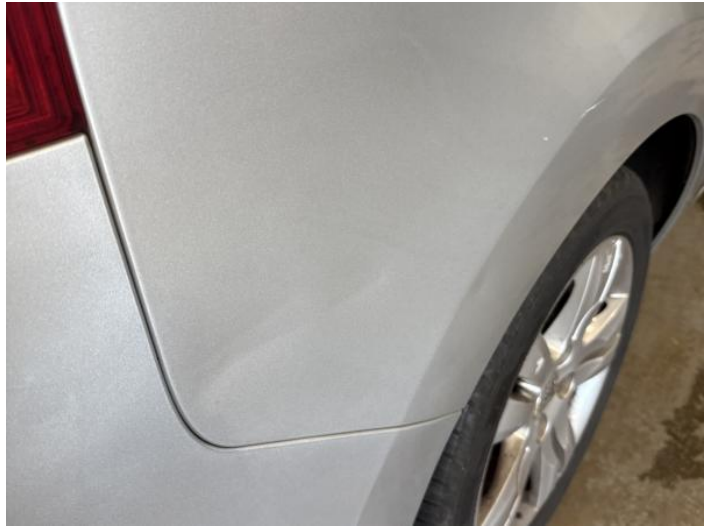
16: Qtr Panel osr  
Dented  
Over 30mm

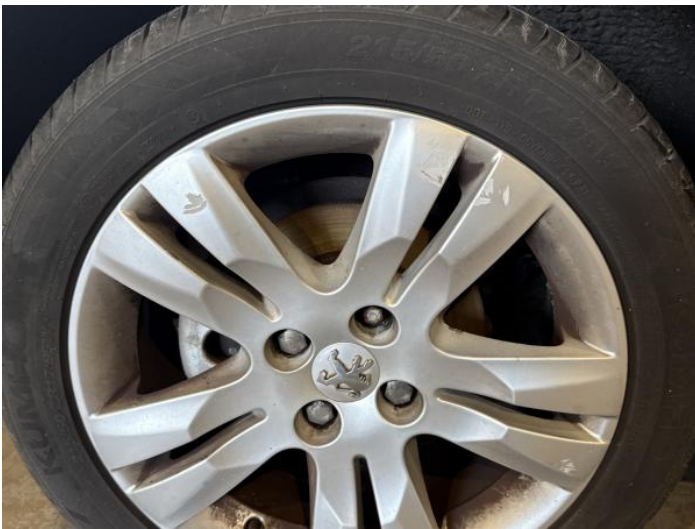
17: Wheel osr  
Scratched  
Over 50mm

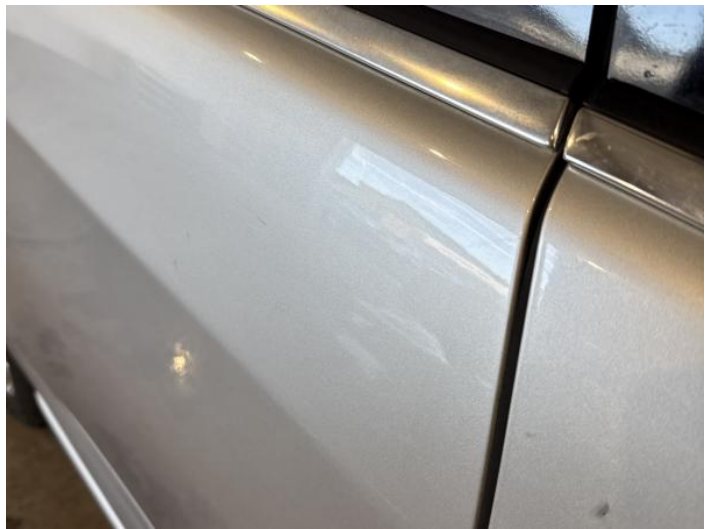
18: Door osr  
Scratched  
UpTo 25mm Thru Paint

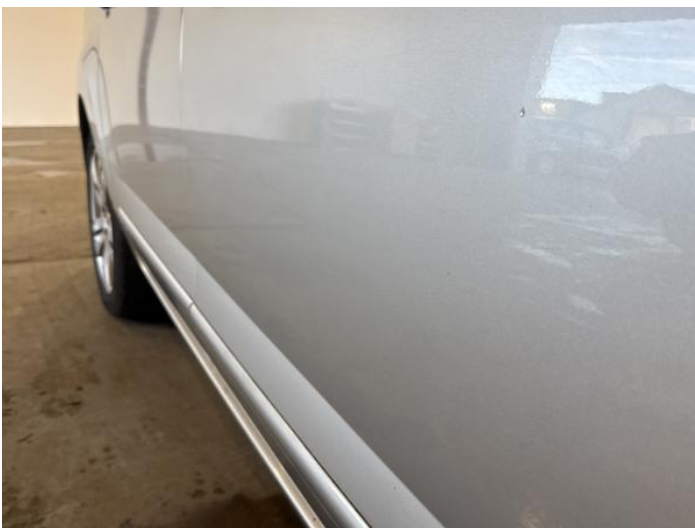
19: Door osf  
Dented  
Between 10mm + 30mm

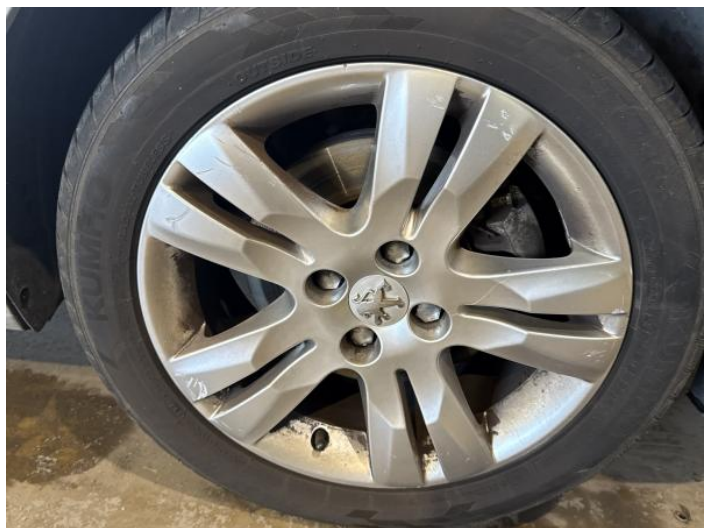
20: Wheel osf  
Scratched  
Over 50mm

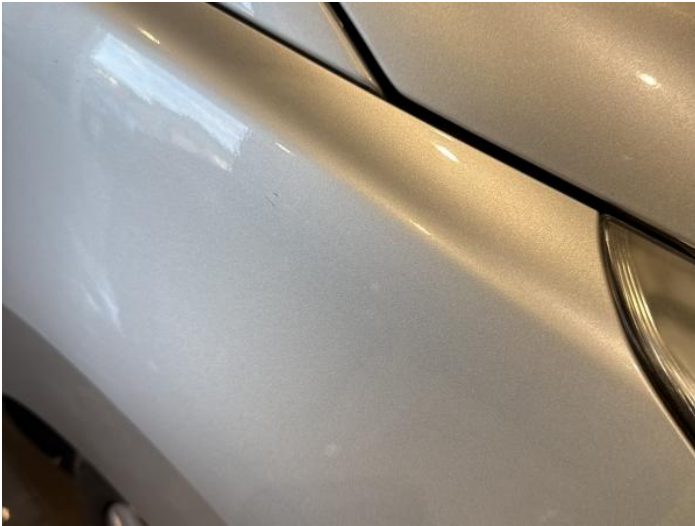
21: Wing osf  
Scratched  
UpTo 25mm Thru Paint

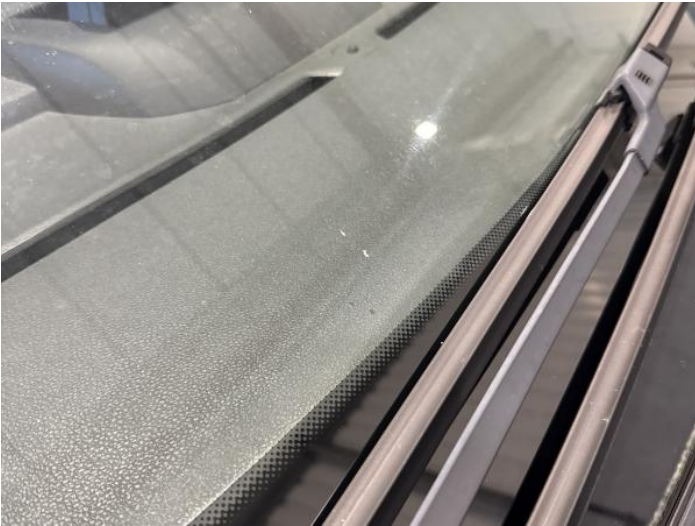
22: Screen Front  
Cracked  
Replace
