## VEHICLE INSPECTION REPORT

**GD64ZFR**

### Skoda Rapid Spaceback 1.2 TSI 105 SE Tech 5dr

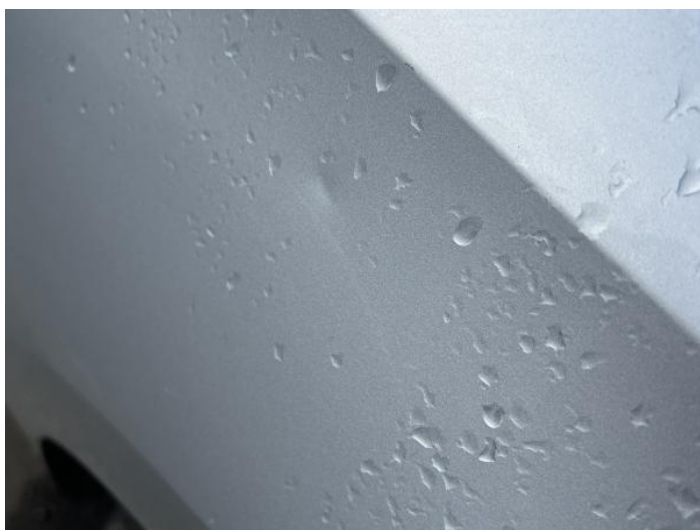
1: Wing osf  
Dented  
2 Or Less UpTo 10mm

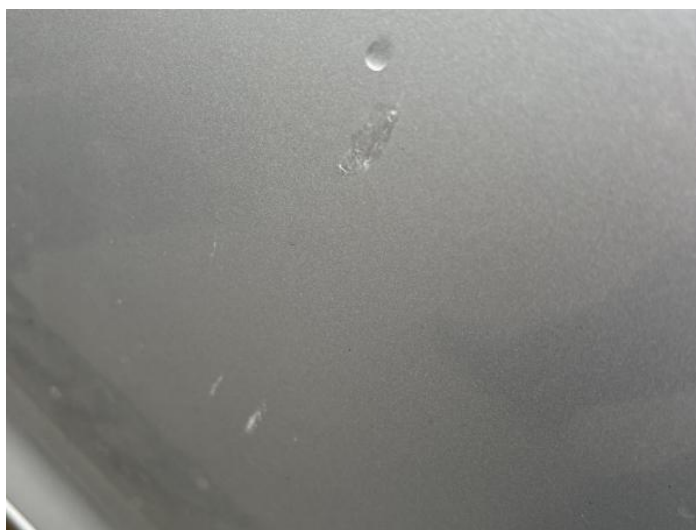
2: Door osf  
Scratched  
UpTo 25mm Thru Paint

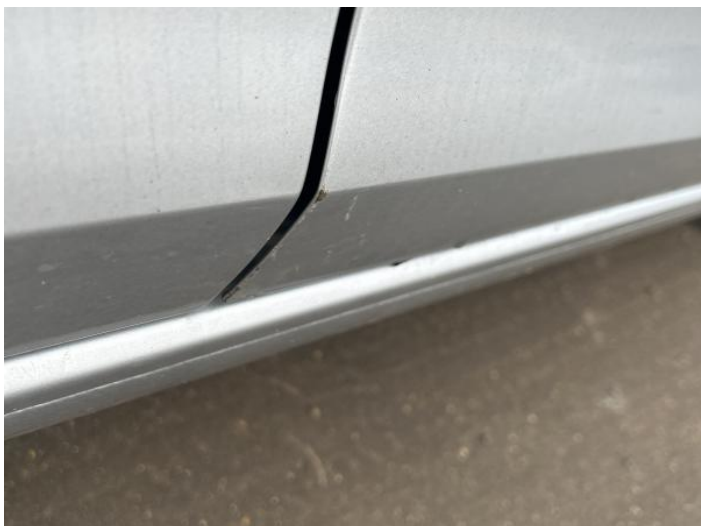
3: Door osf  
Chipped  
Edge Chip

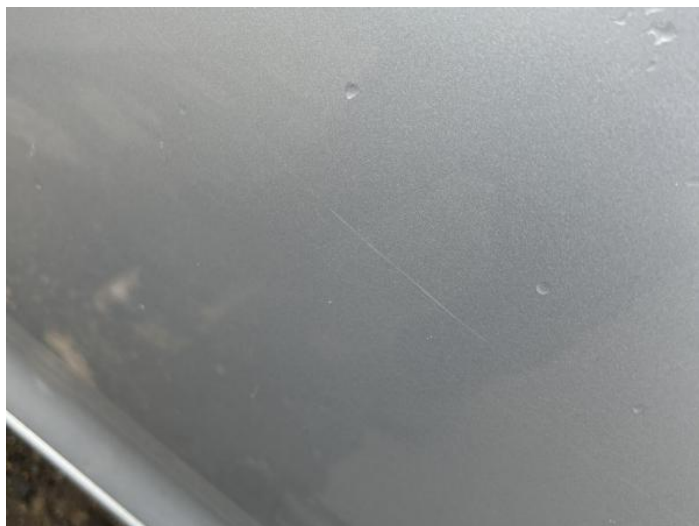
4: Door osr  
Scratched  
Over 25mm Not Thru Paint

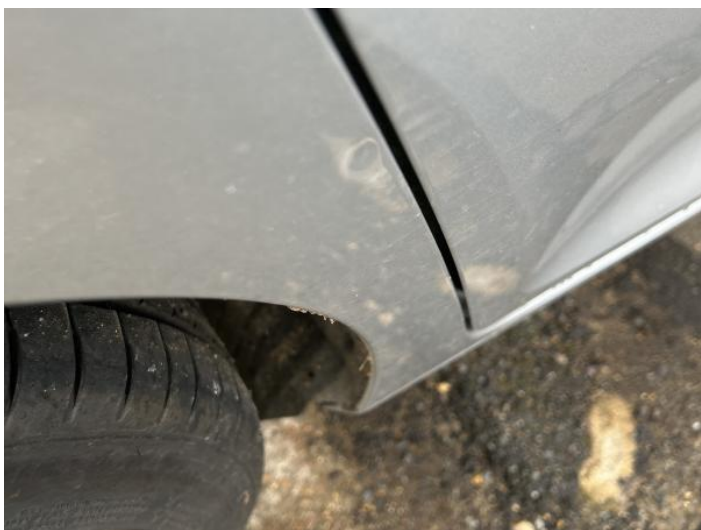
5: Qtr Panel osr  
Dented  
2 Or Less UpTo 10mm

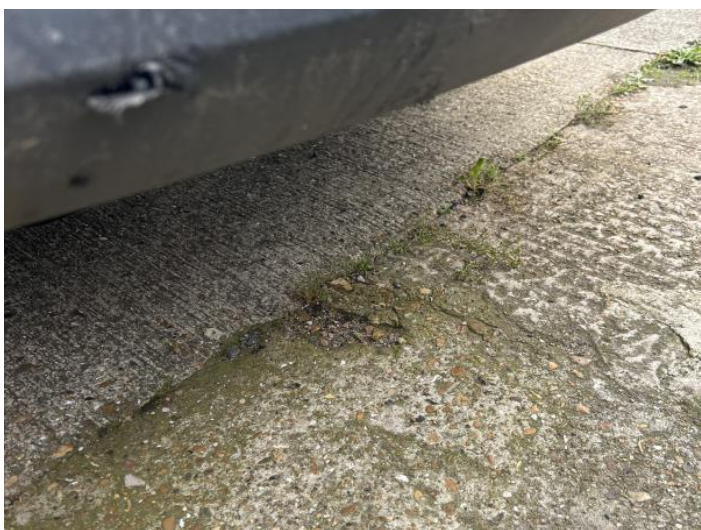
7: Bumper Rear Moulding  
Broken  
Replace

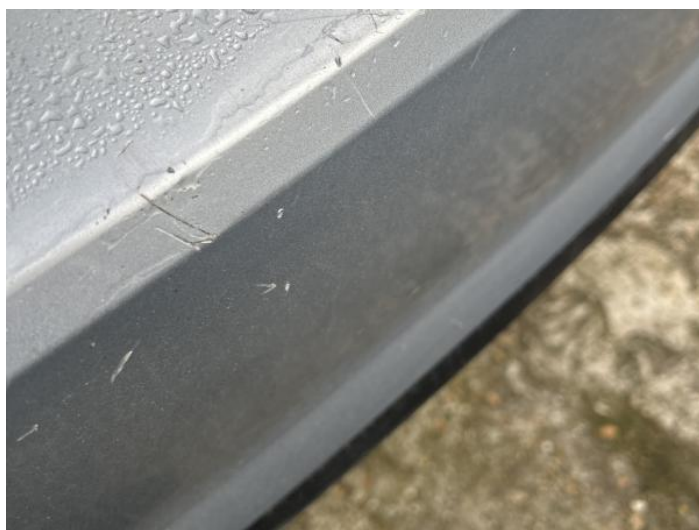
8: Bumper Rear  
Scratched  
Over 100mm Thru Paint

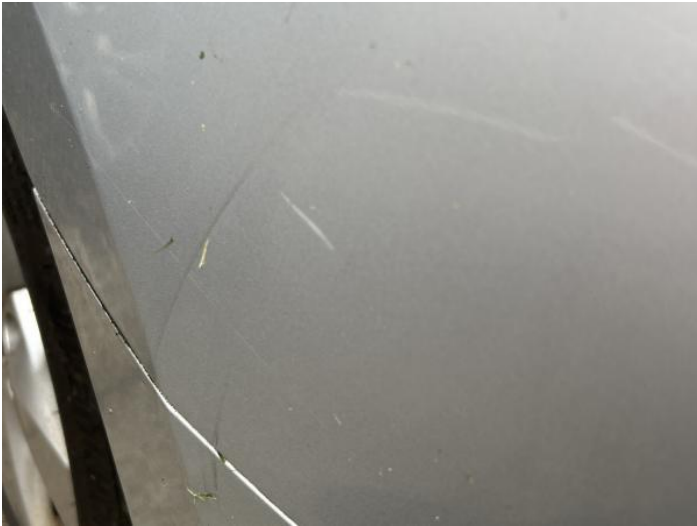
9: Qtr Panel nsr  
Scratched  
Over 25mm Not Thru Paint

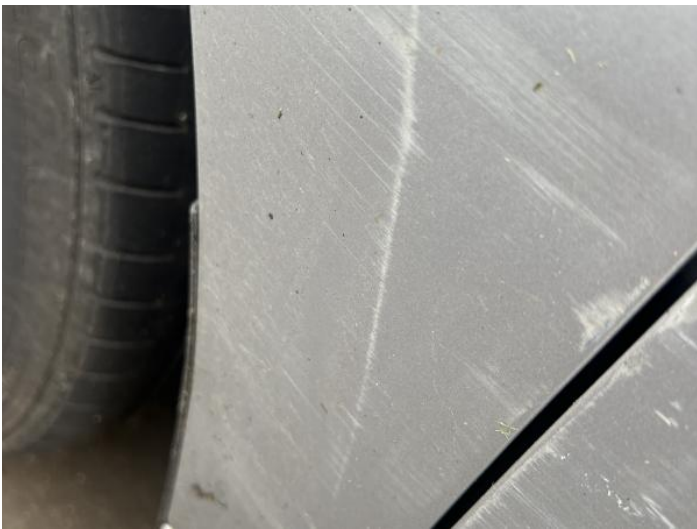
11: Wing nsf  
Scratched  
Over 25mm Not Thru Paint

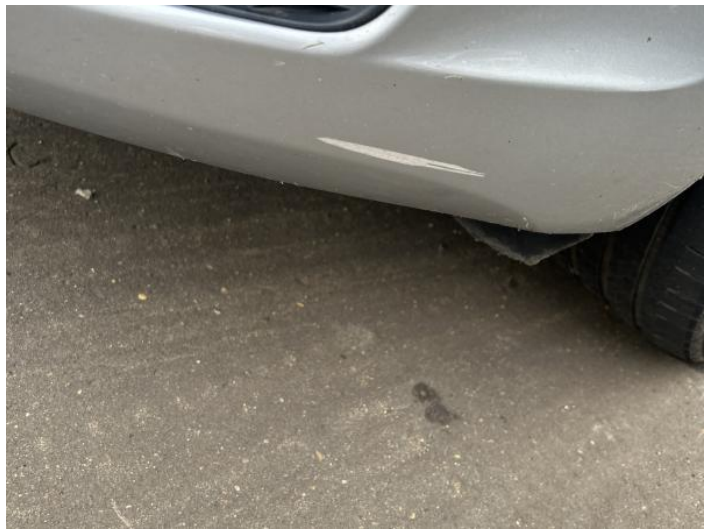
12: Bumper Front  
Scratched  
Over 100mm Thru Paint

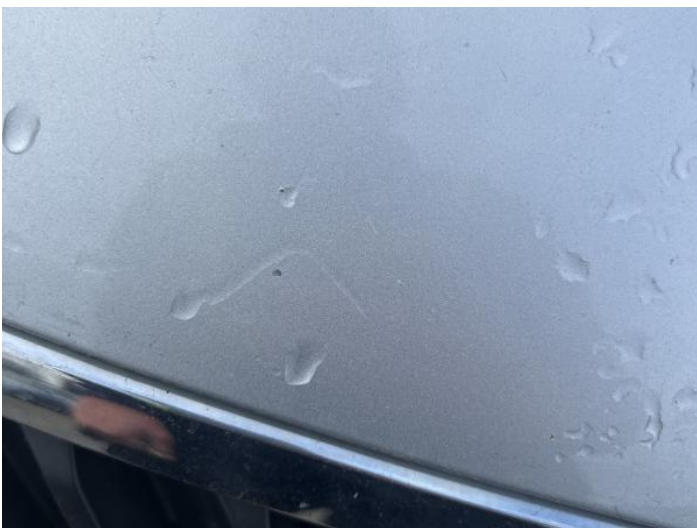
13: Bonnet  
Chipped  
1 To 5
