VEHICLE INSPECTION REPORT

EG15BLN

Ford Grand C-Max 2.0 TDCi Titanium X 5dr

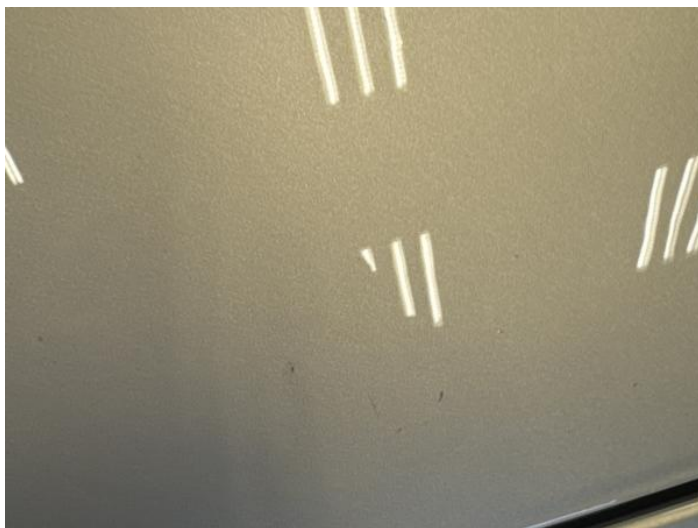
1: Bonnet
Chipped
1 To 5

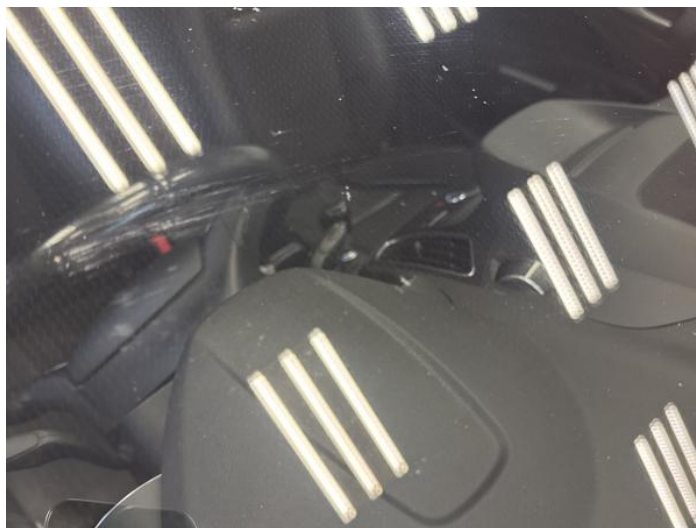
2: Screen Front
Chipped
UpTo 10mm

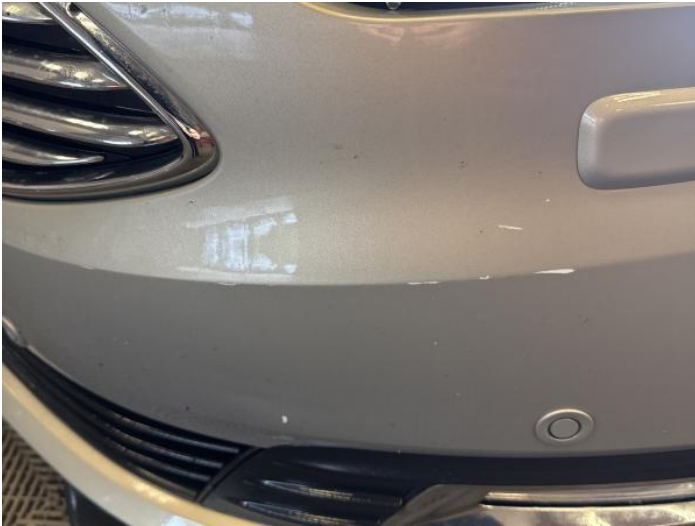
3: Bumper Front
Scratched
25 to 100mm Thru Paint

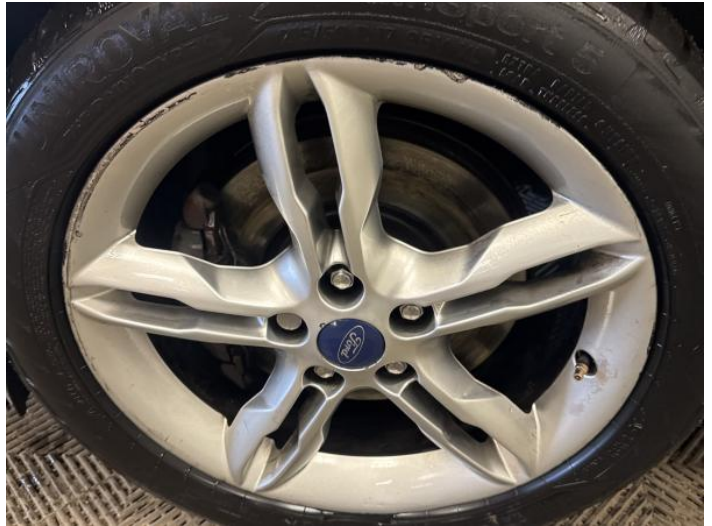
4: Wheel nsf
Scratched
Over 50mm

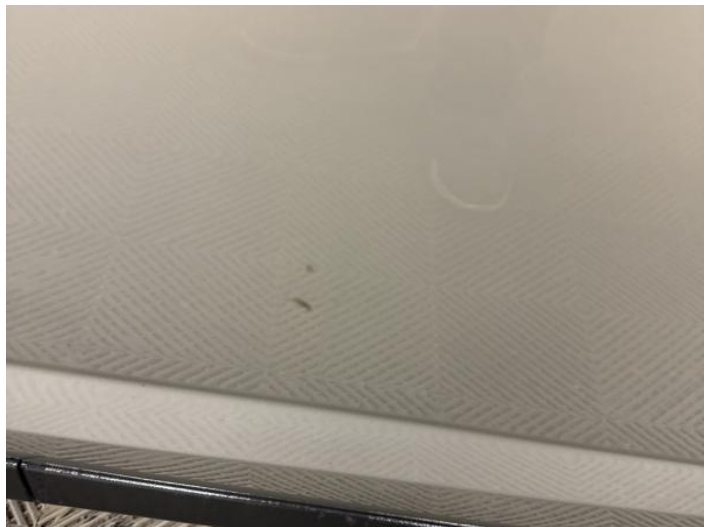
6: Door nsr
Chipped
1 To 5

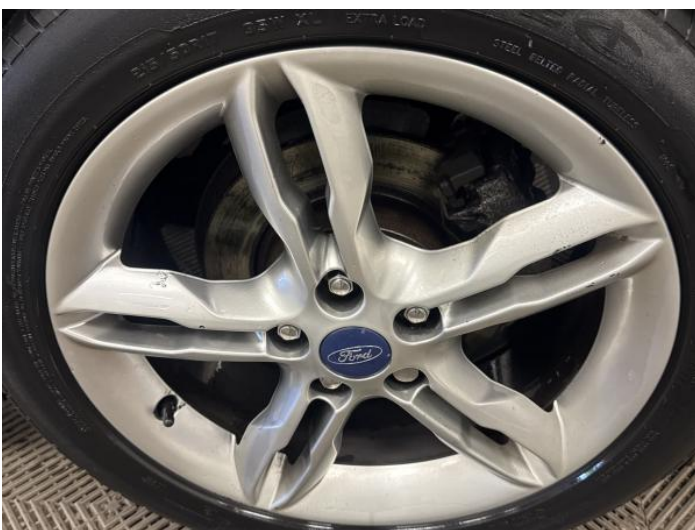
7: Wheel nsr
Corroded
Light

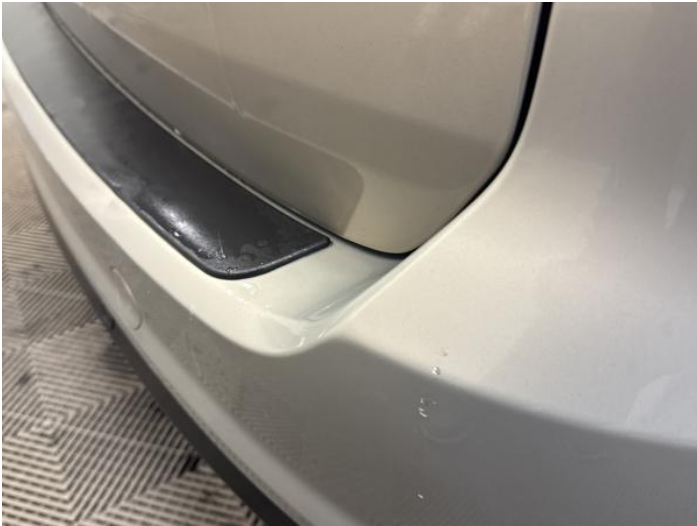
9: Bumper Rear
Scratched
Over 100mm Thru Paint

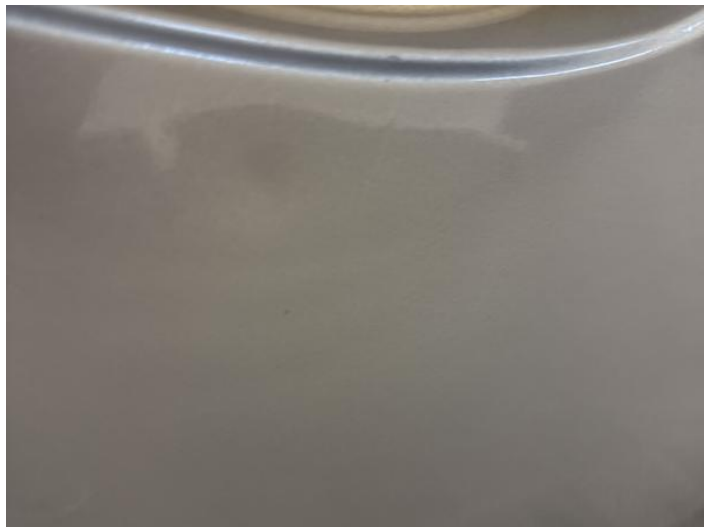
12: Door osf
Dented
Over 2 UpTo 10mm

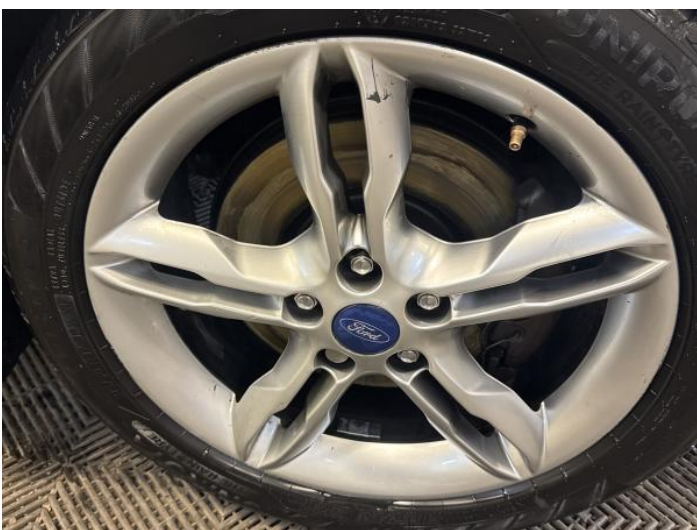
13: Wheel osf
Scratched
Over 50mm
