## VEHICLE INSPECTION REPORT

**GY59EEZ**

### Volvo XC60 D5 [205] SE Lux Premium 5dr AWD Geartronic

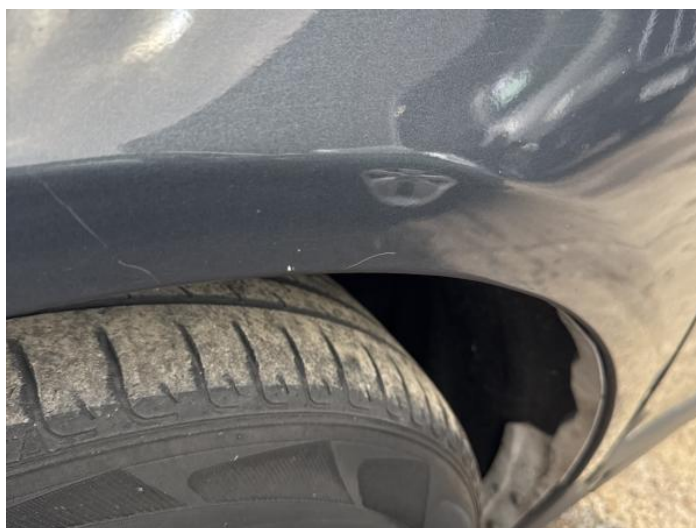
2: Wing nsf  
Dented  
With Paint Damage

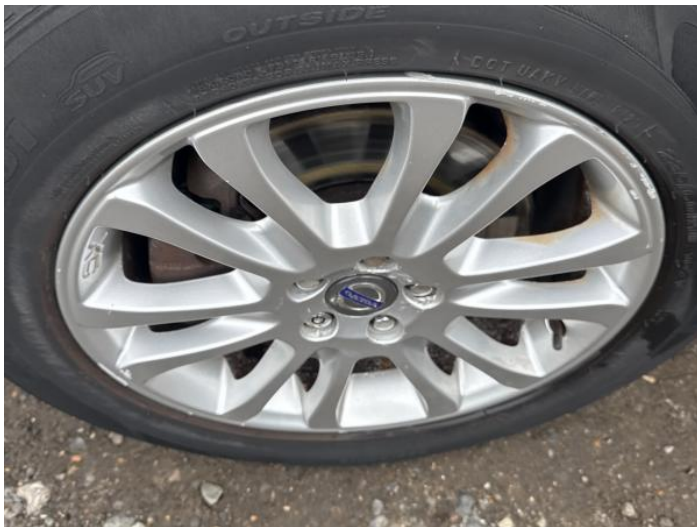
3: Wheel nsf  
Scratched  
Over 50mm

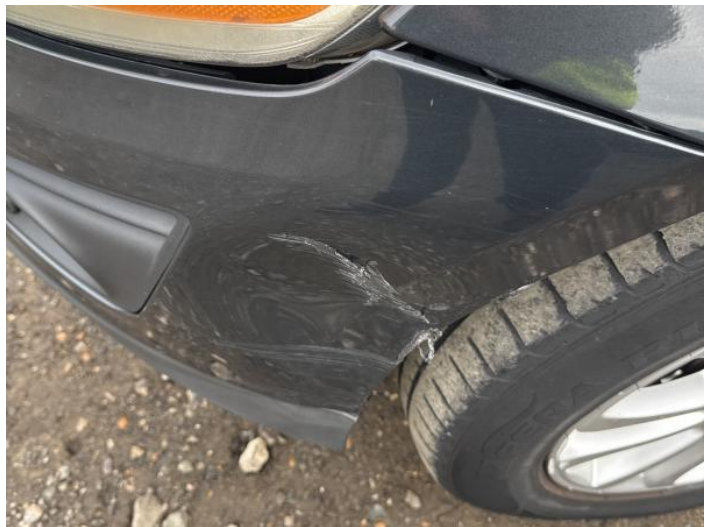
4: Bumper Front  
Cracked  
UpTo 25mm

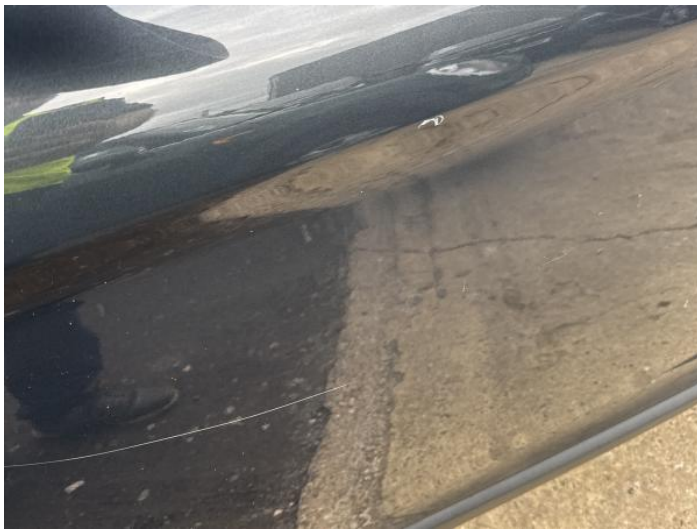
5: Door nsf  
Dented  
With Paint Damage

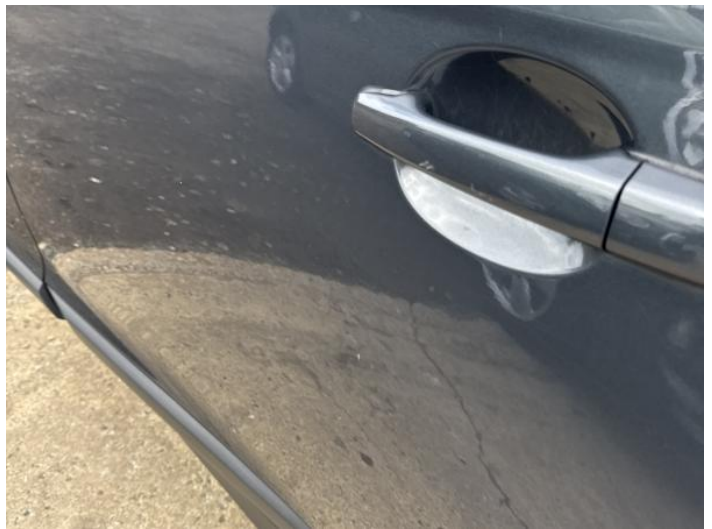
6: Door nsr  
Dented  
With Paint Damage

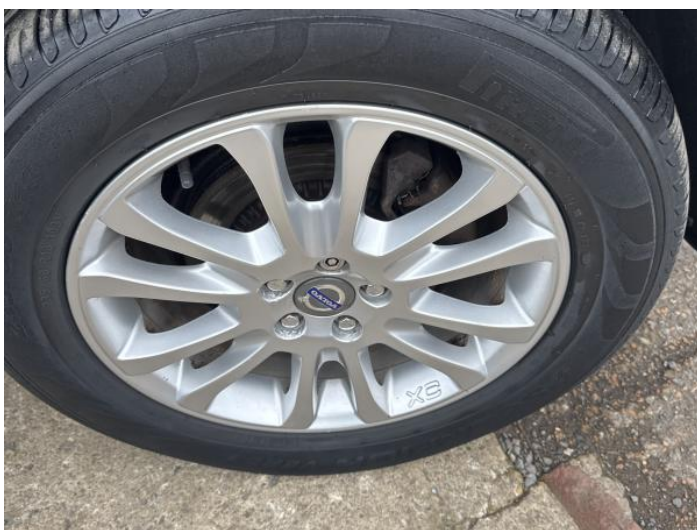
7: Wheel nsr  
Scratched  
Over 50mm

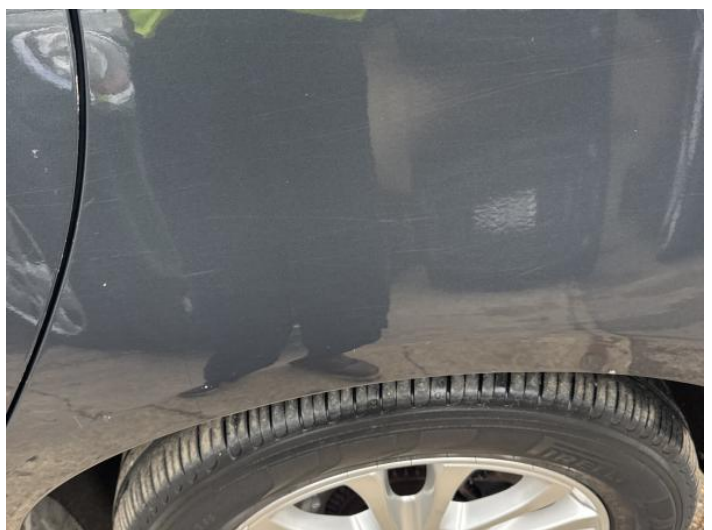
8: Qtr Panel nsr  
Dented  
With Paint Damage

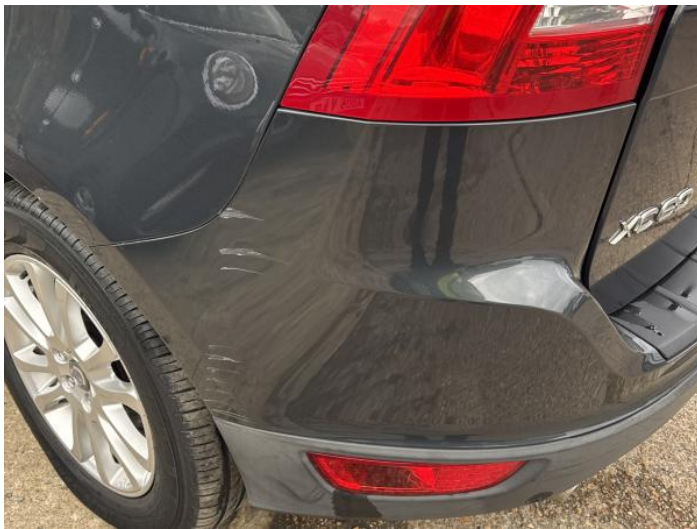
9: Bumper Rear  
Scratched  
Over 100mm Thru Paint

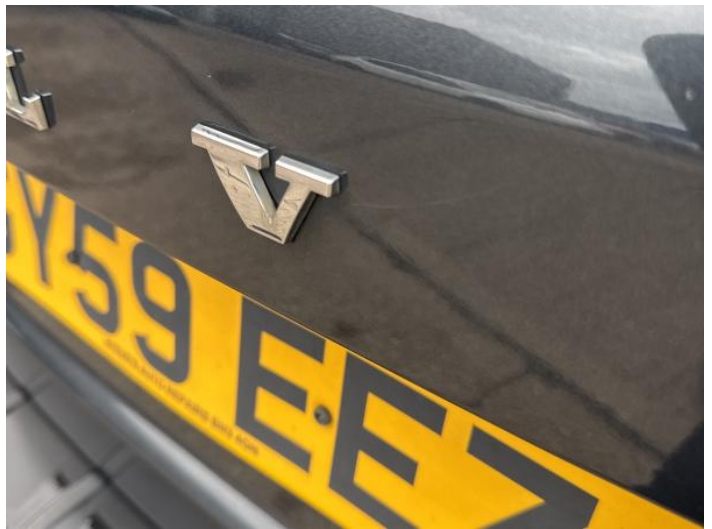
10: Boot Lid  
Scratched  
UpTo 25mm Thru Paint

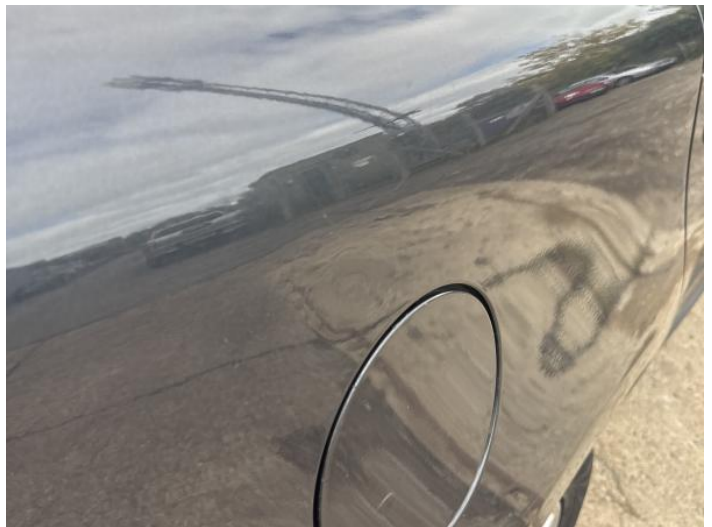
12: Qtr Panel osr  
Dented  
Between 10mm + 30mm

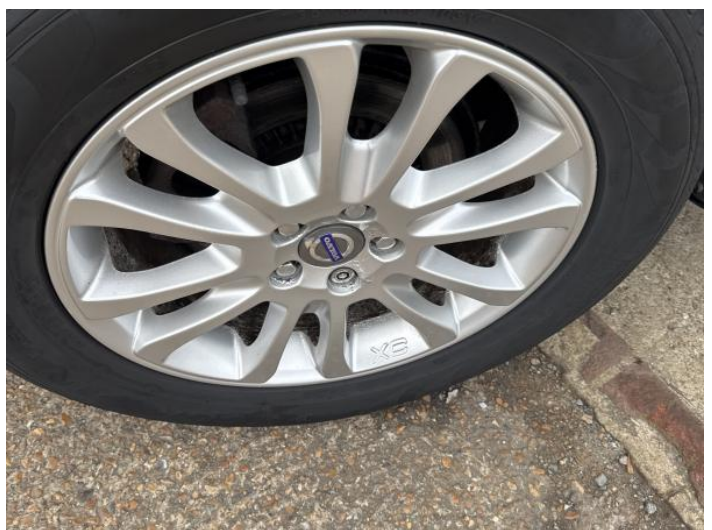
14: Wheel osr  
Scratched  
Up To 50mm

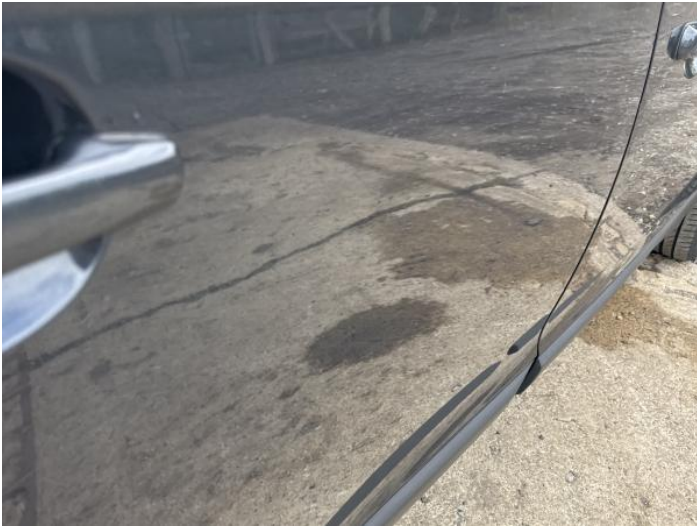
15: Door osr  
Chipped  
1 To 5

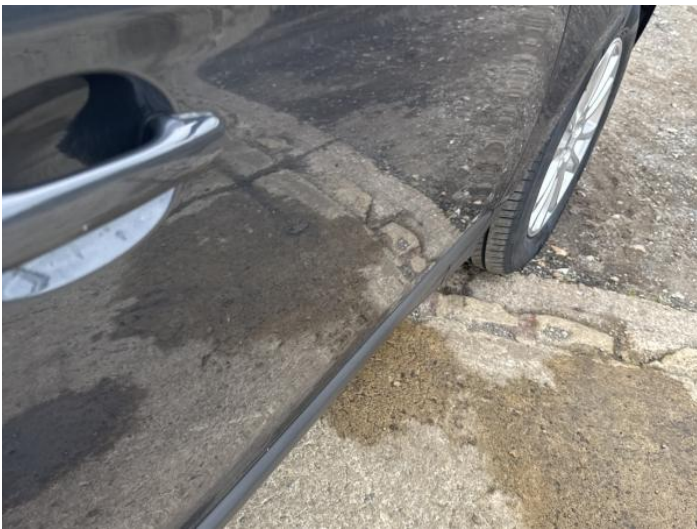
17: Door osf  
Dented  
2 Or Less UpTo 10mm

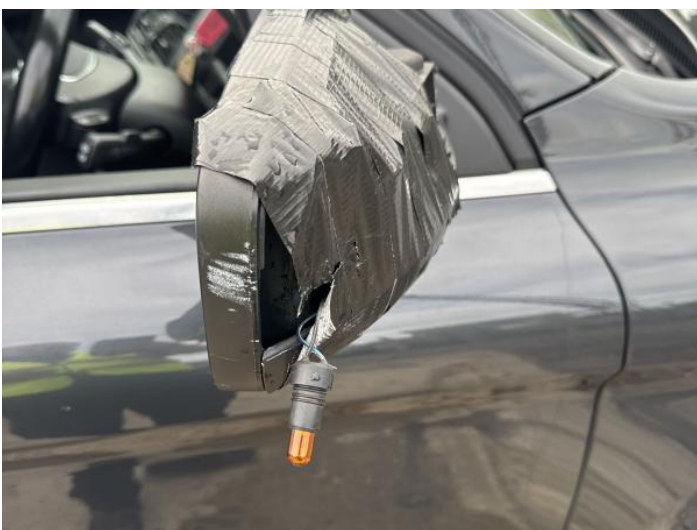
19: Door Mirror Assy osf  
Broken  
Replace

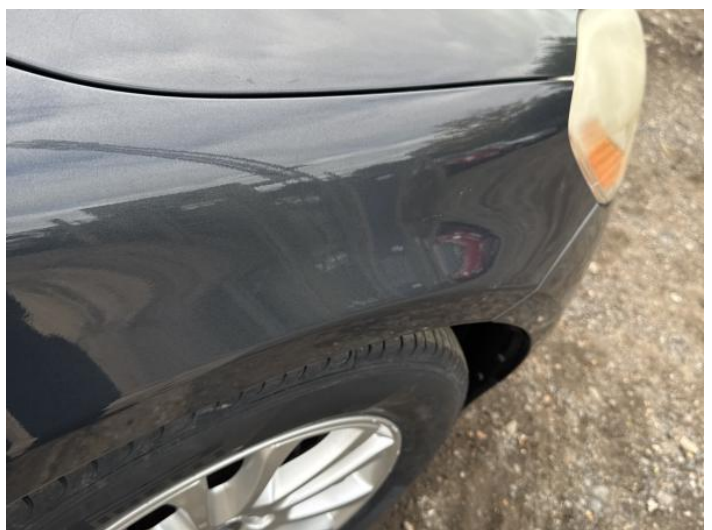
20: Wing osf  
Chipped  
1 To 5

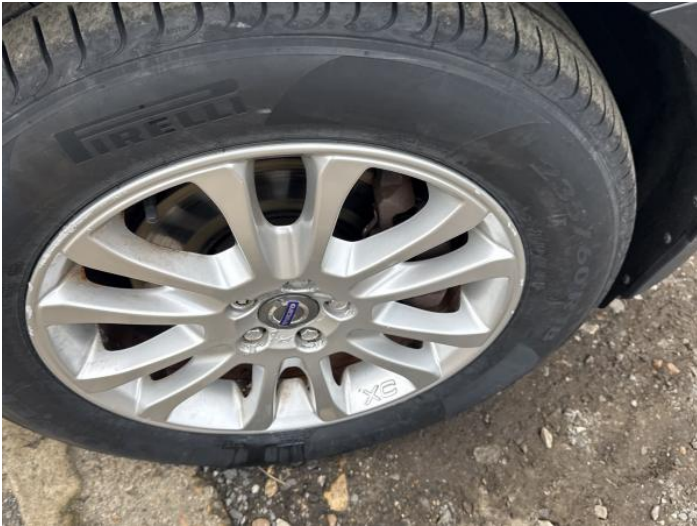
21: Wheel osf  
Scratched  
Over 50mm

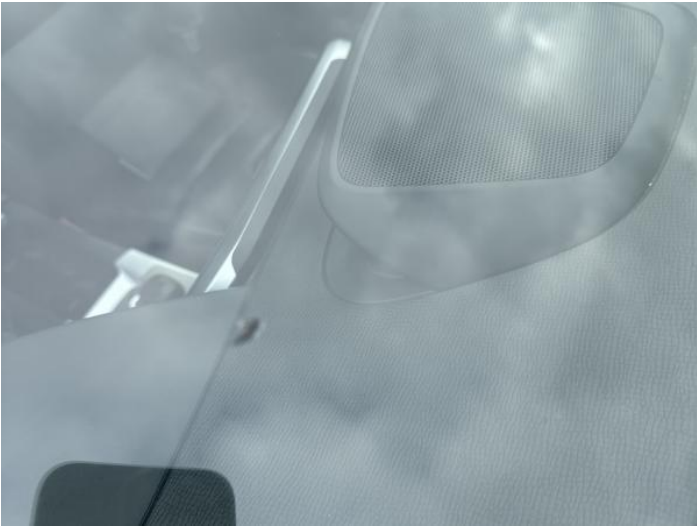
22: Screen Front  
Chipped  
UpTo 10mm

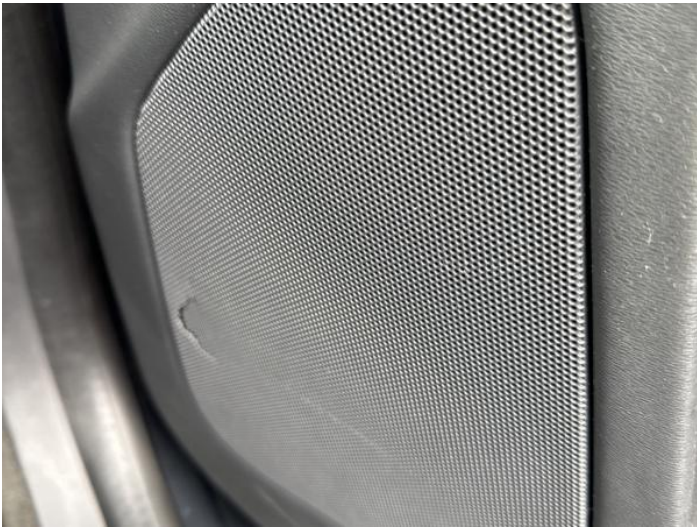
23: Door Pad osf  
Broken  
Replace
