VEHICLE INSPECTION REPORT

GX22USD

MG Mg Hs EXCITE

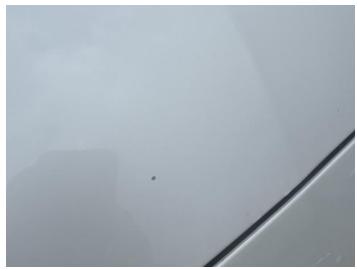
1: Bonnet Chipped 1 To 5

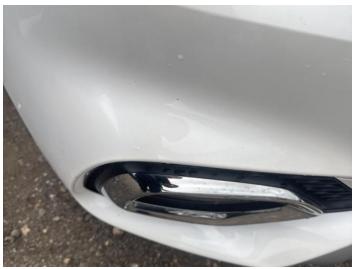
2: Bumper Front Chipped Multiple Chips

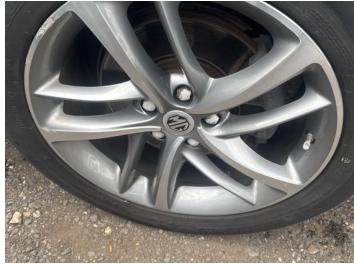
3: Wheel osf Scratched Over 50mm

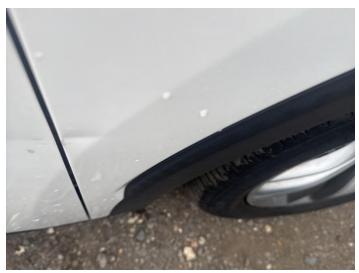
4: Wing osf Dented Between 10mm + 30mm

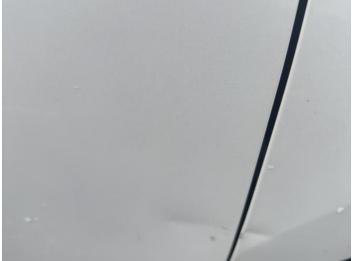
5: Door osf Dented Over 30mm

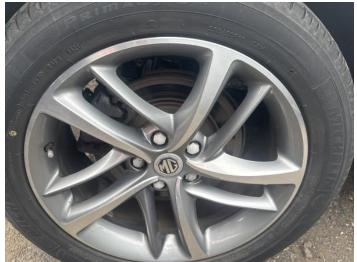
6: Wheel osr Scratched Up To 50mm

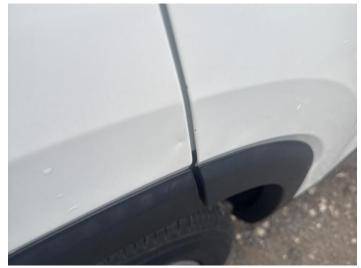
7: Qtr Panel osr Dented 2 Or Less UpTo 10mm

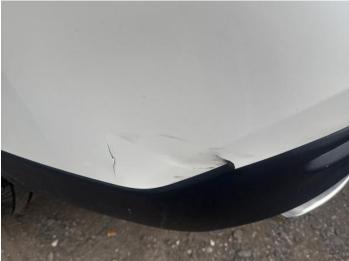
8: Bumper Rear Cracked Over 25mm

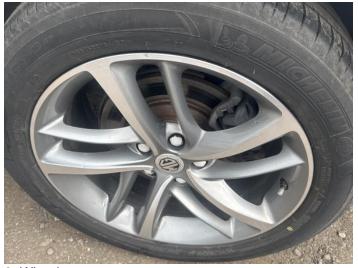
9: Wheel nsr Scratched Up To 50mm

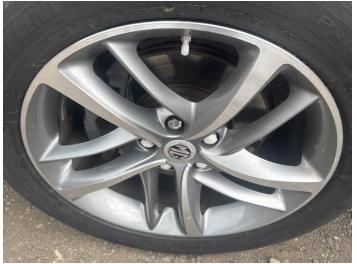
11: Wheel nsf Scratched Over 50mm
