## VEHICLE INSPECTION REPORT

**GL16FDN**

### Ford Mondeo 2.0 TDCi EConetic Zetec 5dr

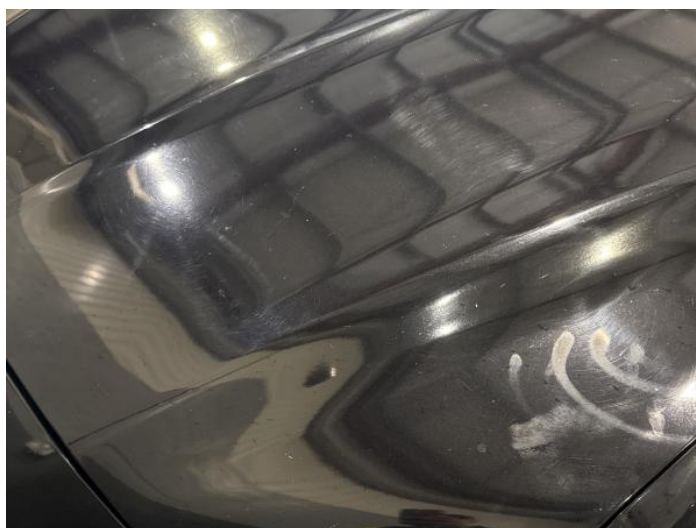
2: Bonnet  
Chipped  
Multiple Chips

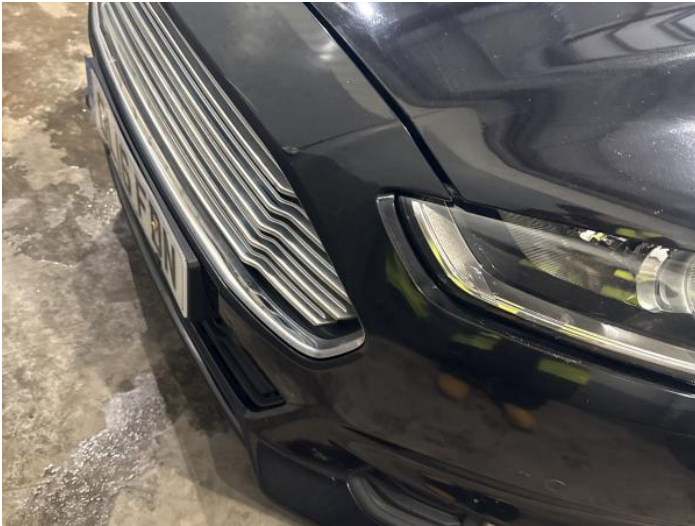
3: Bumper Front  
Scratched  
25 to 100mm Thru Paint

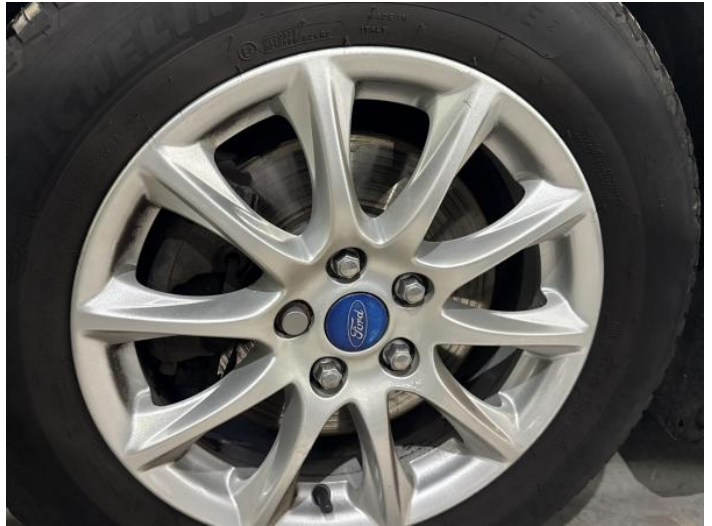
4: Wheel nsf  
Corroded  
Light

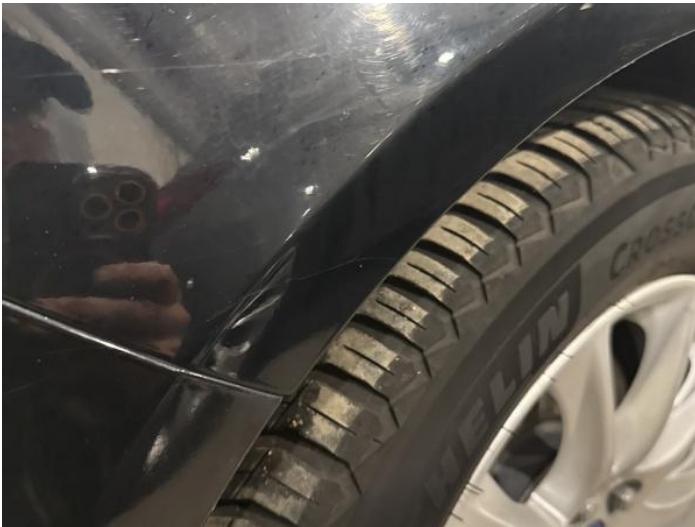
5: Wing nsf  
Scratched  
UpTo 25mm Thru Paint

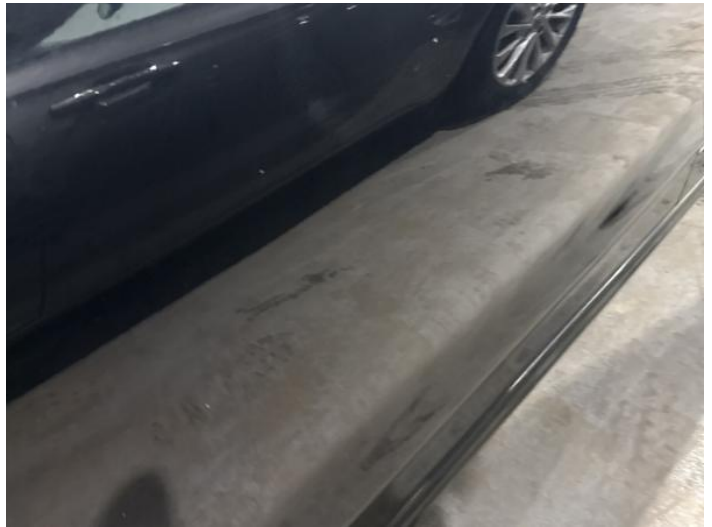
6: Door nsf  
Dented  
Over 30mm

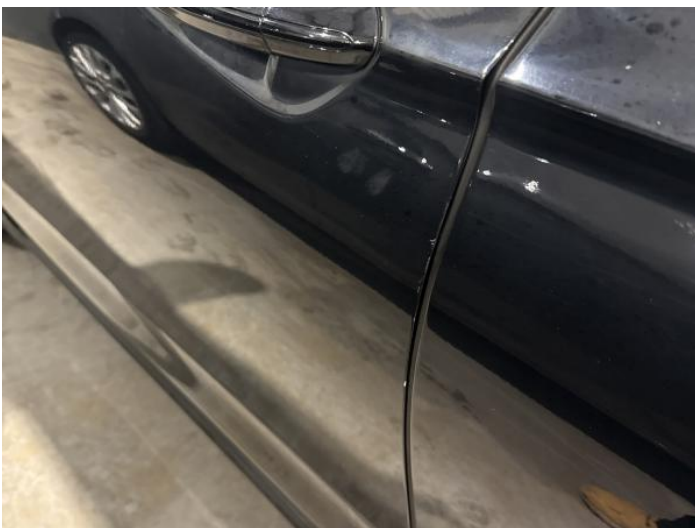
7: Door nsf  
Chipped  
Edge Chip

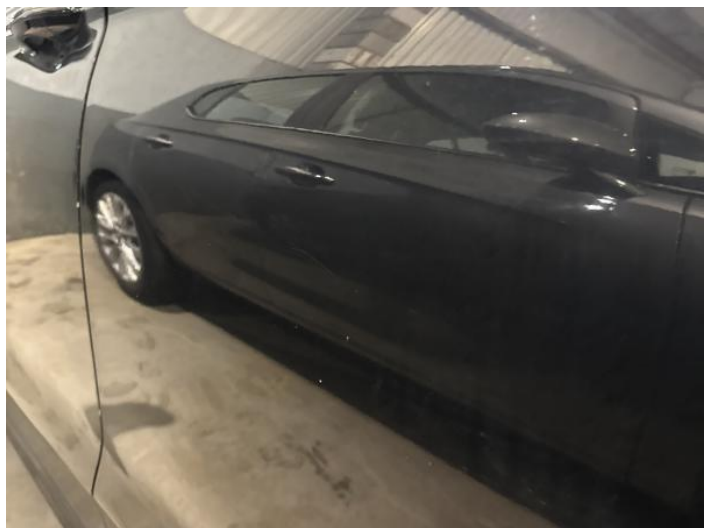
8: Door nsr  
Scratched  
Over 25mm Thru Paint

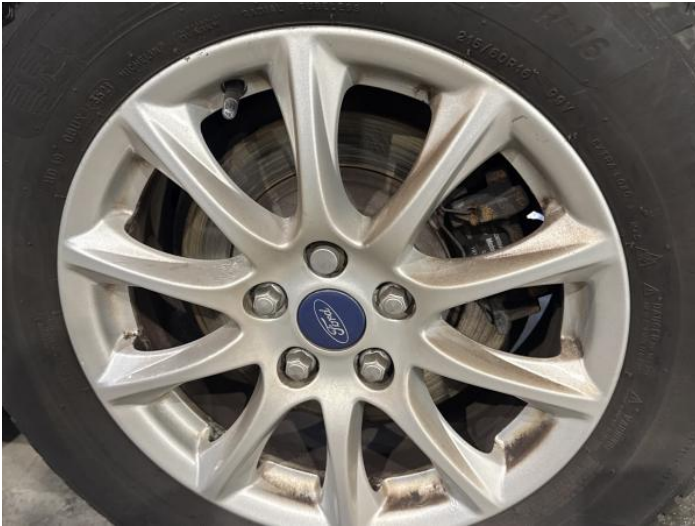
9: Wheel nsr  
Corroded  
Light

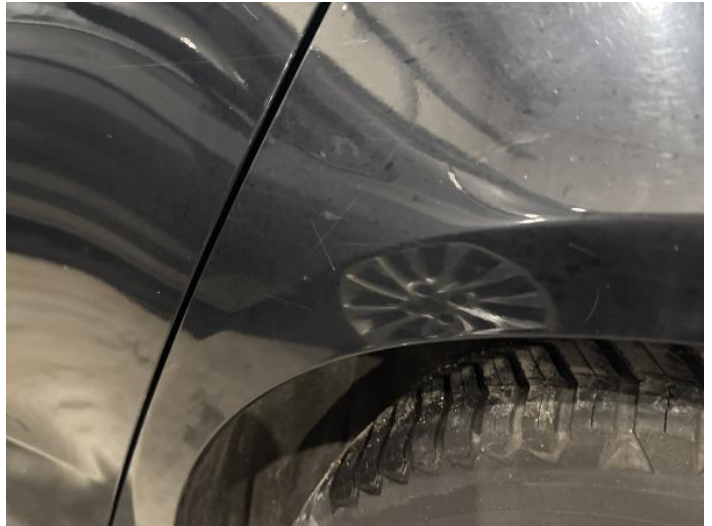
10: Qtr Panel nsr  
Scratched  
UpTo 25mm Thru Paint

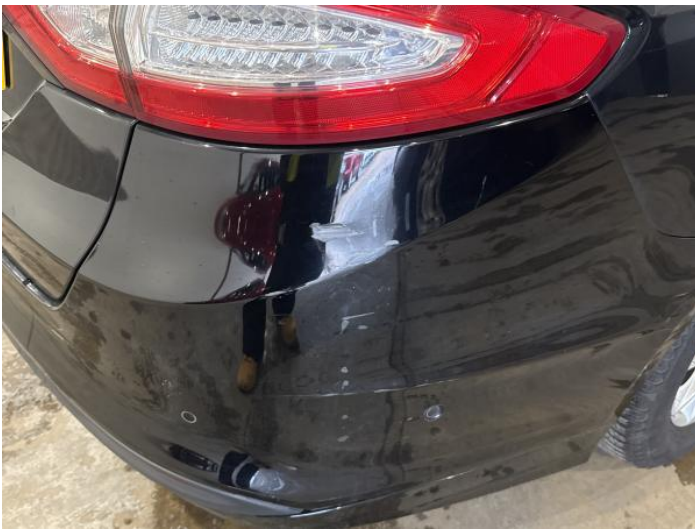
11: Bumper Rear  
Scratched  
25 to 100mm Thru Paint

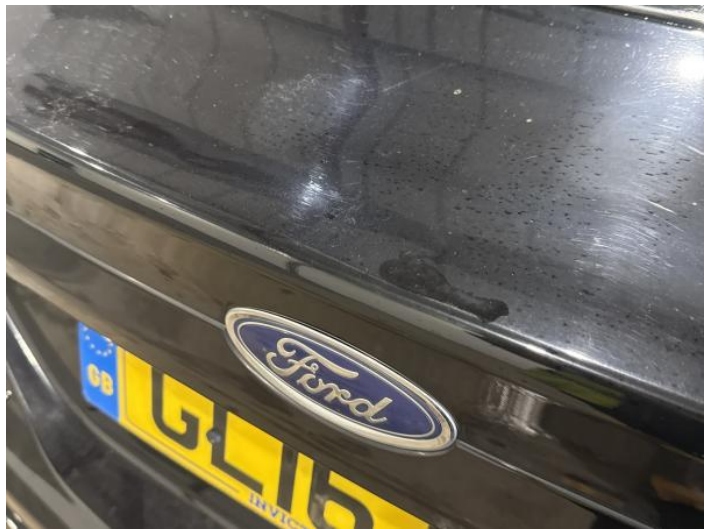
12: Tailgate  
Scratched  
UpTo 25mm Thru Paint

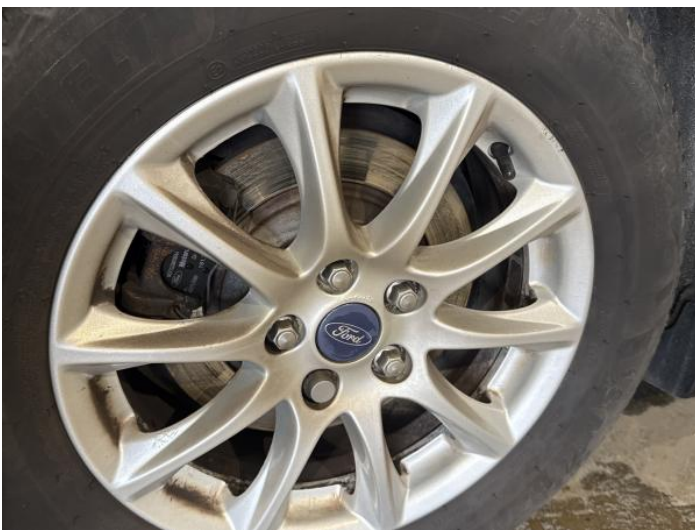
13: Wheel osr  
Corroded  
Light

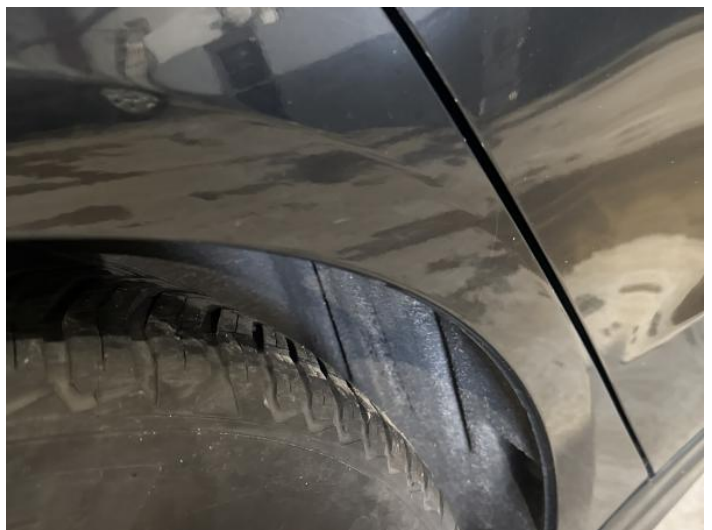
14: Qtr Panel osr  
Scratched  
UpTo 25mm Thru Paint

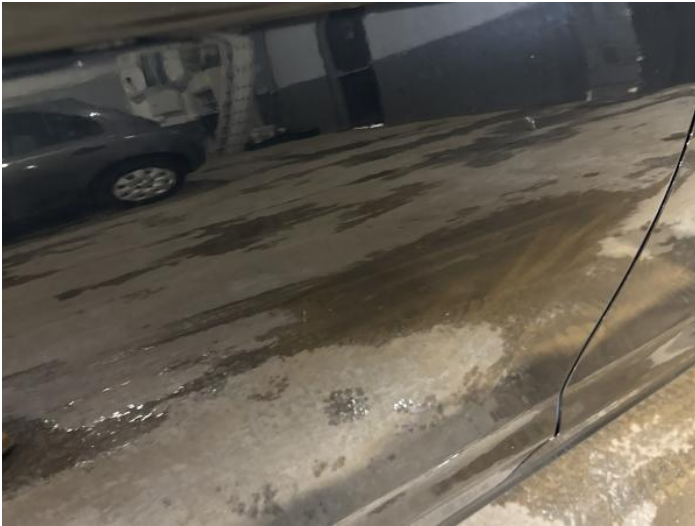
15: Door osr  
Scratched  
UpTo 25mm Thru Paint

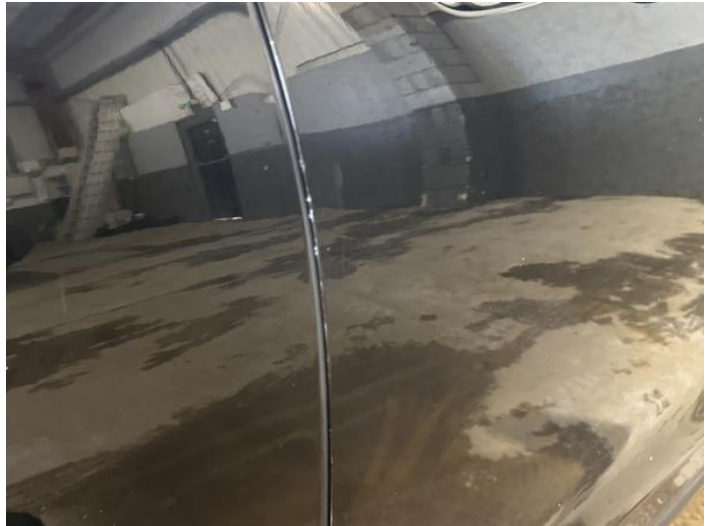
16: Door osf  
Chipped  
Edge Chip

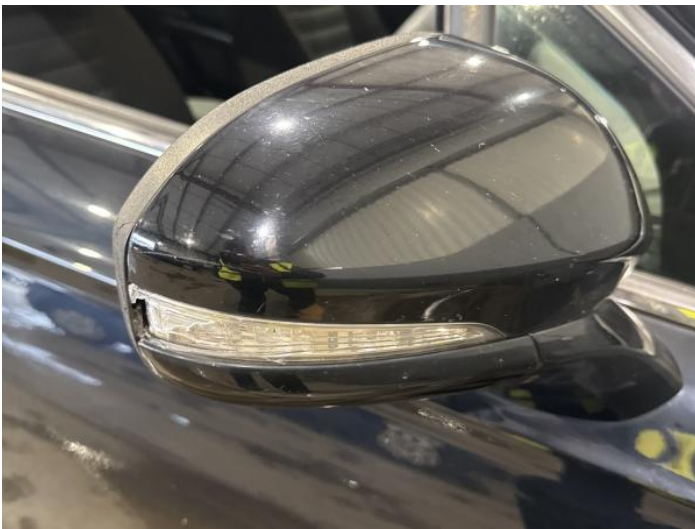
17: Flasher Side Repeater os  
Broken  
Replace

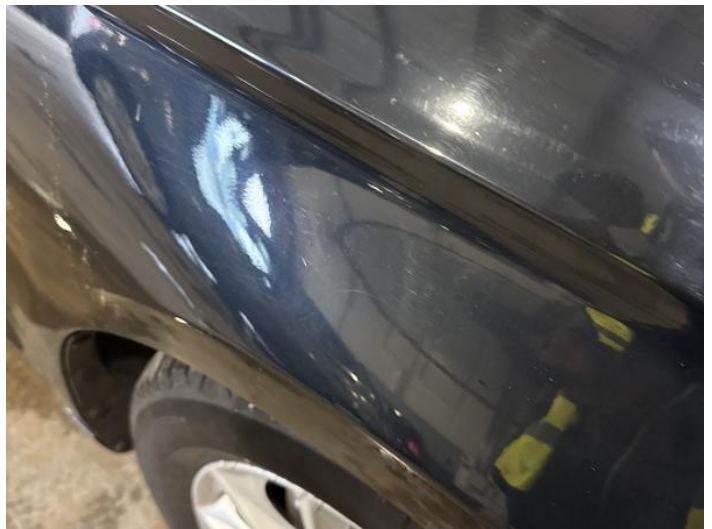
18: Wing osf  
Scratched  
UpTo 25mm Thru Paint

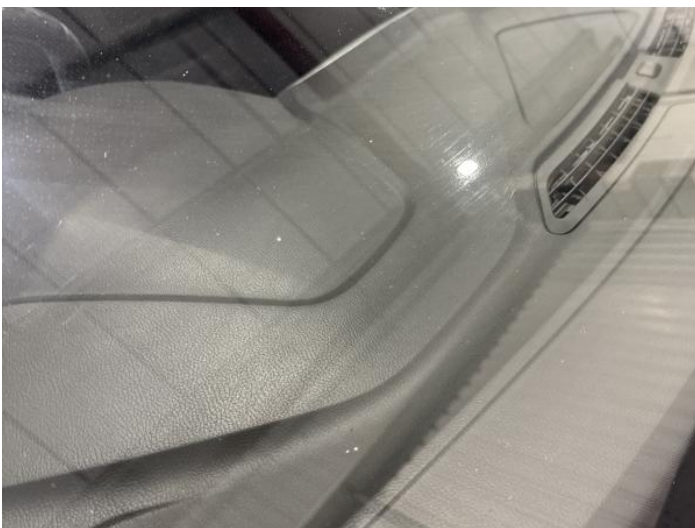
19: Screen Front  
Chipped  
UpTo 10mm

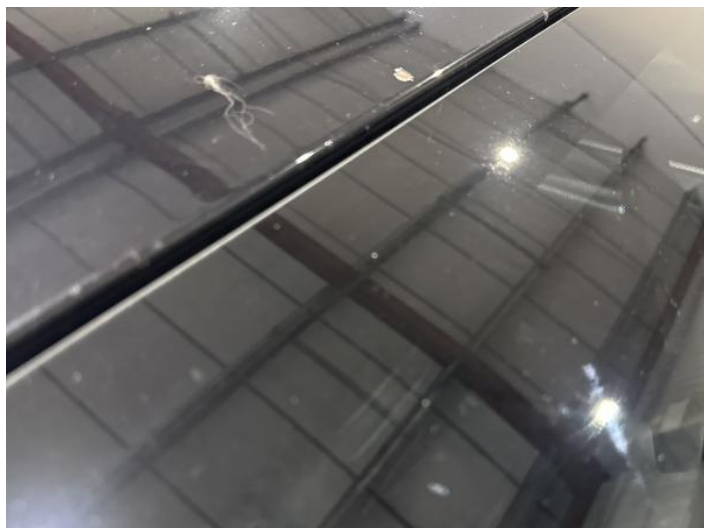
20: Roof  
Chipped  
Over 5mm
