VEHICLE INSPECTION REPORT

WL19NTY

Toyota RAV4 2.5 VVT-i Hybrid Dynamic 5dr CVT

nama  
GRADE  
4

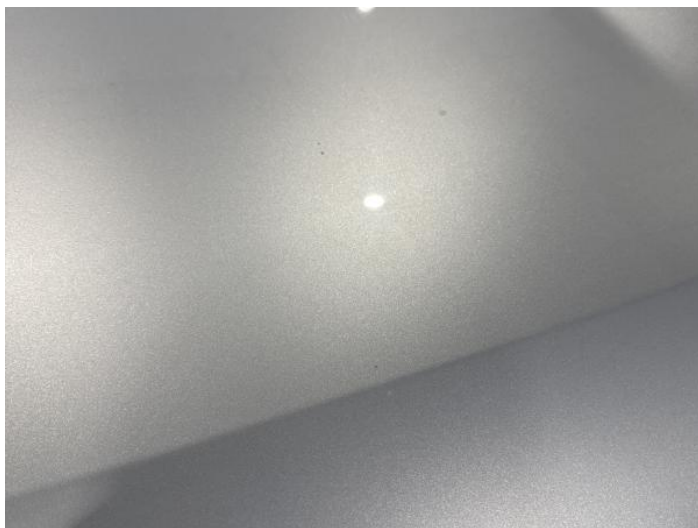
1: Bonnet  
Chipped  
1 To 5

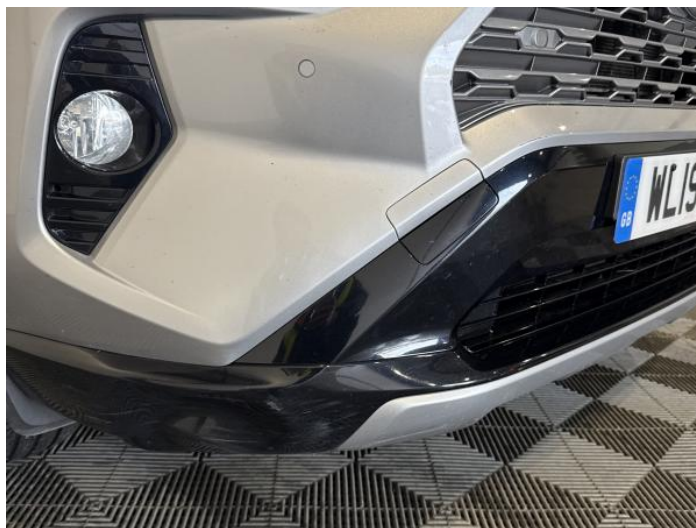
2: Bumper Front  
Dented  
With Paint Damage

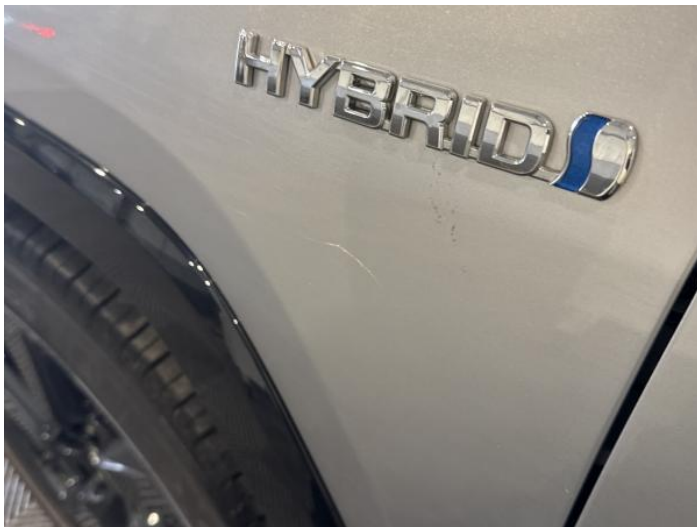
3: Wing nsf  
Scratched  
Over 25mm Thru Paint

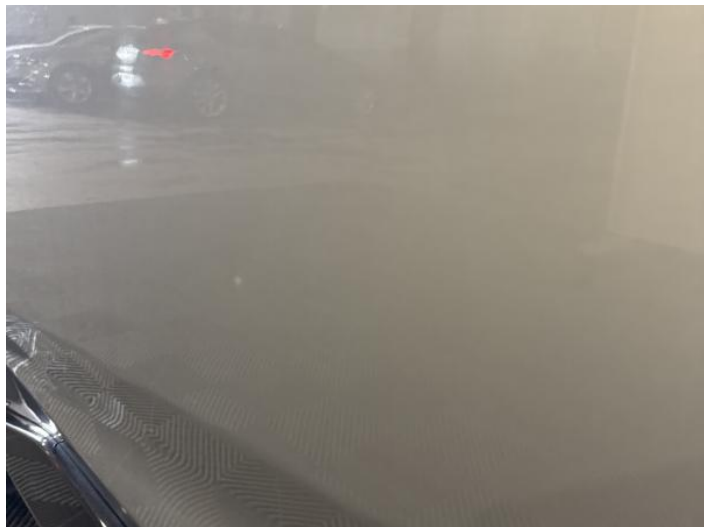
4: Door nsf  
Dented  
Between 10mm + 30mm

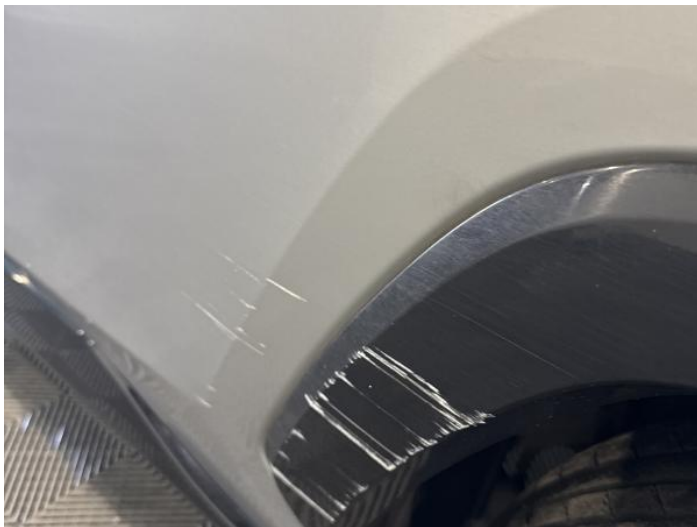
5: Door nsr  
Scratched  
Over 25mm Thru Paint

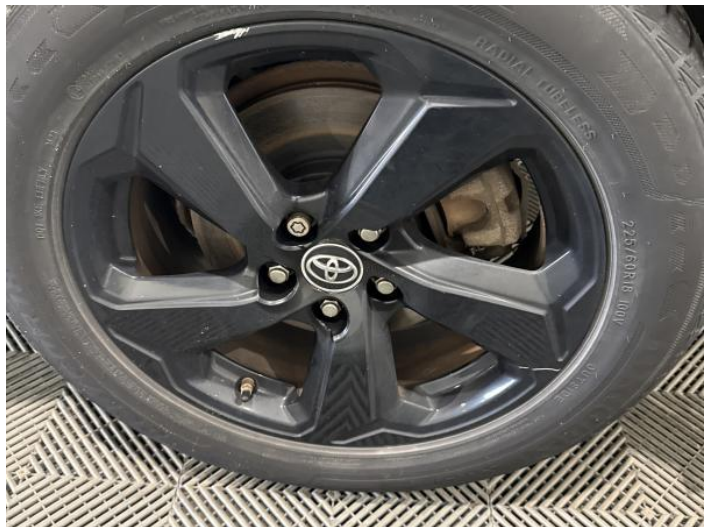
6: Wheel nsr  
Scratched  
Up To 50mm

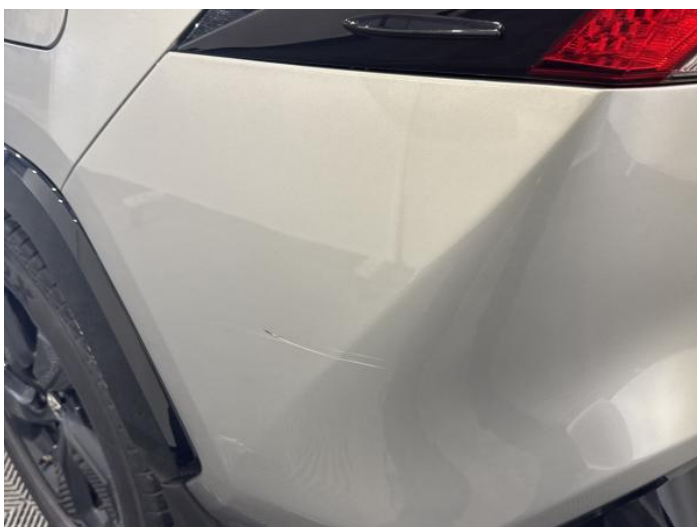
7: Bumper Rear Moulding  
Scratched (Painted)  
Over 25mm Thru Paint

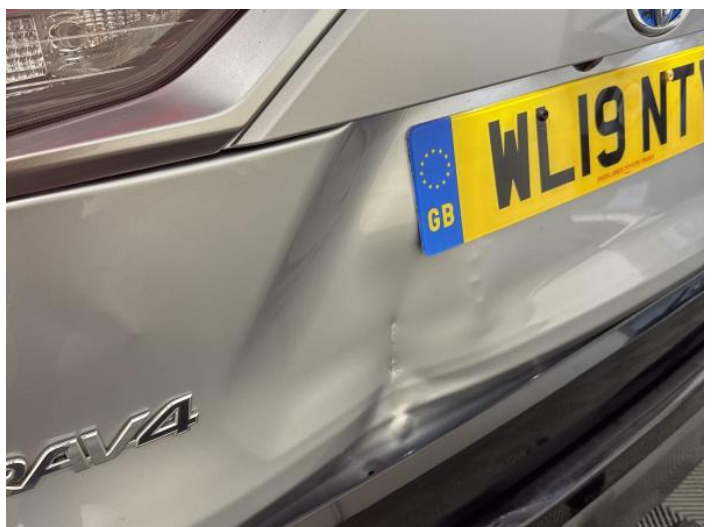
8: Tailgate  
Dented  
With Paint Damage

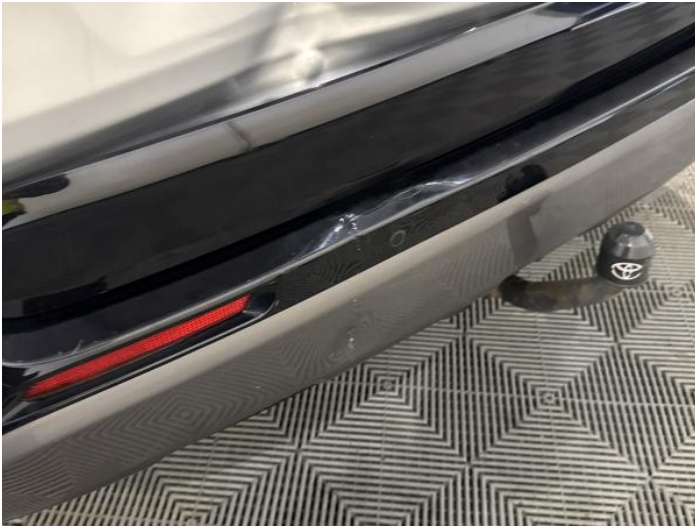
9: Bumper Rear  
Dented  
Over 30mm

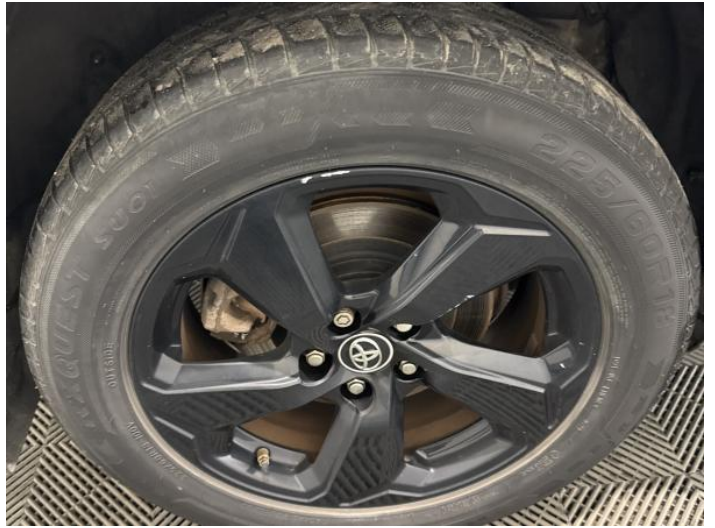
10: Wheel osr  
Scratched  
Up To 50mm

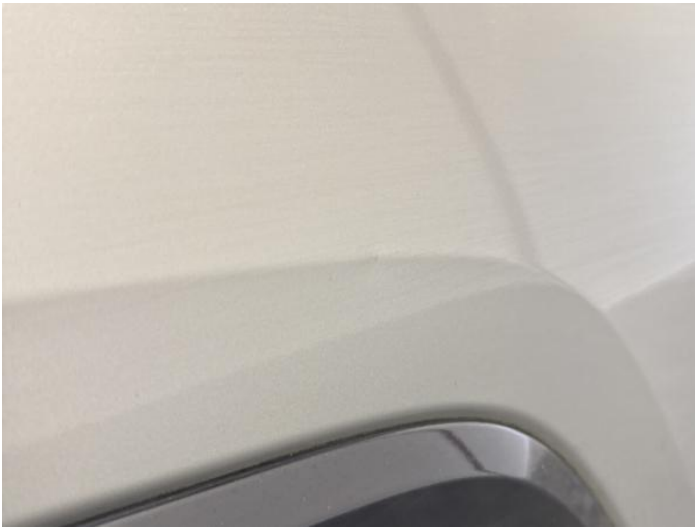
11: Door osr  
Chipped  
1 To 5

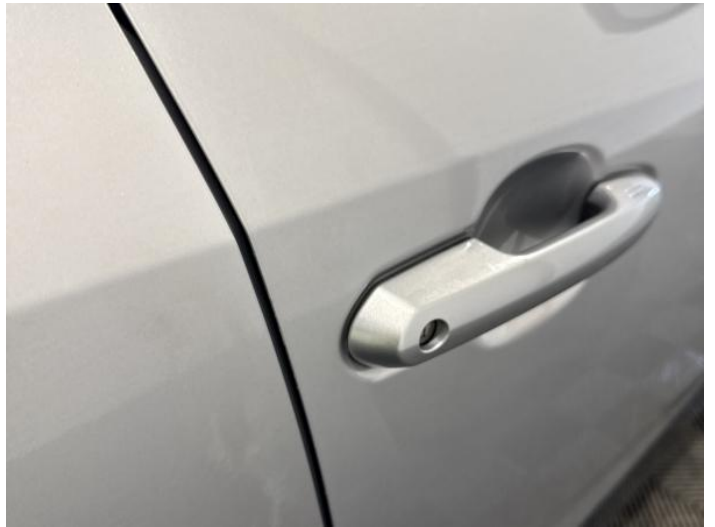
12: Door osf  
Chipped  
Edge Chip

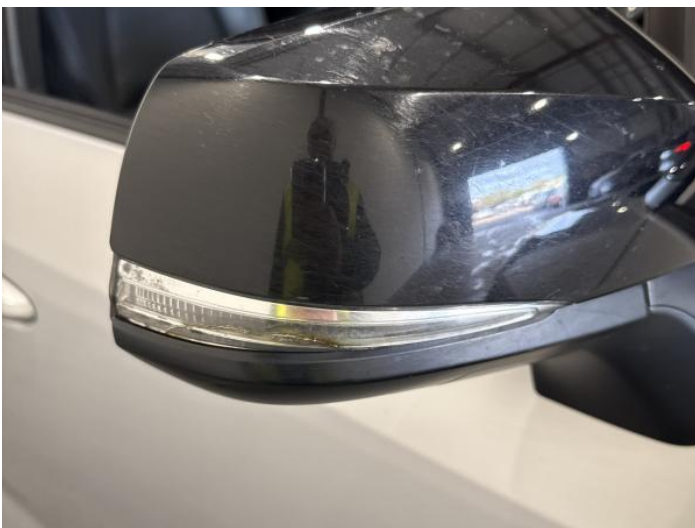
13: Flasher Side Repeater os  
Broken  
Replace
