# VEHICLE INSPECTION REPORT

**MJ71NFH**

## Peugeot 3008 1.5 BlueHdi GT 5dr

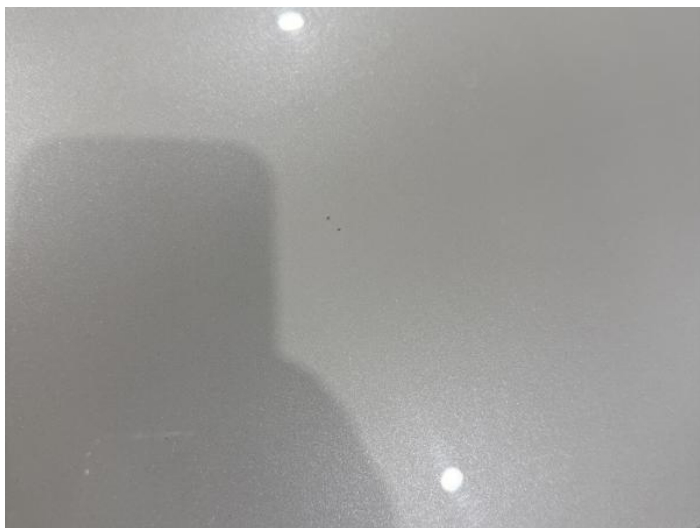
1: Bonnet  
Chipped  
1 To 5

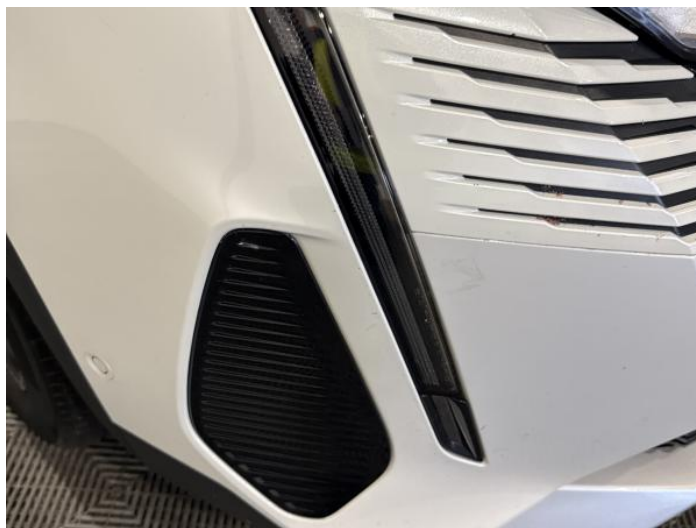
2: Bumper Front  
Scratched  
25 to 100mm Thru Paint

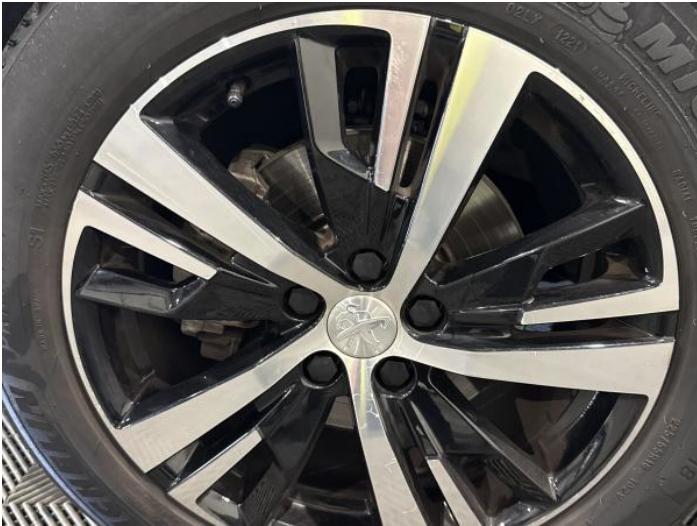
3: Wheel nsf  
Scratched  
Up To 50mm

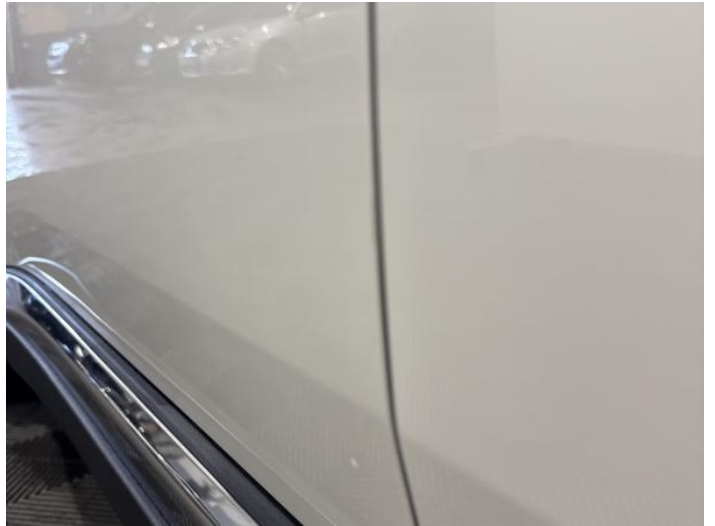
4: Door nsf  
Chipped  
Edge Chip

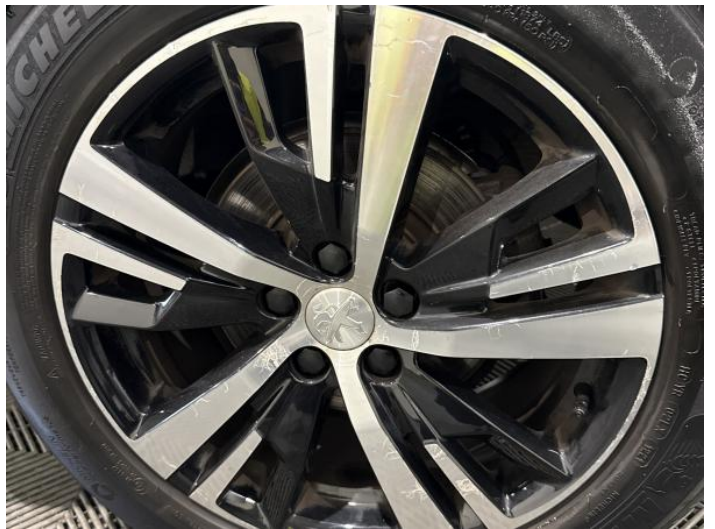
6: Wheel nsr  
Corroded  
Light

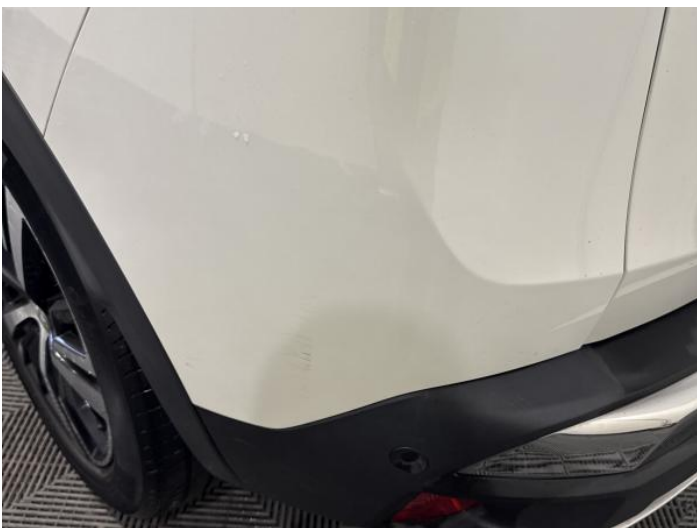
7: Bumper Rear  
Scratched  
25 to 100mm Thru Paint

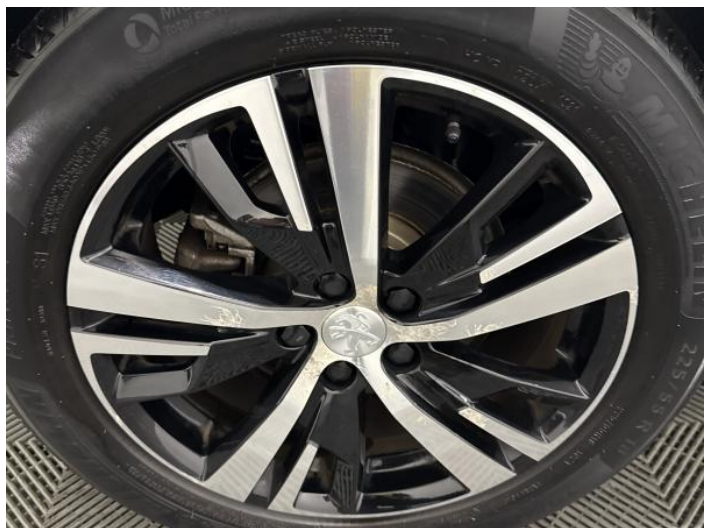
8: Wheel osr  
Corroded  
Light

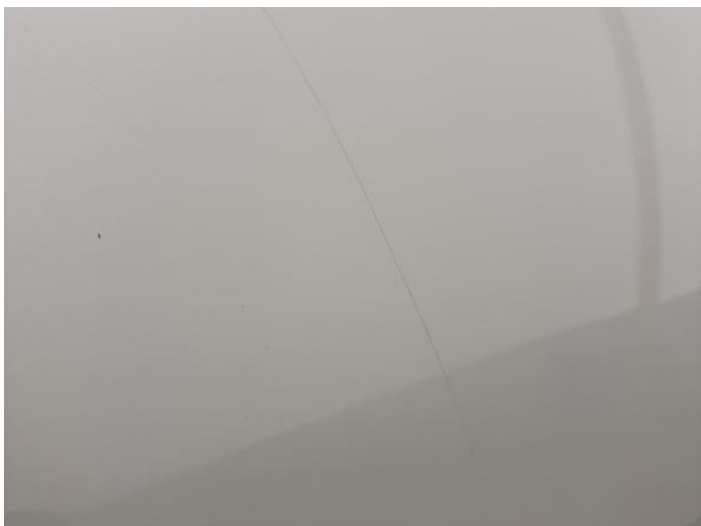
9: Door osr  
Scratched  
Over 25mm Not Thru Paint

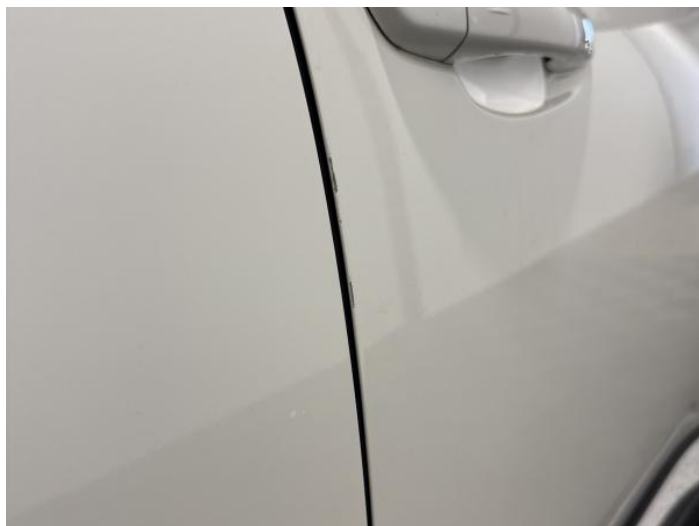
10: Door osf  
Chipped  
Edge Chip

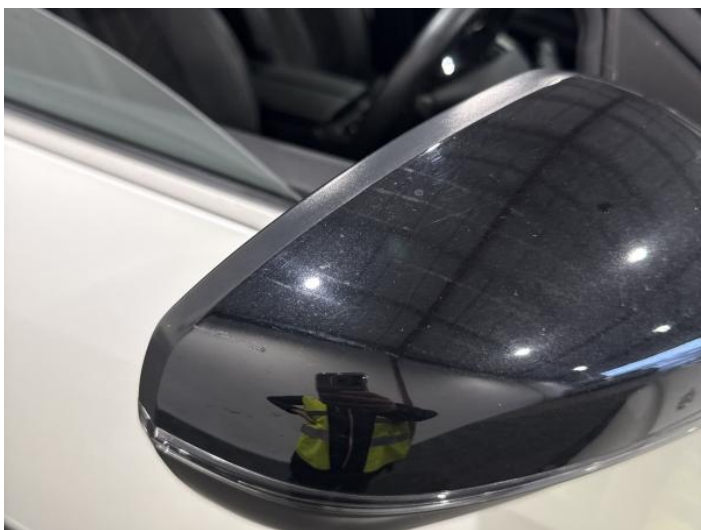
11: Door Mirror Assy osf  
Scratched (Painted)  
UpTo 25mm Thru Paint

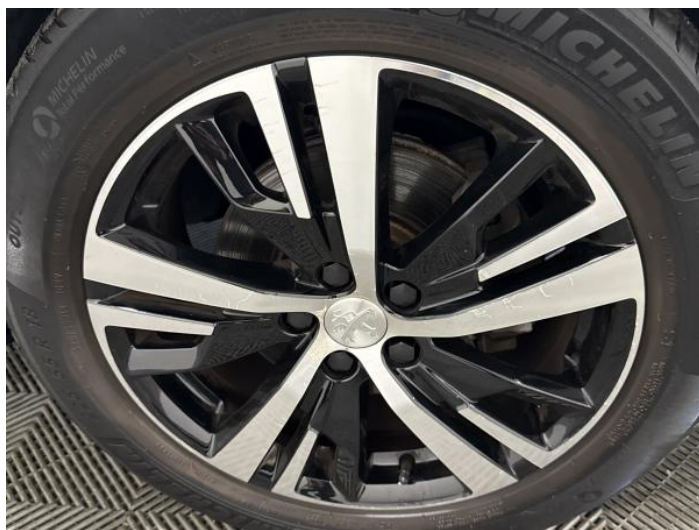
12: Wheel osf  
Corroded  
Light

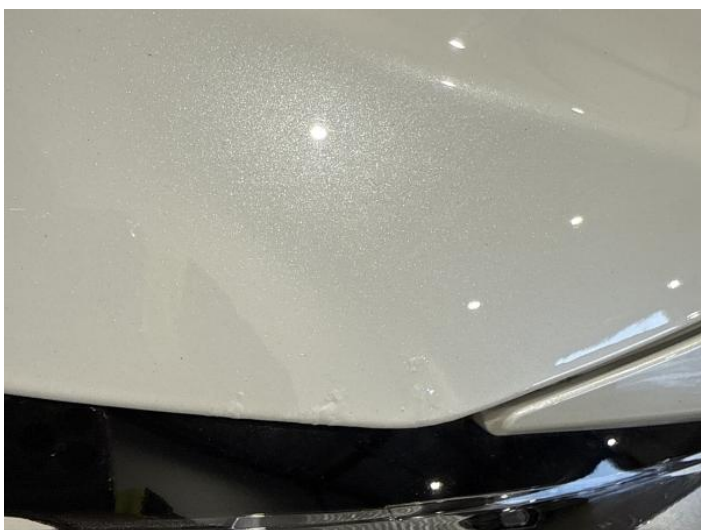
13: Bonnet  
Rusted  
UpTo 5mm
