# VEHICLE INSPECTION REPORT

**GD14GYG**

## Hyundai IX35 1.6 GDI SE 5dr 2WD

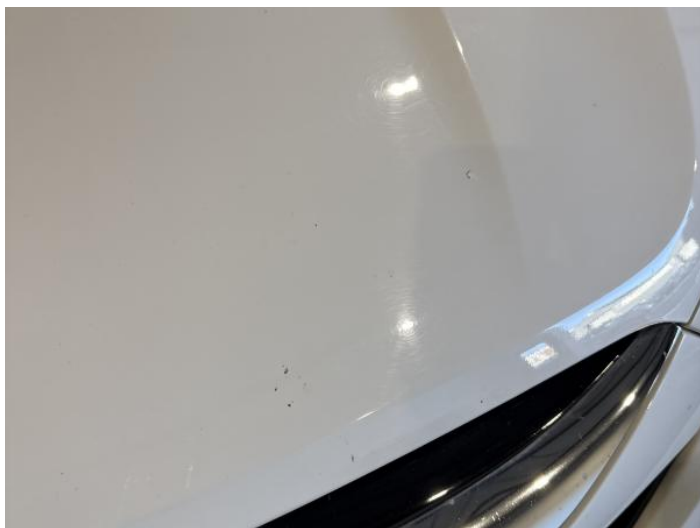
1: Bonnet  
Chipped  
Multiple Chips

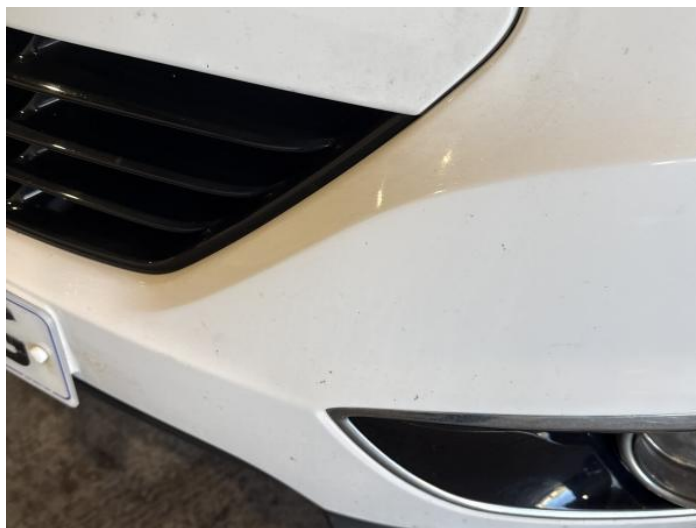
2: Bumper Front  
Scratched  
25 to 100mm Thru Paint

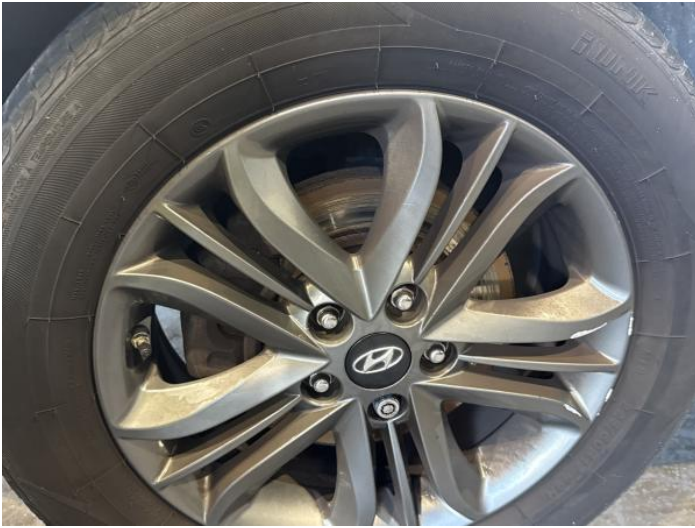
3: Wheel nsf  
Scratched  
Over 50mm

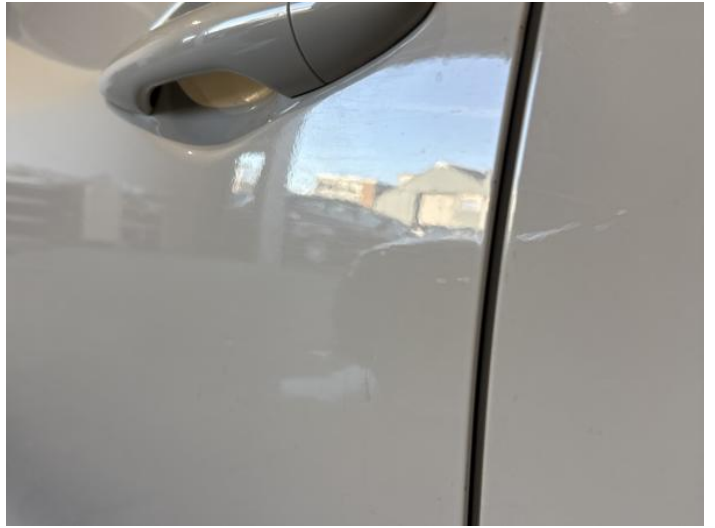
4: Door nsf  
Scratched  
UpTo 25mm Thru Paint

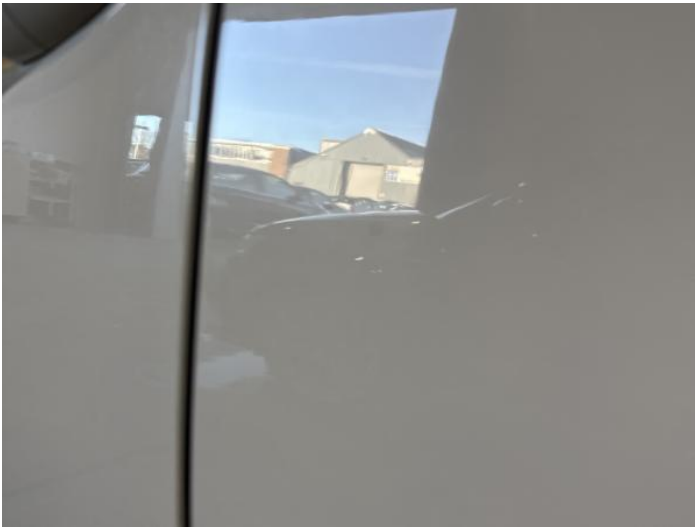
5: Door nsr  
Dented  
Between 10mm + 30mm

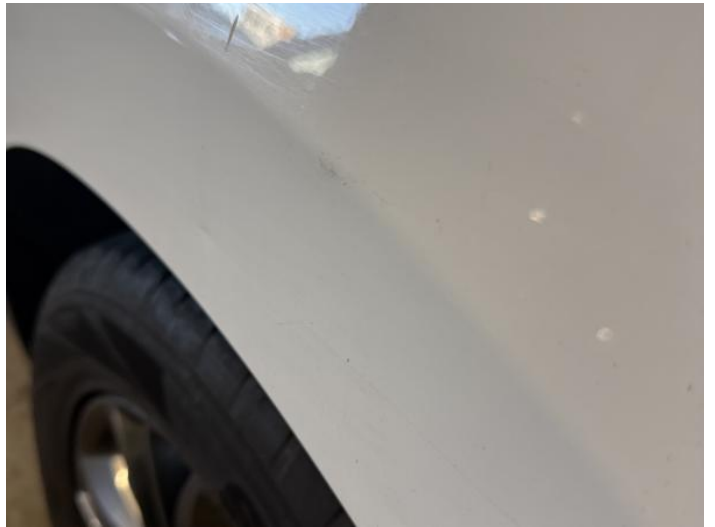
6: Qtr Panel nsr  
Dented  
Between 10mm + 30mm

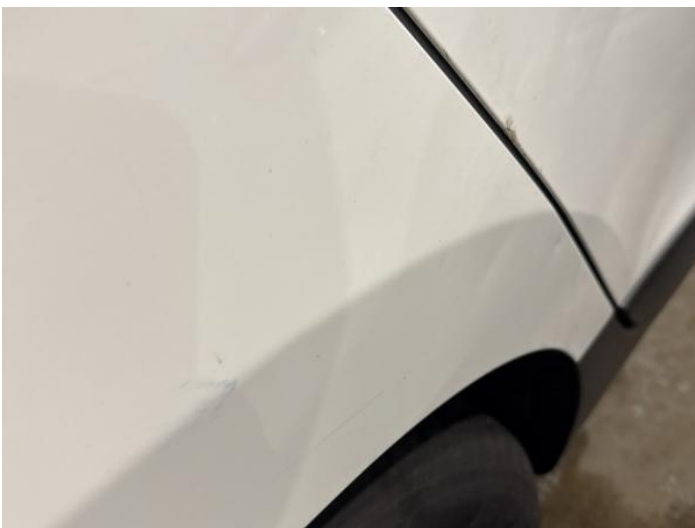
7: Qtr Panel osr  
Dented  
Over 30mm

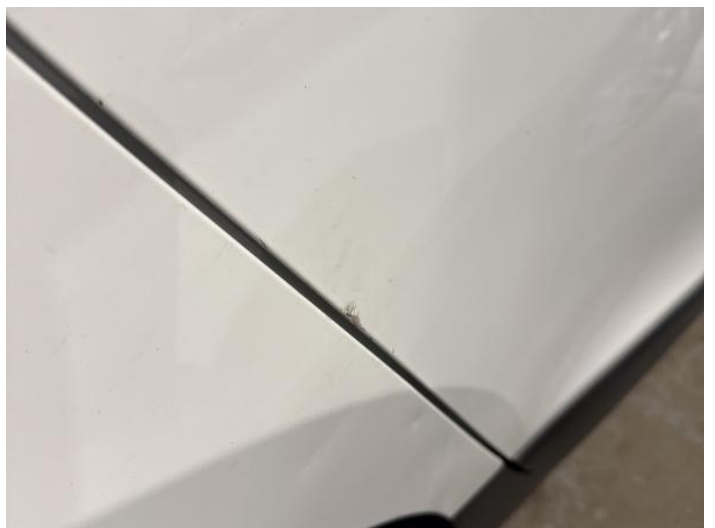
8: Door osr  
Scratched  
UpTo 25mm Thru Paint

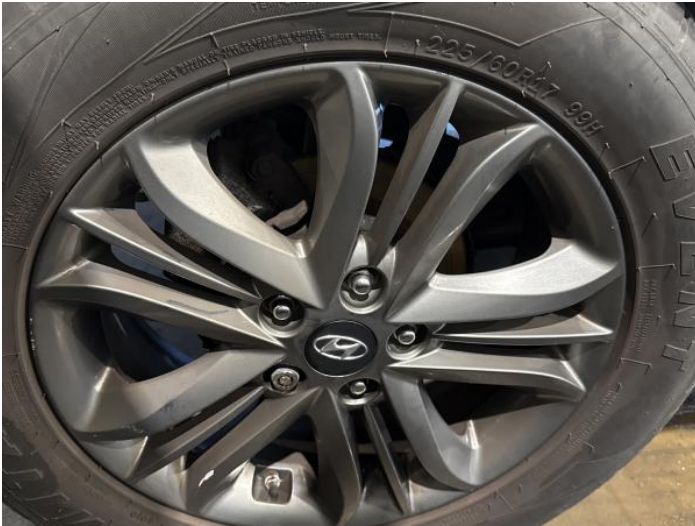
9: Wheel osr  
Scratched  
Over 50mm

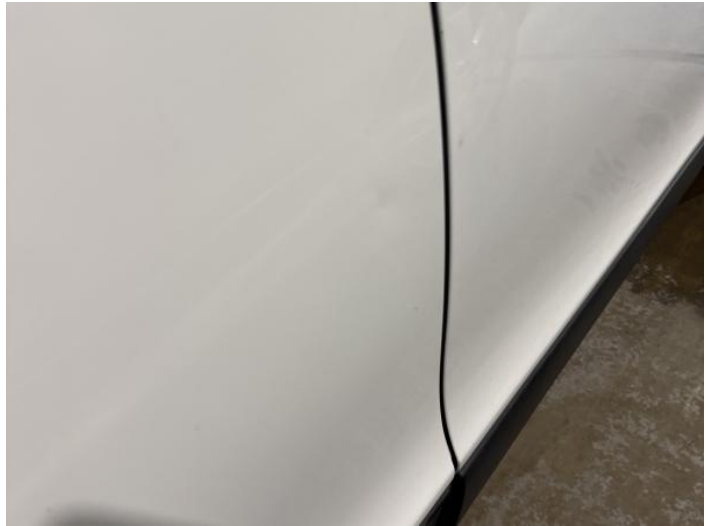
10: Door osr  
Dented  
Between 10mm + 30mm

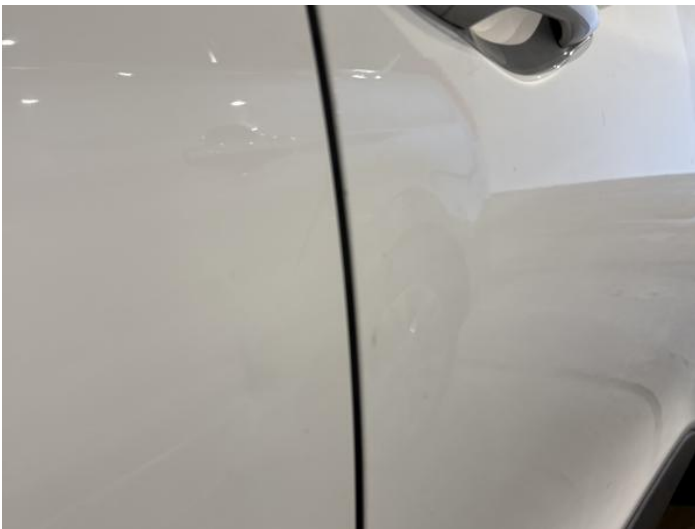
11: Door osf  
Chipped  
Edge Chip

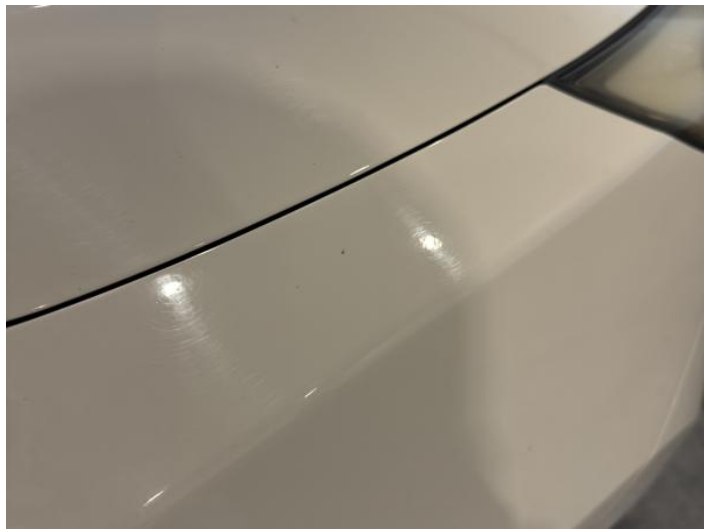
12: Wing osf  
Chipped  
1 To 5

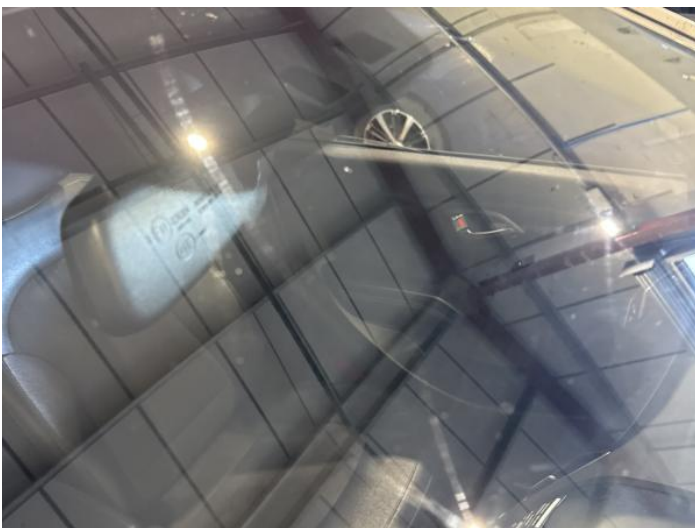
13: Screen Front  
Chipped  
UpTo 10mm

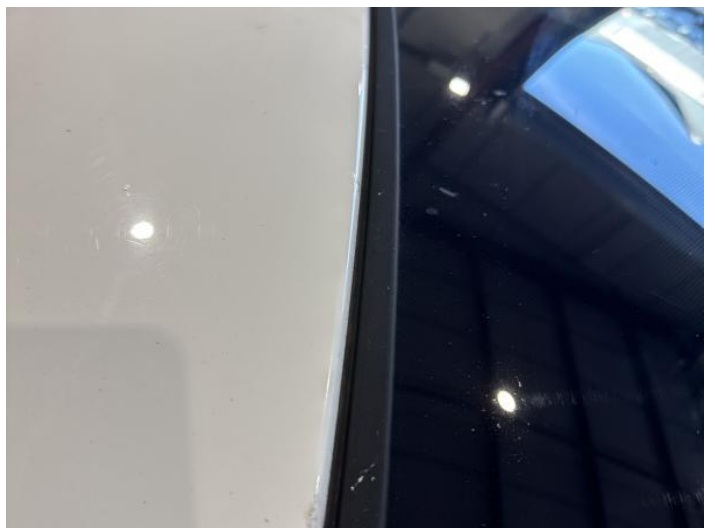
14: Roof  
Scratched  
Rusted

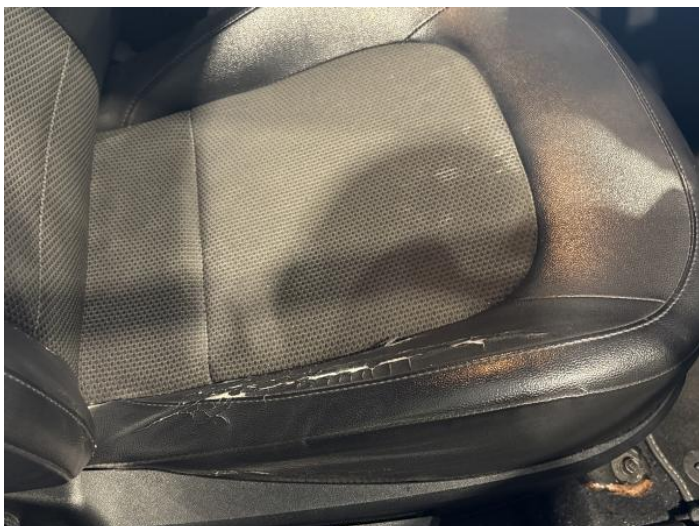
15: Seat Base Cover osf  
Scuffed  
Over 25mm

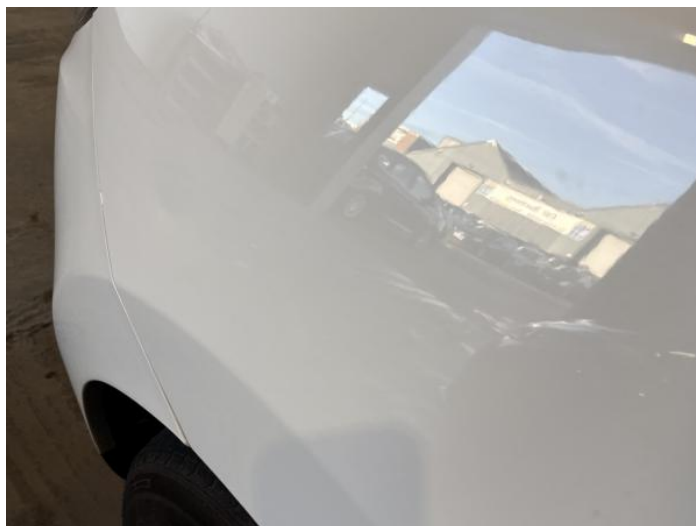
16: Wing nsf  
Dented  
Over 30mm
