## VEHICLE INSPECTION REPORT

**CF68DZT**

### Kia Sportage 1.6T GDi ISG 2 5dr [AWD]

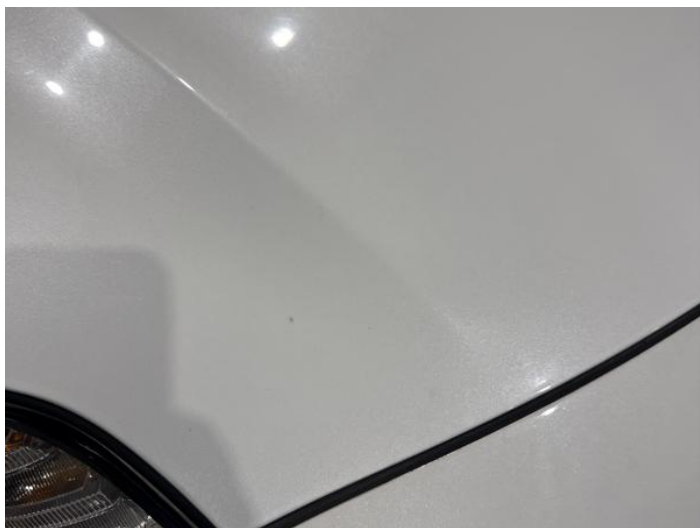
1: Bonnet  
Chipped  
1 To 5

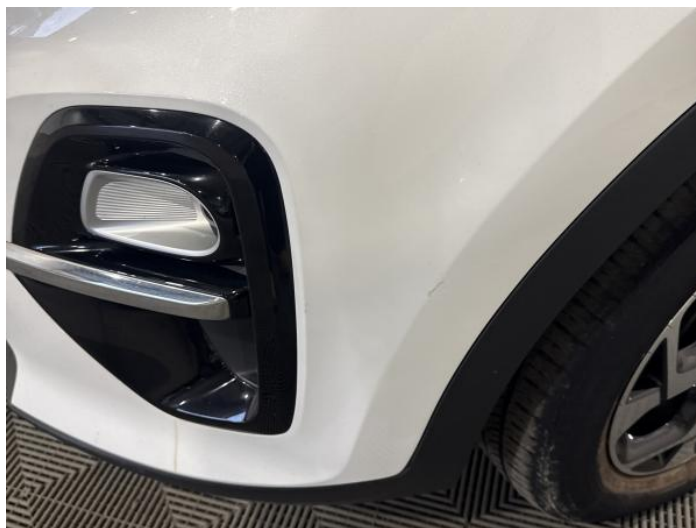
2: Bumper Front  
Scratched  
25 to 100mm Thru Paint

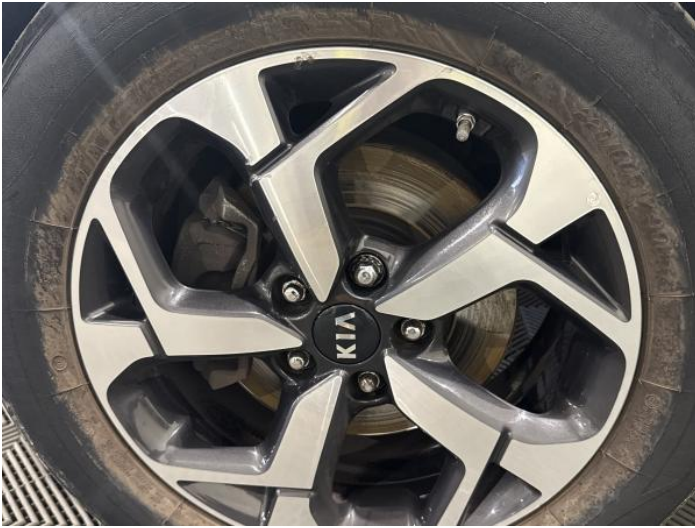
3: Wheel nsf  
Scratched  
Up To 50mm

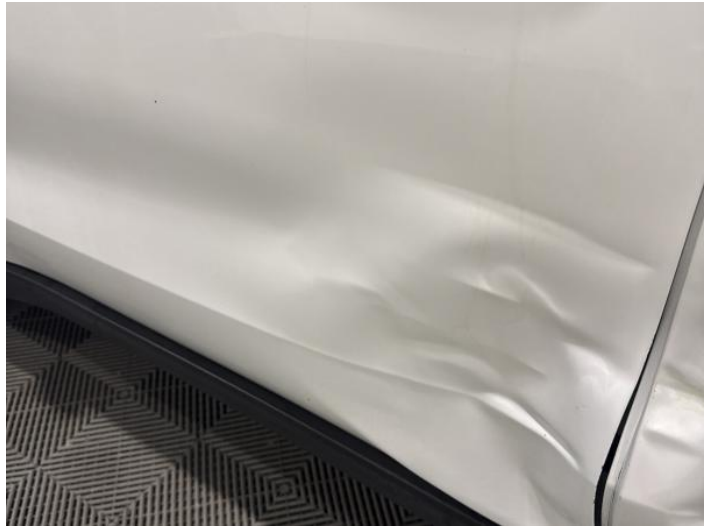
4: Door nsf  
Dented  
Over 30mm

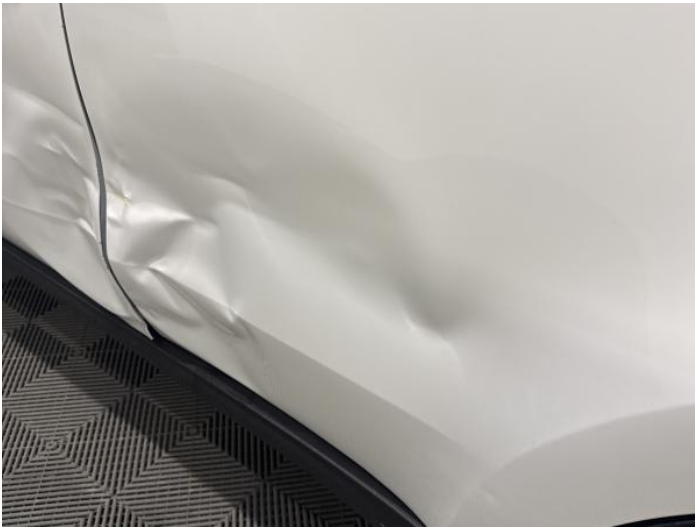
5: Door nsr  
Dented  
Over 30% Of Panel

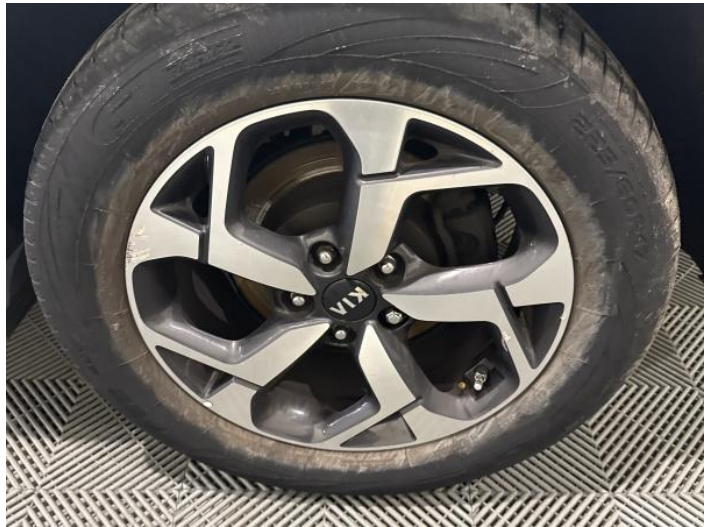
6: Wheel nsr  
Scratched  
Over 50mm

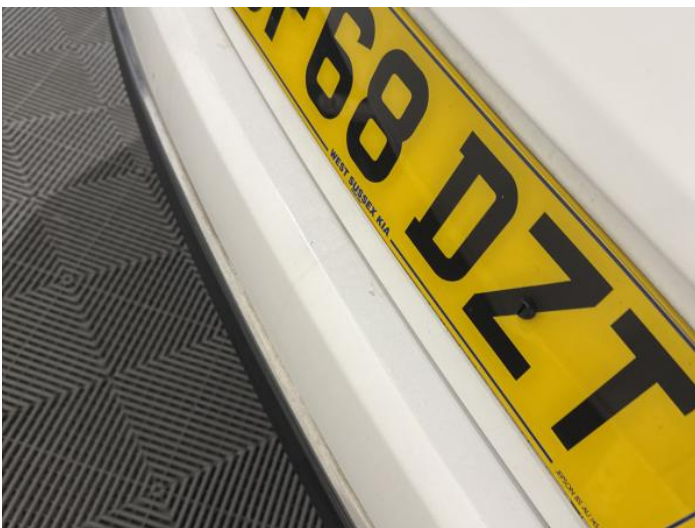
7: Bumper Rear  
Scratched  
Up To 25mm Thru Paint

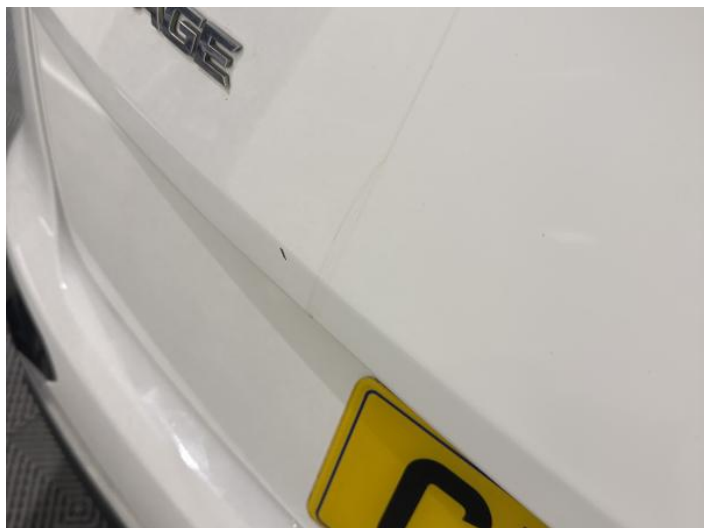
8: Tailgate  
Scratched  
UpTo 25mm Thru Paint

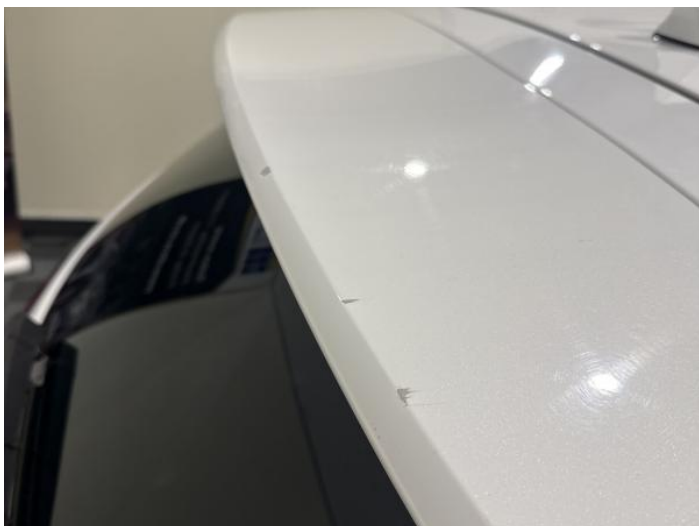
9: Spoiler Rear  
Scratched (Painted)  
Over 25mm Thru Paint

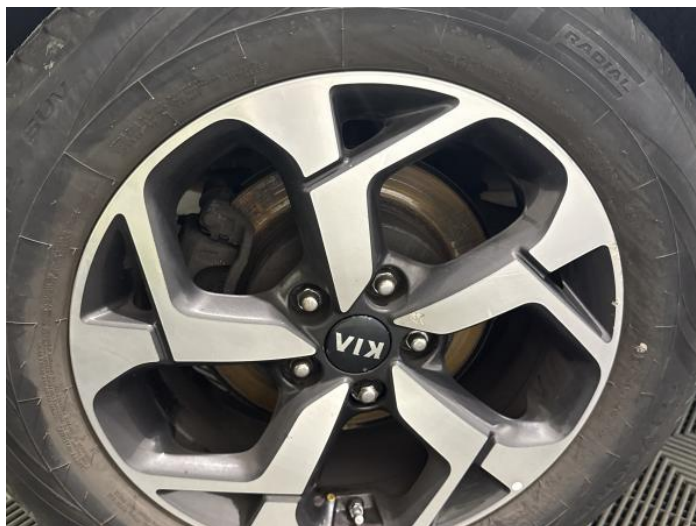
10: Wheel osr  
Scratched  
Over 50mm

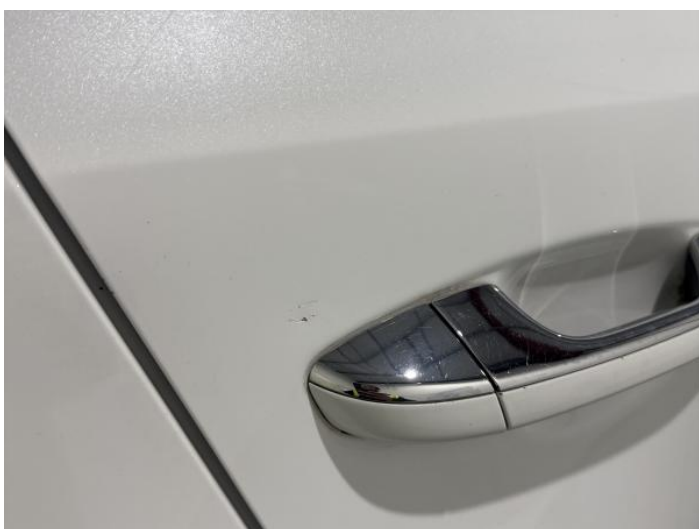
11: Door osr  
Scratched  
UpTo 25mm Thru Paint

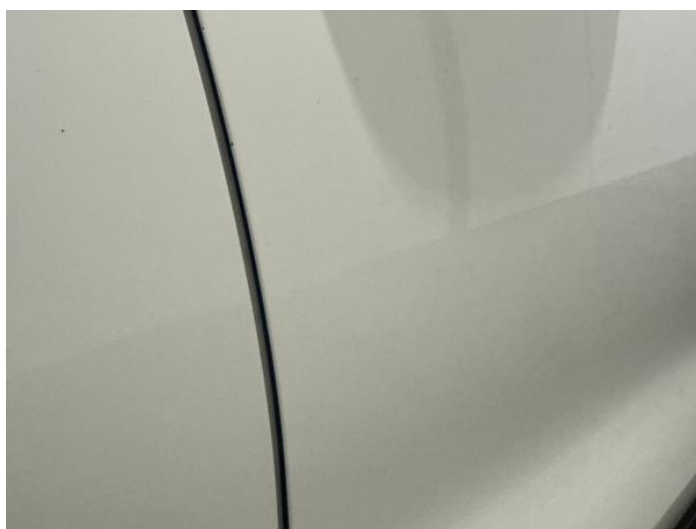
12: Door osf  
Dented  
Between 10mm + 30mm

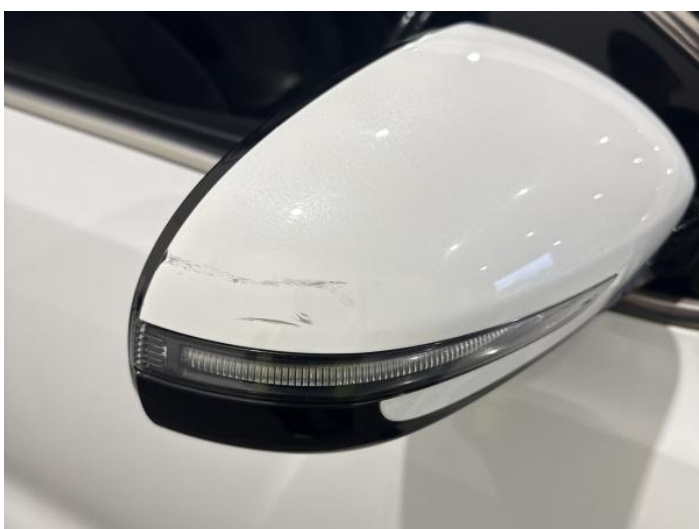
13: Door Mirror Assy osf  
Scratched (Painted)  
UpTo 25mm Thru Paint

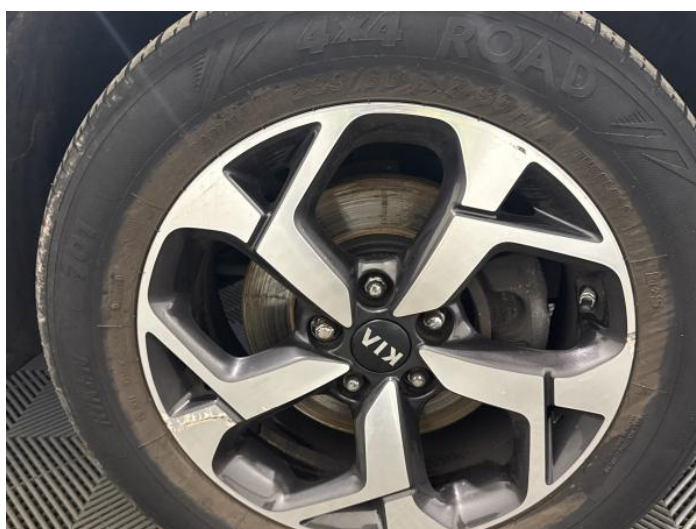
14: Wheel osf  
Scratched  
Over 50mm

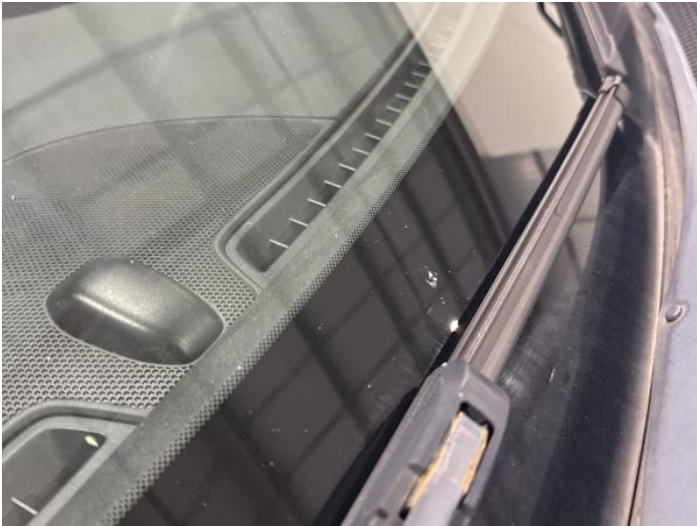
15: Screen Front  
Chipped  
UpTo 10mm

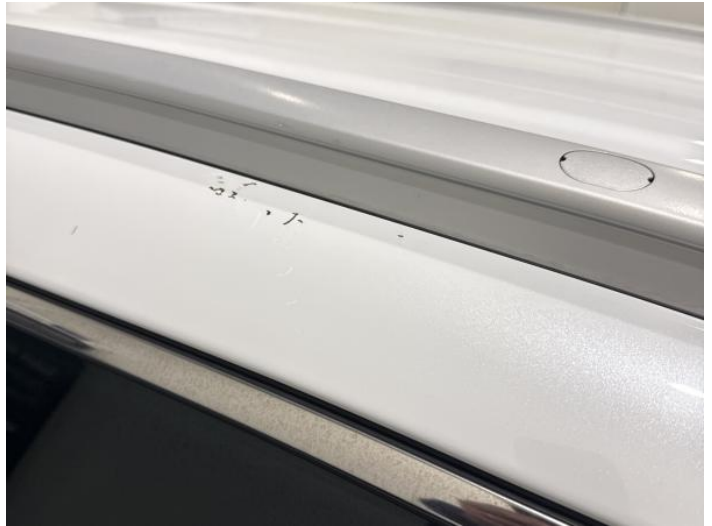
16: B Post os  
Scratched  
Over 25mm Thru Paint

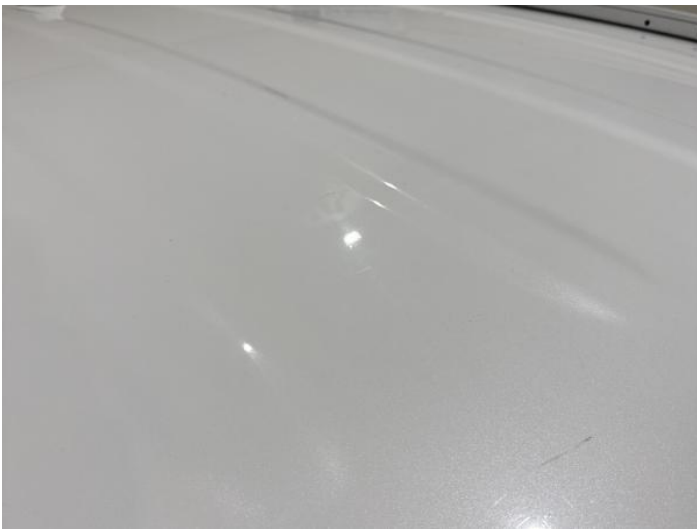
17: Roof  
Dented  
Over 30mm

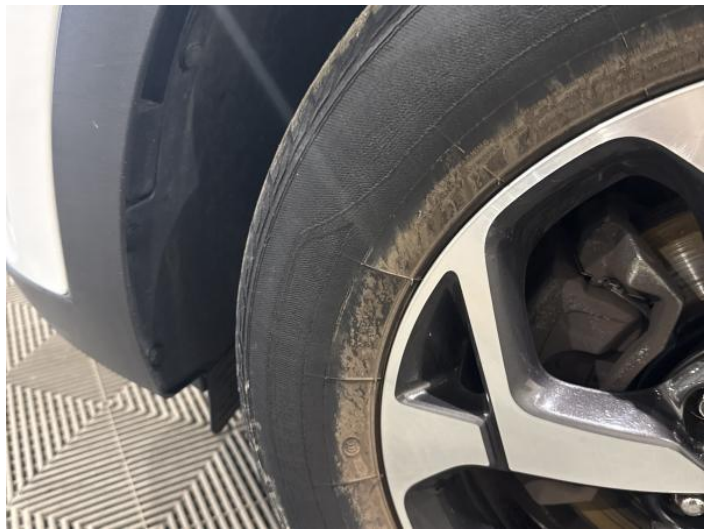
| NSF | BUDGET | Damaged |

18: Tyre nsf  
Damaged  
Replace

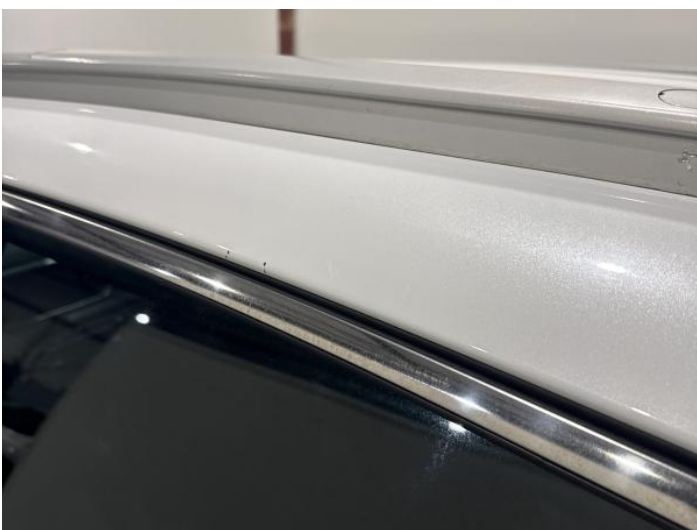
19: B Post ns  
Chipped  
1 To 5
