# VEHICLE INSPECTION REPORT

**GV72BCZ**

## Toyota Yaris 1.5 Hybrid Design 5dr CVT

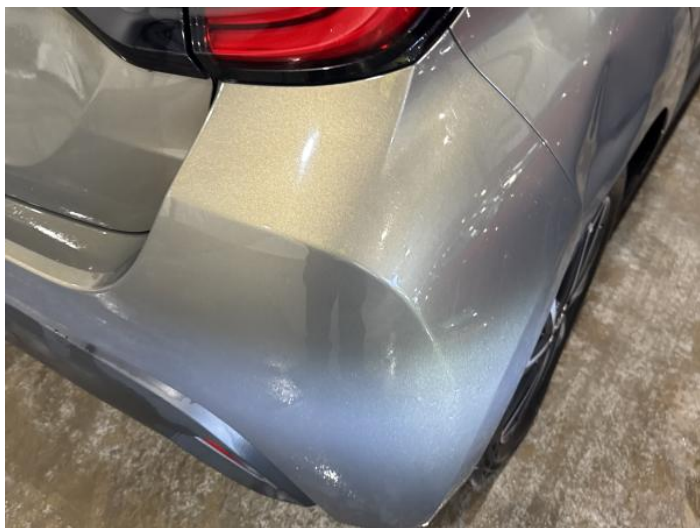
1: Bumper Rear  
Chipped  
Multiple Chips

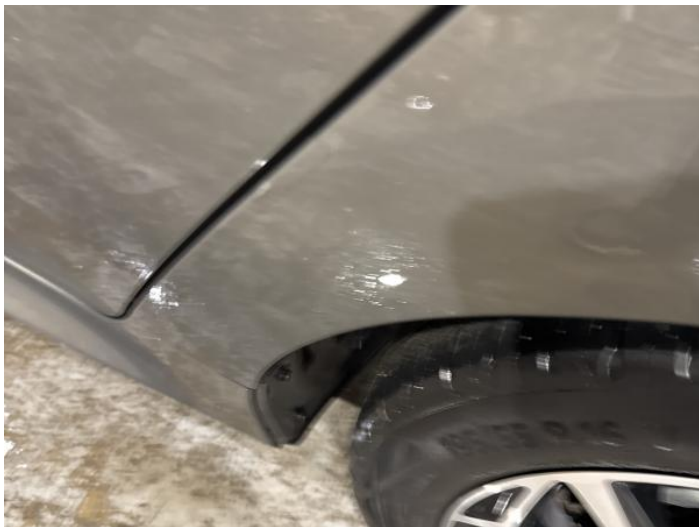
3: Qtr Panel nsr  
Dented  
Over 2 UpTo 10mm

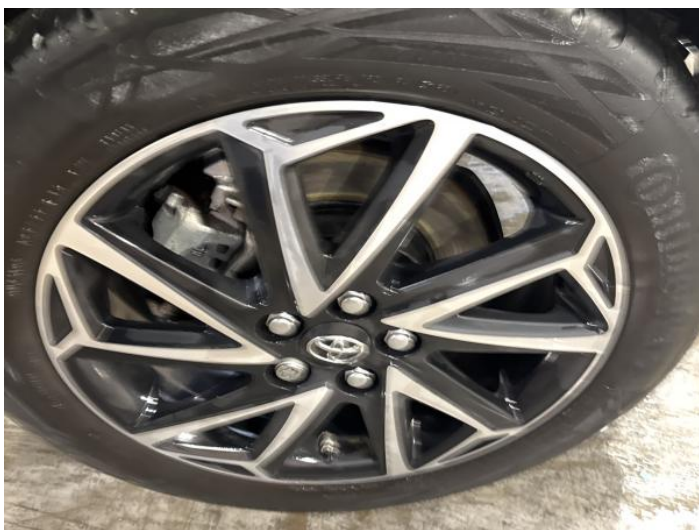
5: Wheel nsr  
Scratched  
Up To 50mm

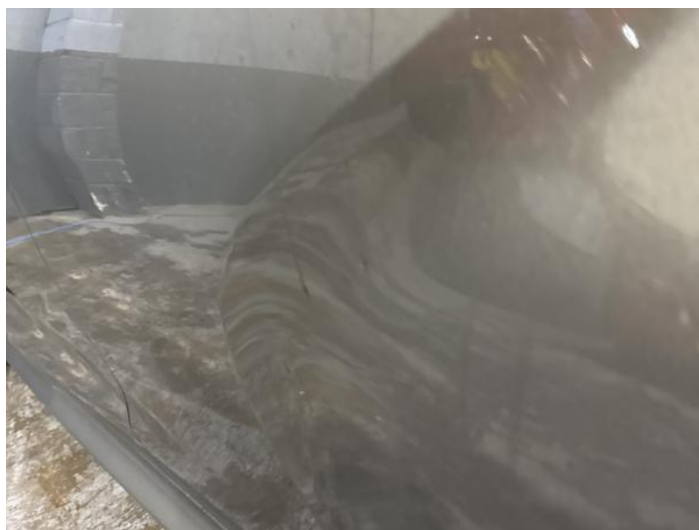
6: Door nsr  
Dented  
2 Or Less UpTo 10mm

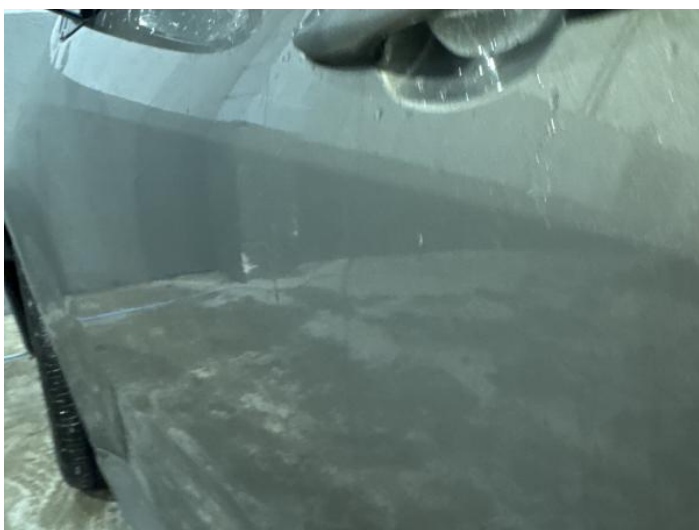
7: Door nsf  
Chipped  
1 To 5

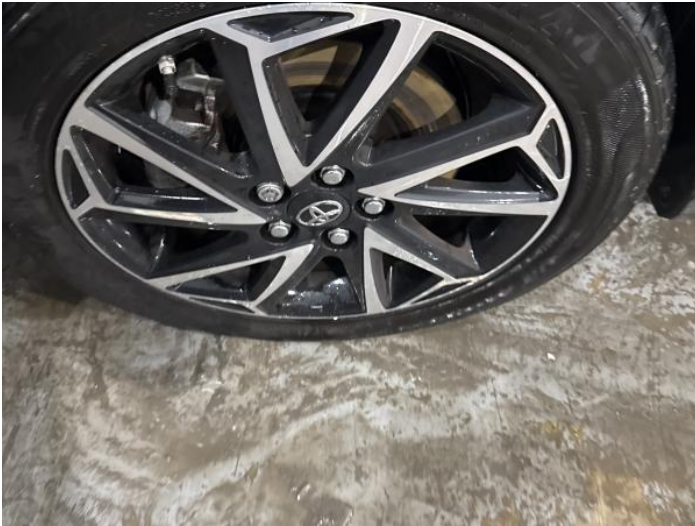
9: Wheel nsf  
Scratched  
Up To 50mm

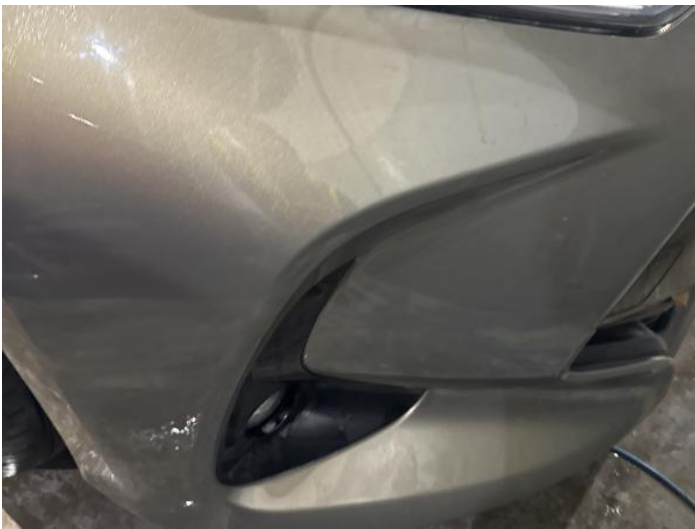
11: Bumper Front  
Chipped  
Multiple Chips

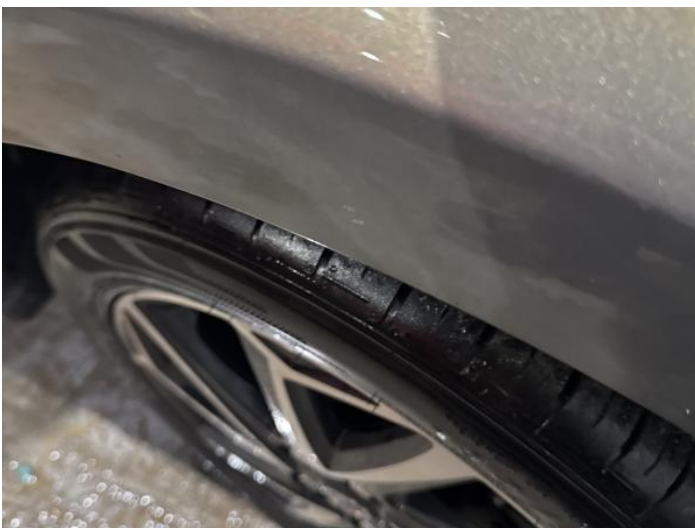
13: Wing osf  
Chipped  
1 To 5

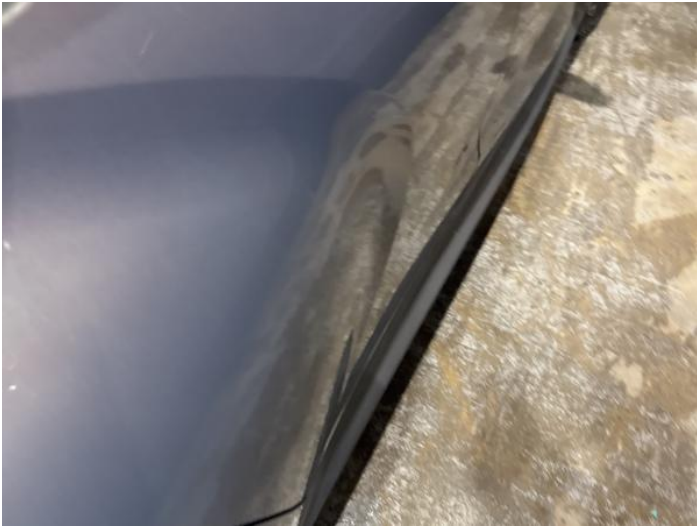
15: Door osr  
Dented  
Over 2 UpTo 10mm

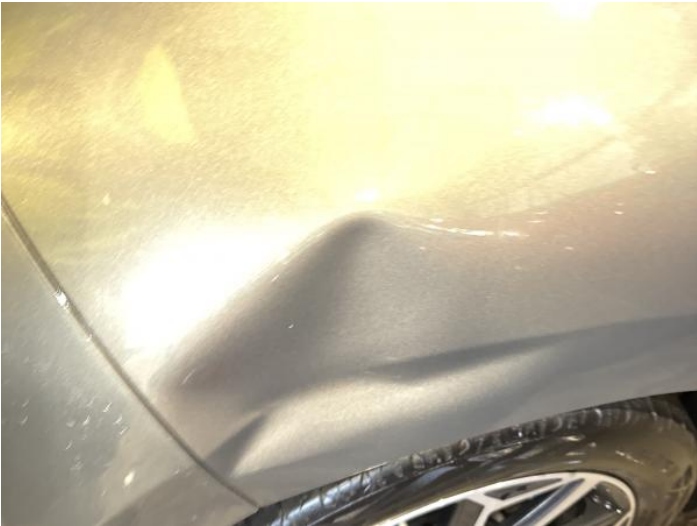
16: Qtr Panel osr  
Dented  
Over 30mm

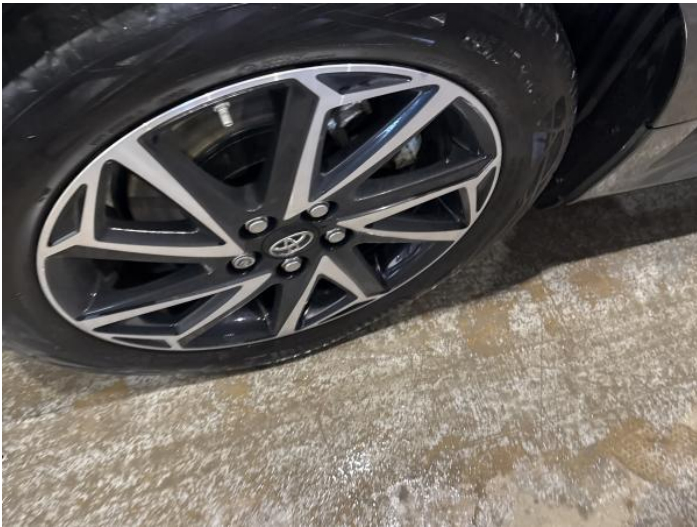
17: Wheel osr  
Scratched  
Up To 50mm
