# VEHICLE INSPECTION REPORT

**KP18HNO**

## Peugeot 2008 1.6 BlueHDi 100 Active 5dr

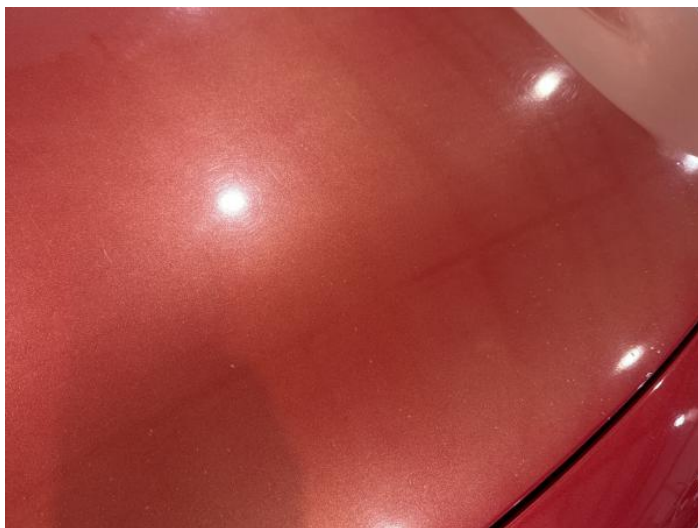
1: Bonnet  
Chipped  
Multiple Chips

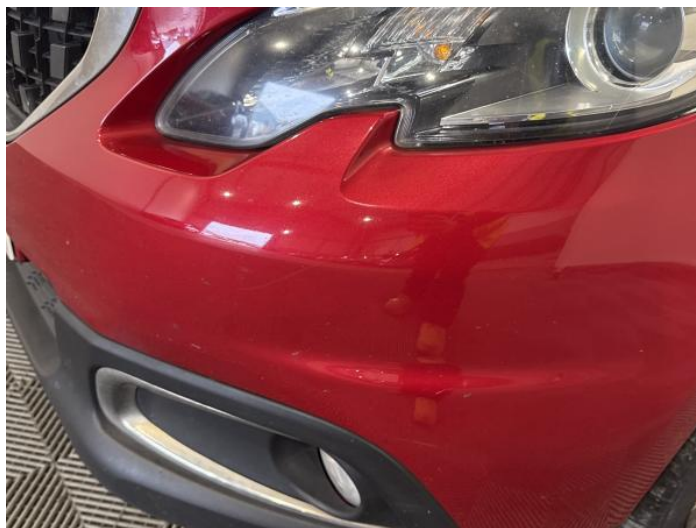
2: Bumper Front  
Scratched  
25 to 100mm Thru Paint

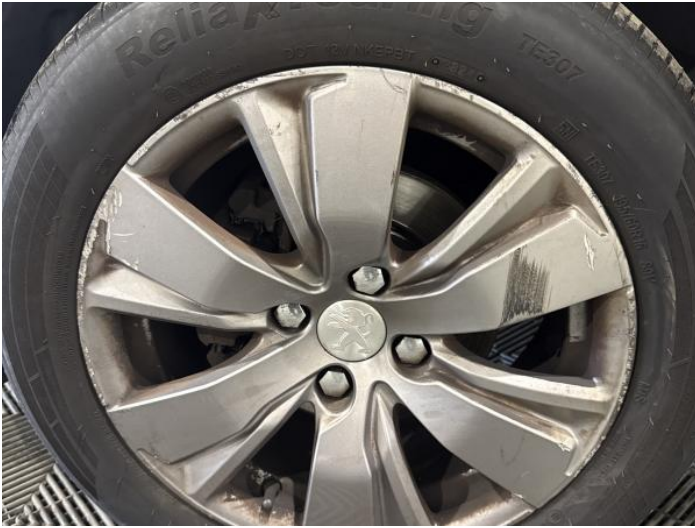
3: Wheel nsf  
Scratched  
Over 50mm

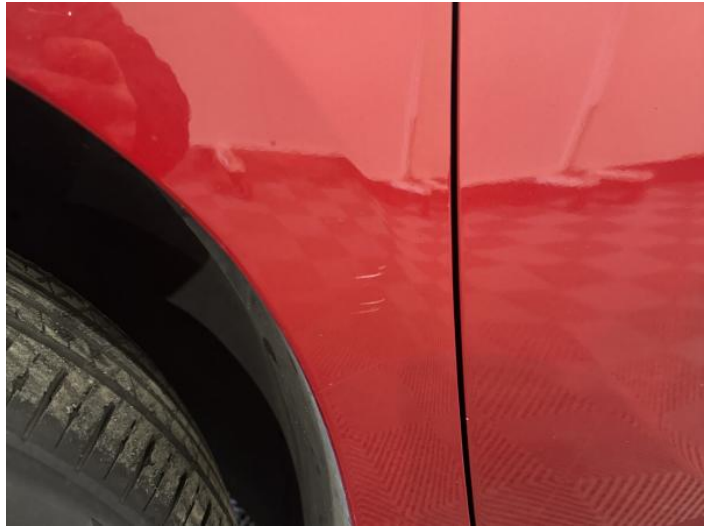
4: Wing nsf  
Scratched  
Over 25mm Thru Paint

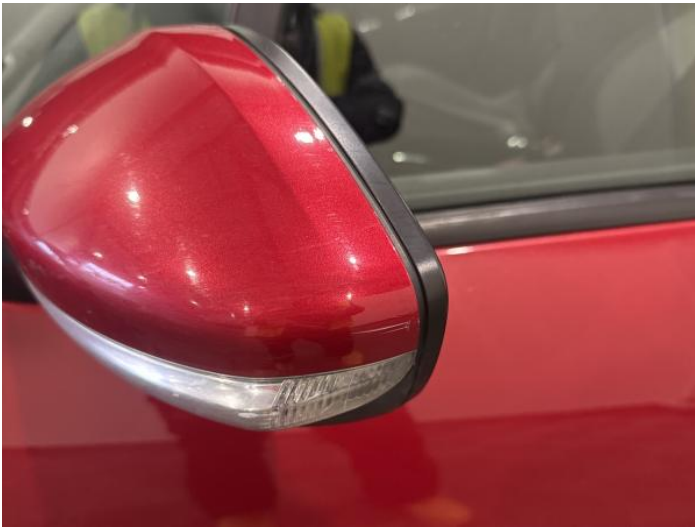
5: Door Mirror Assy nsf  
Scratched (Painted)  
UpTo 25mm Thru Paint

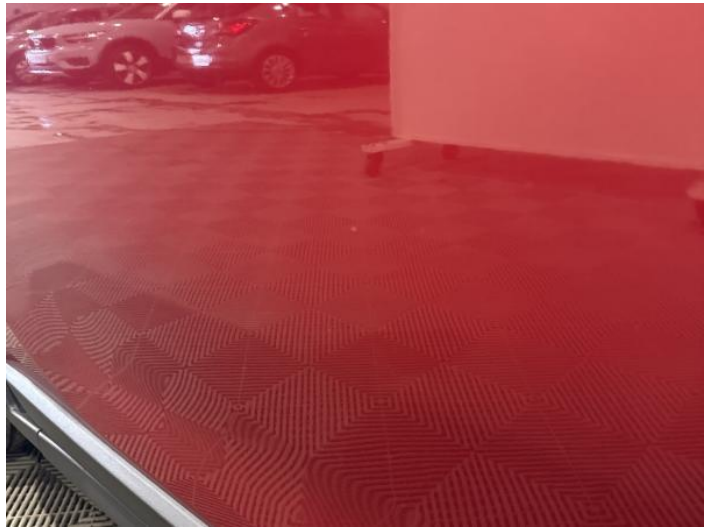
6: Door nsf  
Chipped  
1 To 5

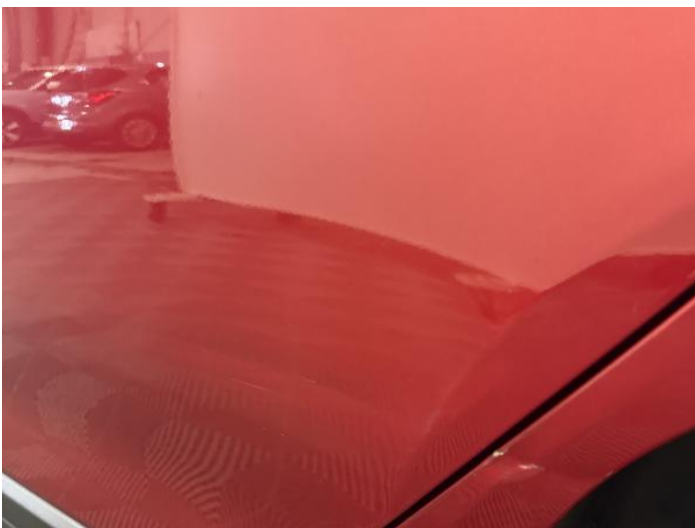
7: Door nsr  
Dented  
With Paint Damage

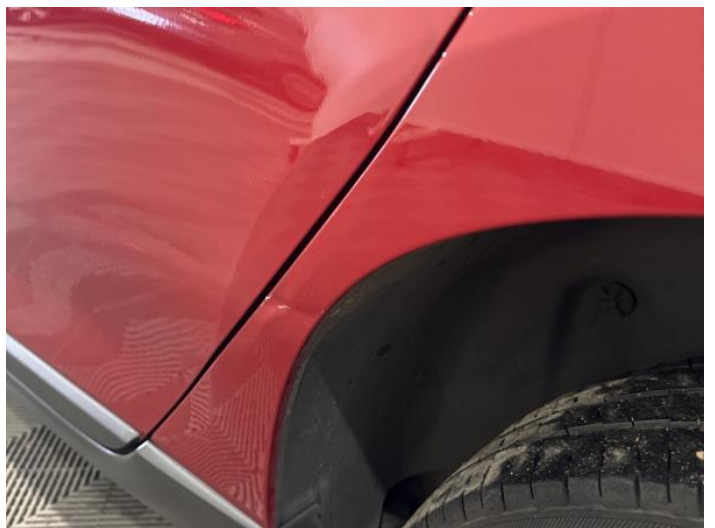
8: Qtr Panel nsr  
Dented  
Over 30mm

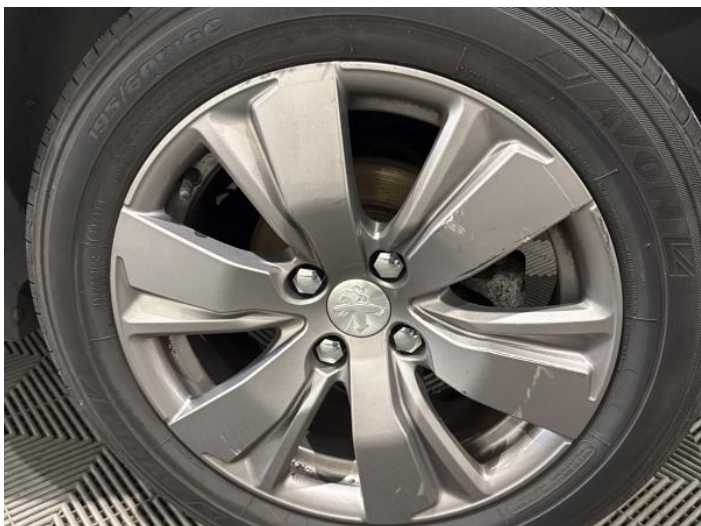
9: Wheel nsr  
Scratched  
Over 50mm

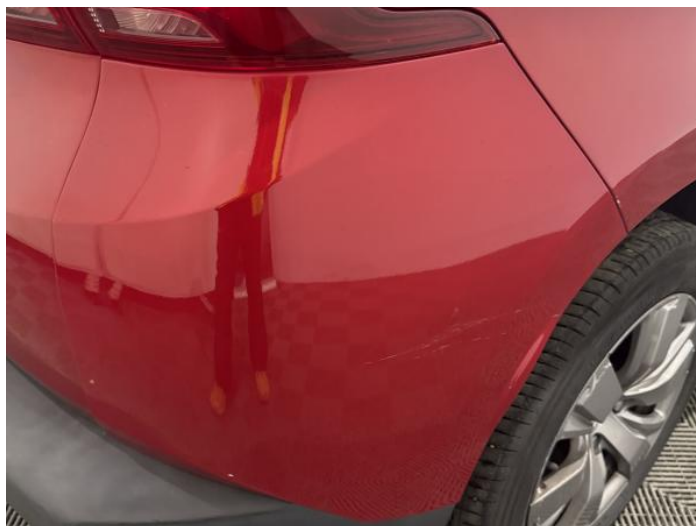
10: Bumper Rear Moulding  
Scratched (Painted)  
Over 25mm Thru Paint

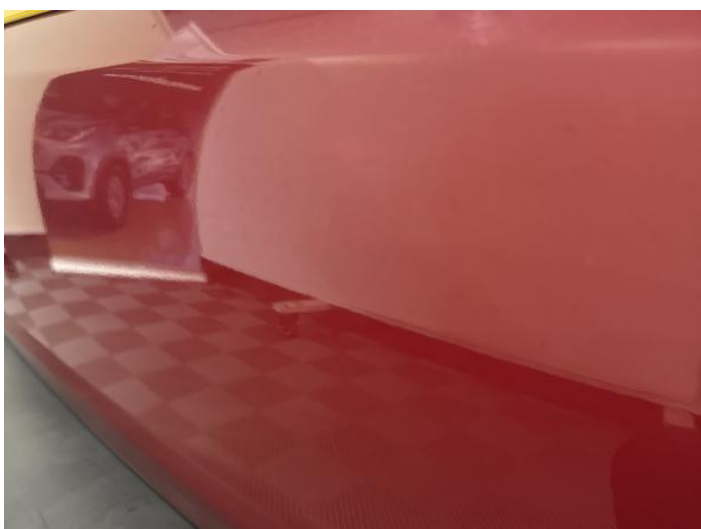
11: Tailgate  
Scratched  
UpTo 25mm Thru Paint

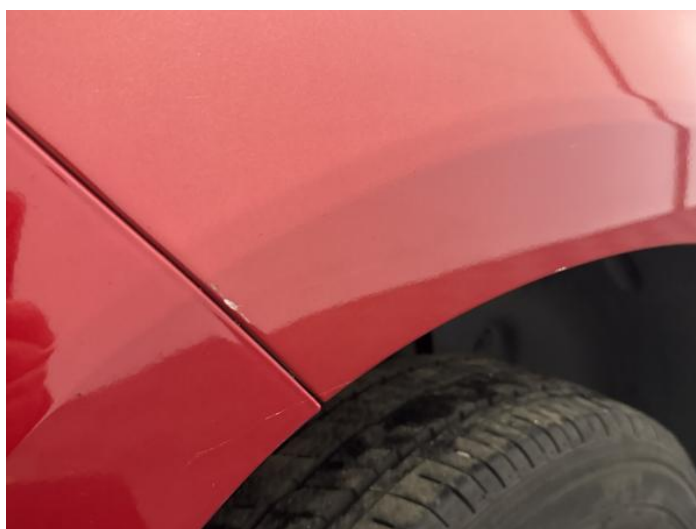
12: Qtr Panel osr  
Scratched  
UpTo 25mm Thru Paint

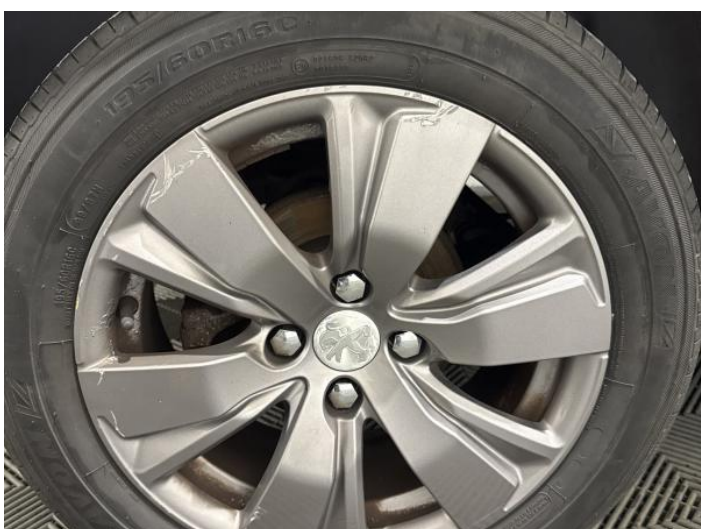
13: Wheel osr  
Scratched  
Over 50mm

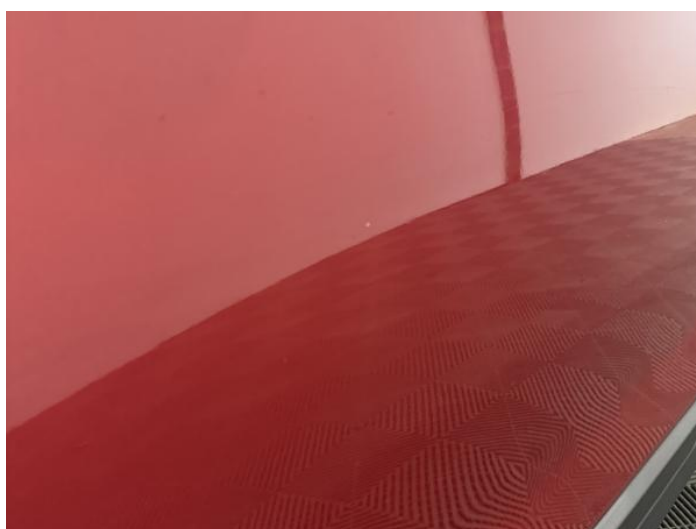
14: Door osr  
Chipped  
1 To 5

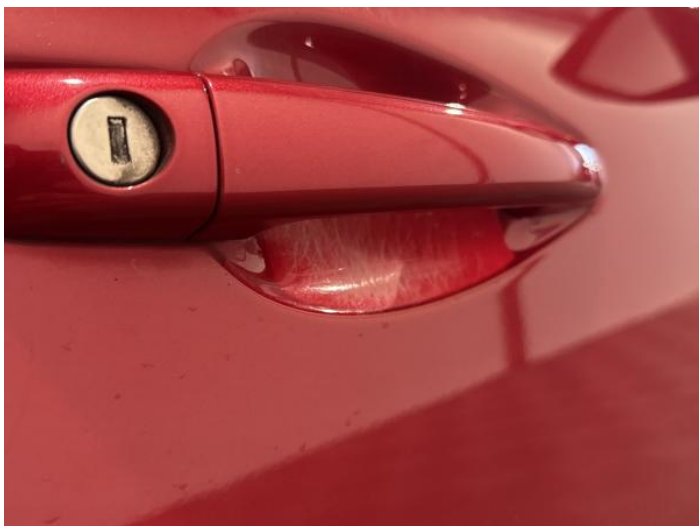
15: Door osf  
Scratched  
Over 25mm Thru Paint

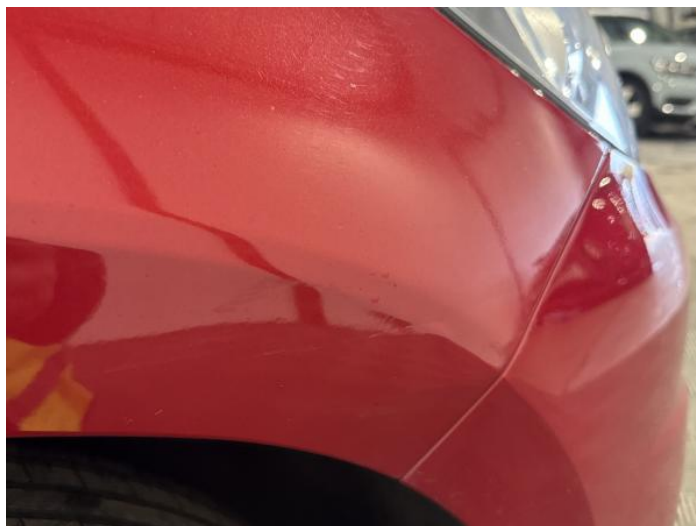
16: Wing osf  
Dented  
Over 30mm

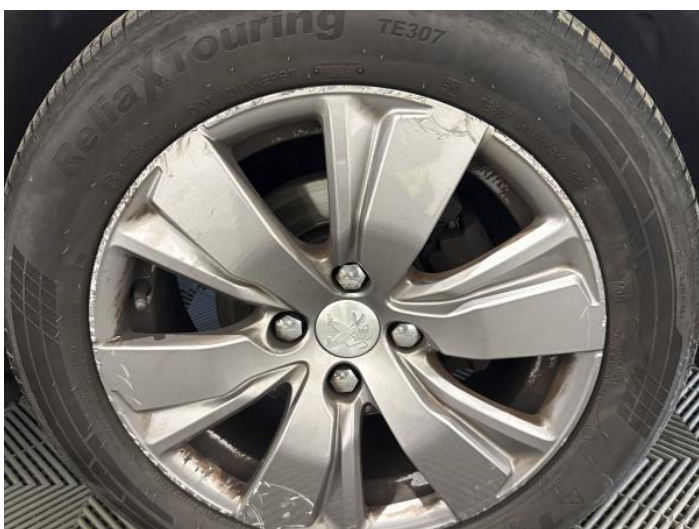
17: Wheel osf  
Scratched  
Over 50mm

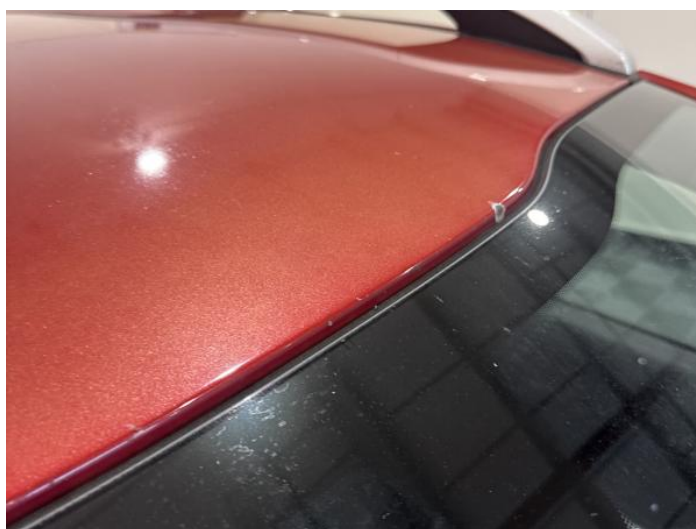
18: Roof  
Chipped  
Over 5mm
