# VEHICLE INSPECTION REPORT

AJ72SDV

## Vauxhall Corsa 1.2 Turbo Design 5dr

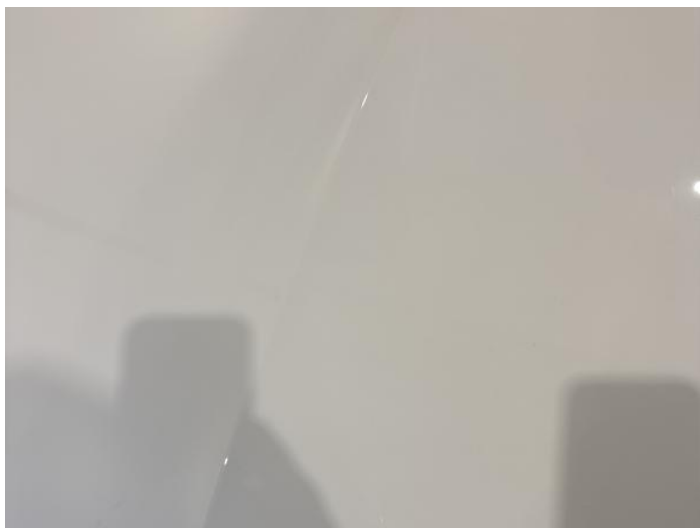
1: Bonnet  
Chipped  
1 To 5

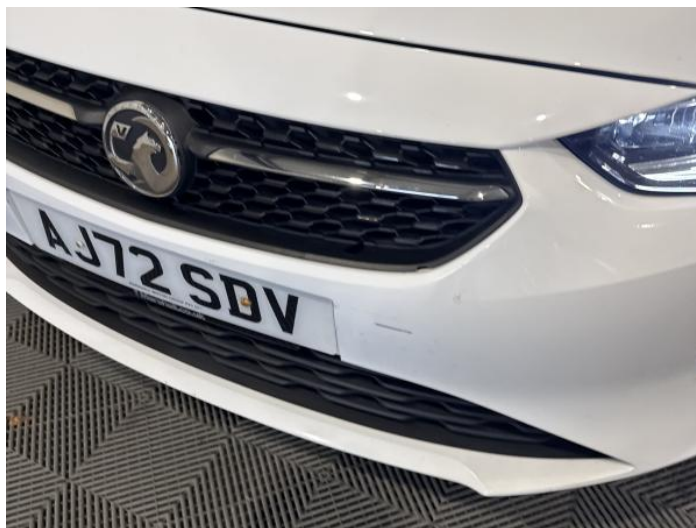
2: Bumper Front  
Scratched  
Over 100mm Thru Paint

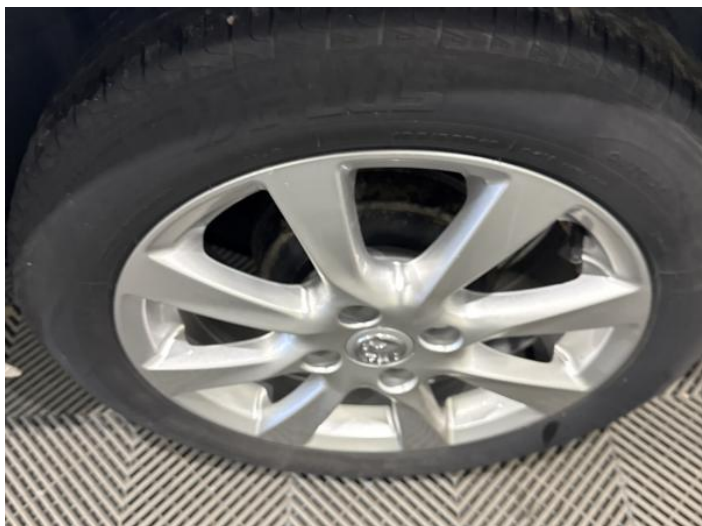
9: Wheel nsr  
Scratched  
Up To 50mm

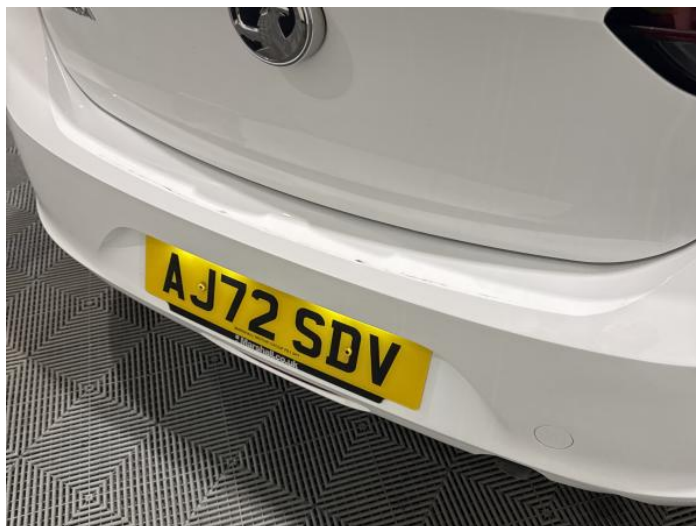
10: Bumper Rear  
Scratched  
25 to 100mm Thru Paint

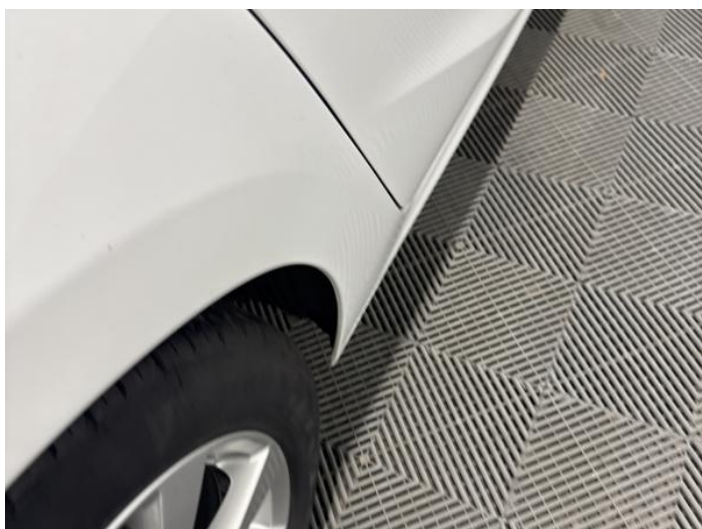
13: Qtr Panel osr  
Dented  
Over 30mm

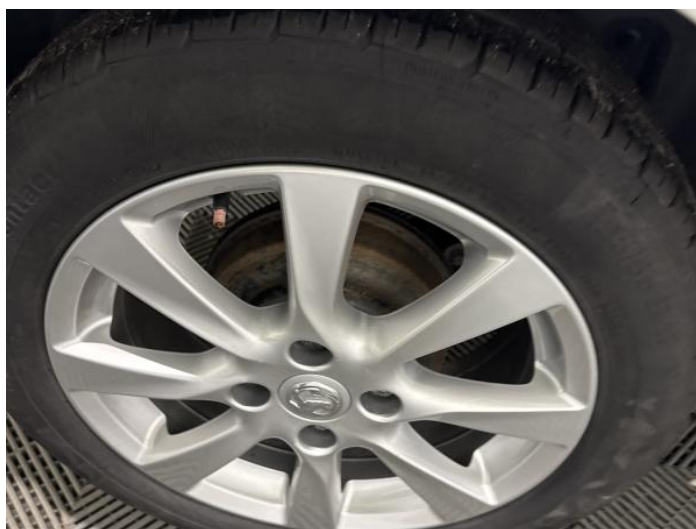
14: Wheel osr  
Scratched  
Up To 50mm

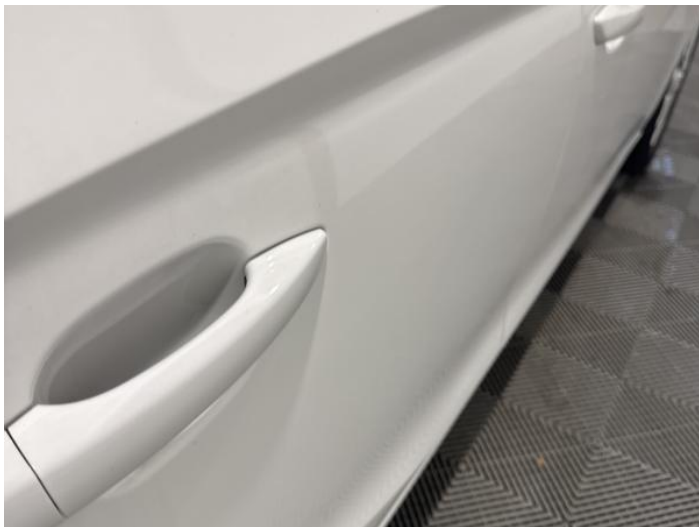
15: Door osr  
Chipped  
1 To 5

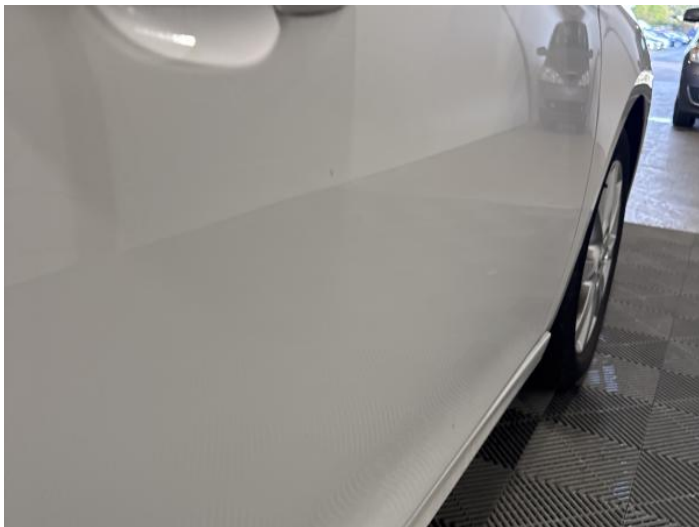
17: Door osf  
Chipped  
1 To 5

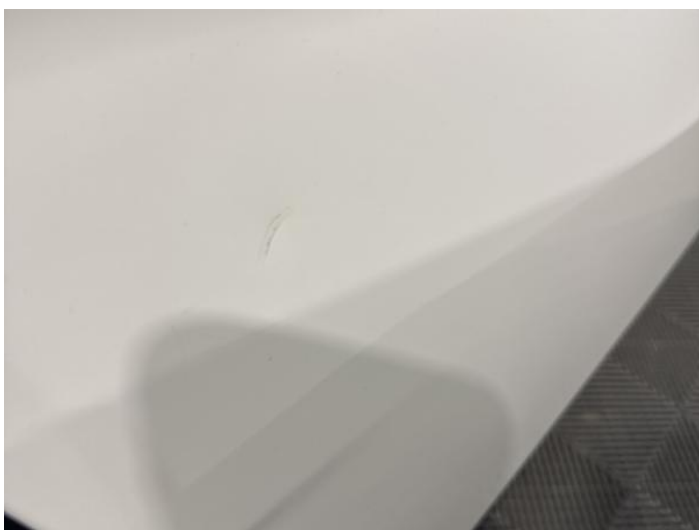
19: Wing osf  
Dented  
Between 10mm + 30mm

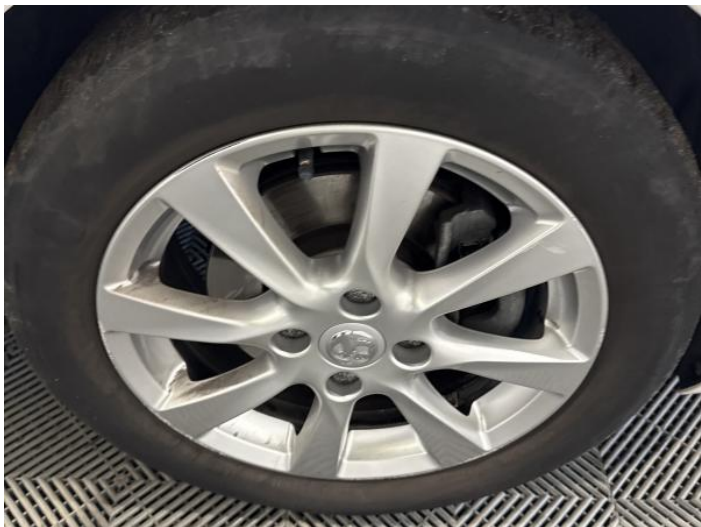
21: Wheel of  
Scratched  
Over 50mm
