# **VEHICLE INSPECTION REPORT**

## Alfa Romeo Mito 0.9 TB TwinAir 105 QV Line 3dr

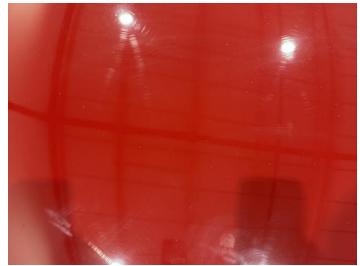
1: Bonnet Chipped Multiple Chips

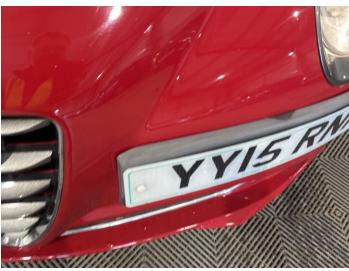
2: Bumper Front Poor Previous Repair Poor Paint

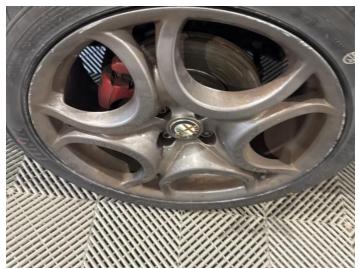
3: Wheel nsf Scratched Over 50mm

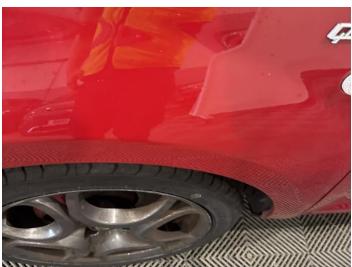
4: Wing nsf Chipped 1 To 5

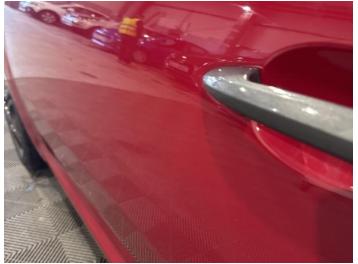
5: Door nsf Chipped 1 To 5

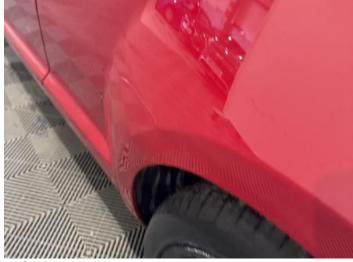
7: Qtr Panel nsr Dented Over 30mm

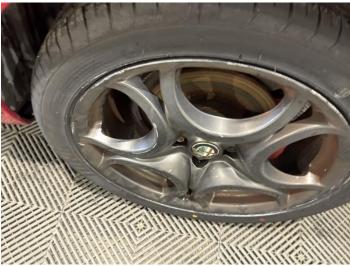
8: Wheel nsr Scratched Over 50mm

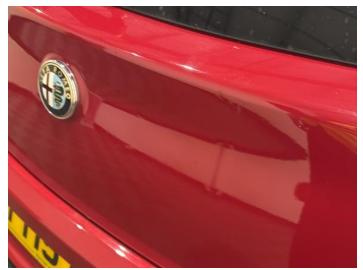
11: Boot Lid Chipped 1 To 5

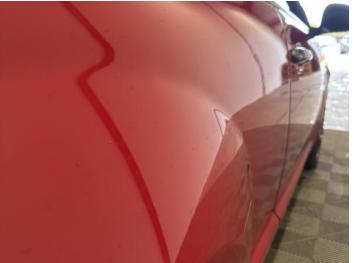
12: Qtr Panel osr Poor Previous Repair Poor Paint

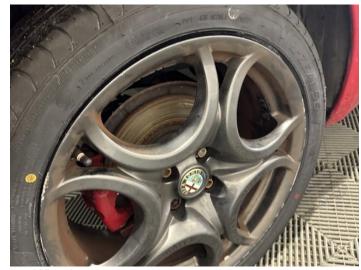
13: Wheel osr Scratched Over 50mm

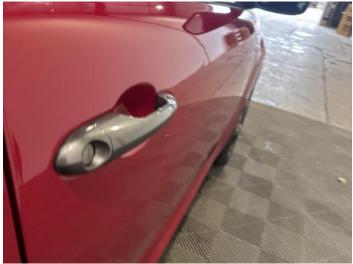
14: Door osf Dented Over 30mm

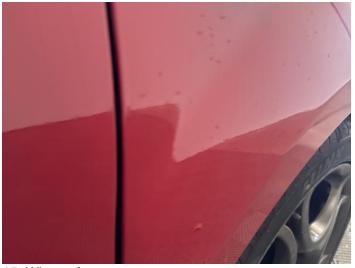
15: Wing osf Poor Previous Repair Poor Paint

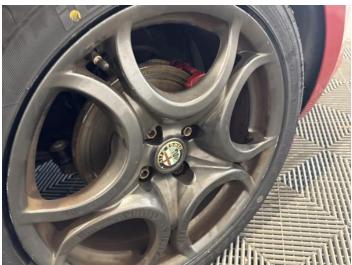
16: Wheel osf Scratched Over 50mm
