# VEHICLE INSPECTION REPORT

**LD66RXP**

## Volkswagen Golf 1.6 TDI 110 Match Edition 5dr

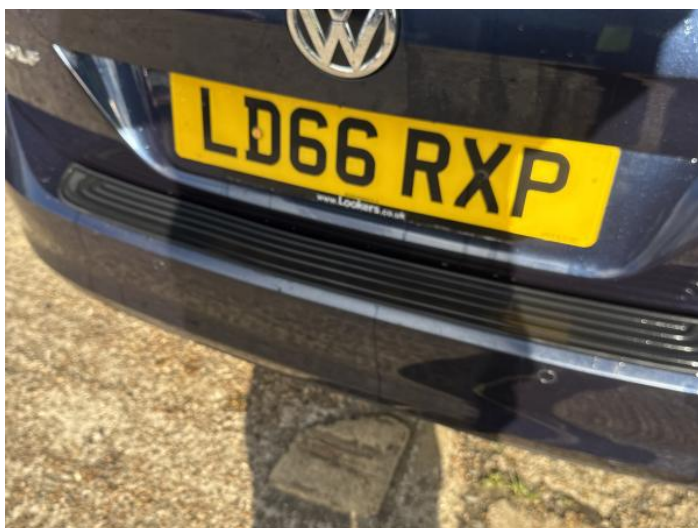
1: Bumper Rear  
Scratched  
Over 100mm Thru Paint

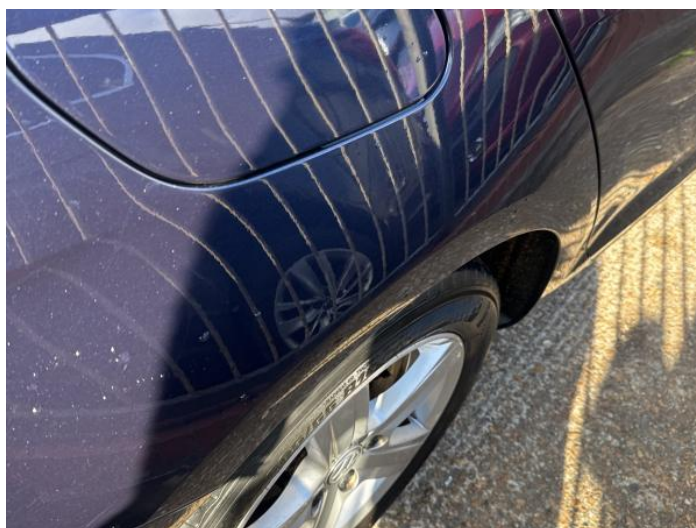
2: Qtr Panel or  
Chipped  
1 To 5

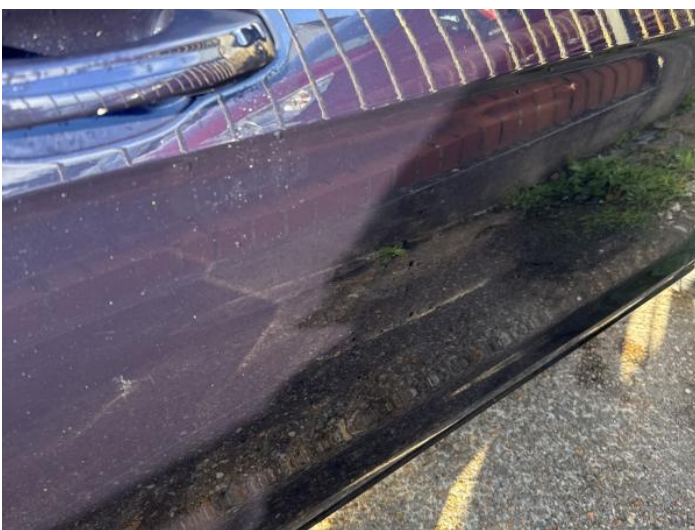
6: Door osr  
Scratched  
Over 25mm Not Thru Paint

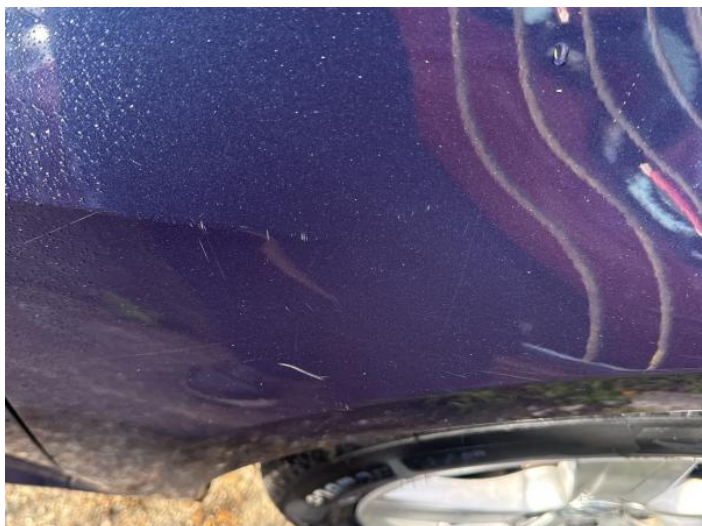
8: Door osf  
Scratched  
Over 25mm Not Thru Paint

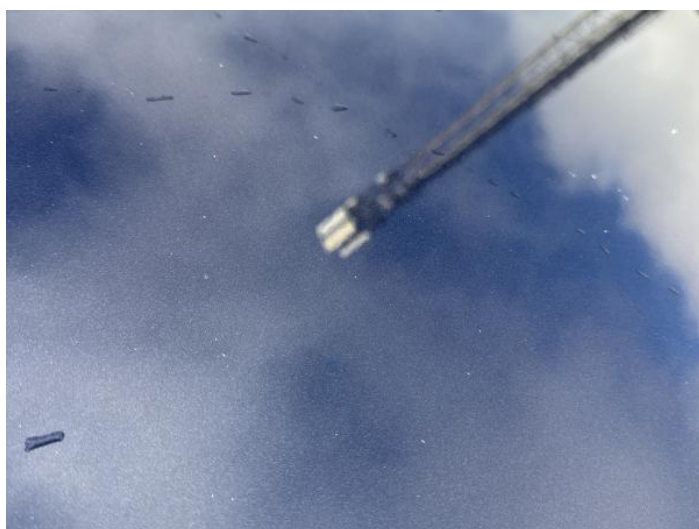
11: Roof  
Chipped  
Edge Chip

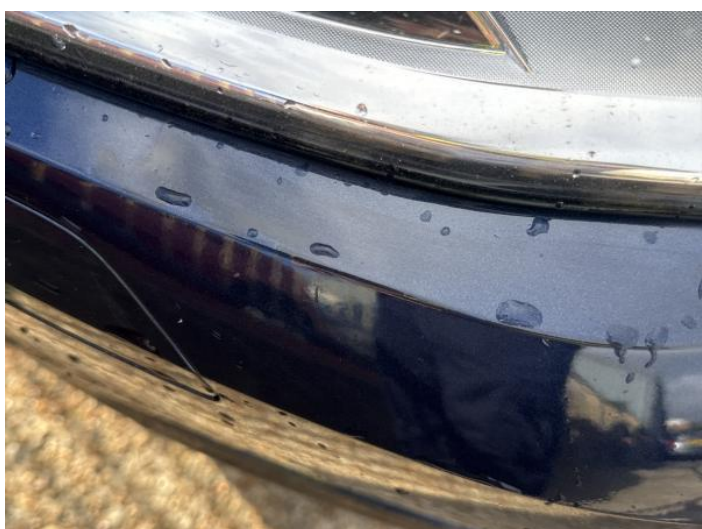
12: Bonnet  
Chipped  
Multiple Chips

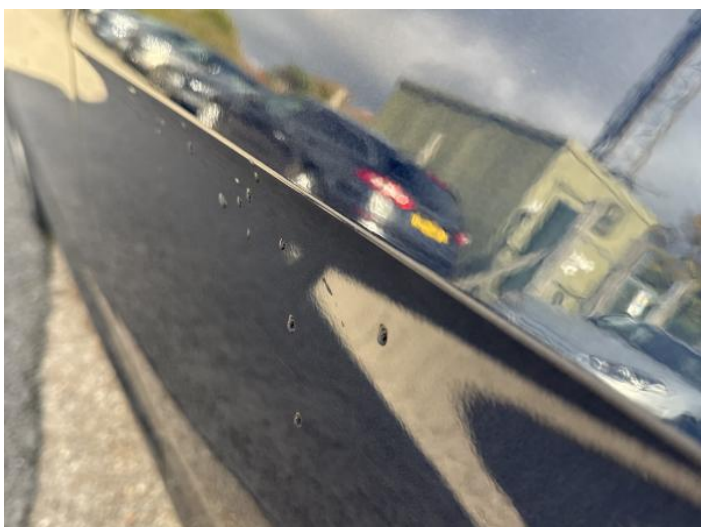
18: Door nsf  
Scratched  
Over 25mm Not Thru Paint
