## **VEHICLE INSPECTION REPORT**

FG63KUF

## Kia Sportage 2.0 CRDi KX-3 5dr [Sat Nav]

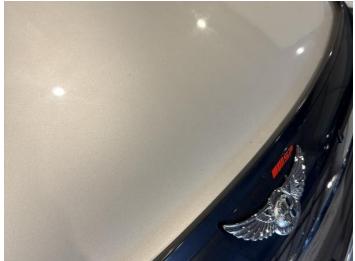
1: Bonnet Chipped Multiple Chips

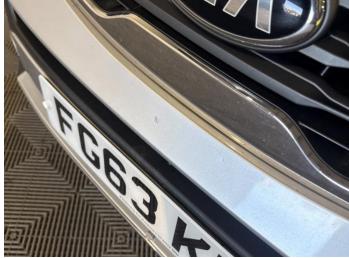
2: Bumper Front Chipped Over 5mm

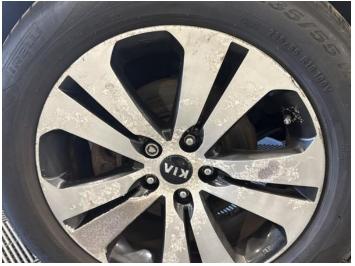
3: Wheel nsf Scratched Over 50mm

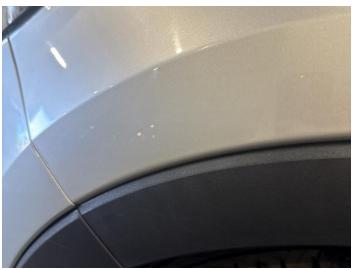
4: Wing nsf Scratched UpTo 25mm Thru Paint

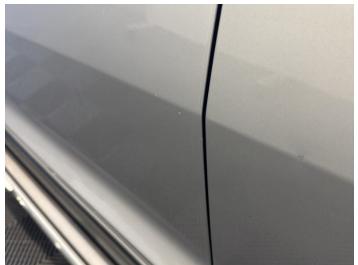
5: Door nsf Scratched Over 25mm Thru Paint

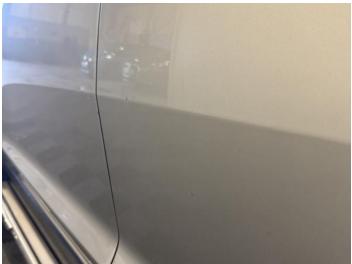
6: Door nsr Dented Between 10mm + 30mm

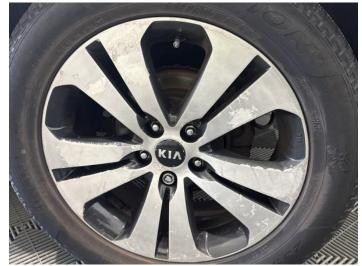
7: Wheel osr Scratched Over 50mm

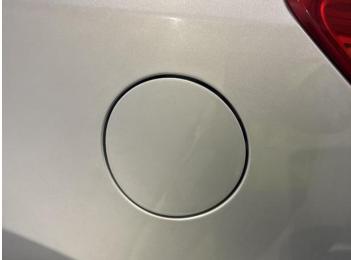
8: Qtr Panel nsr Chipped 1 To 5

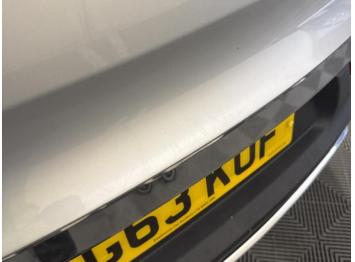
9: Tailgate Scratched UpTo 25mm Thru Paint

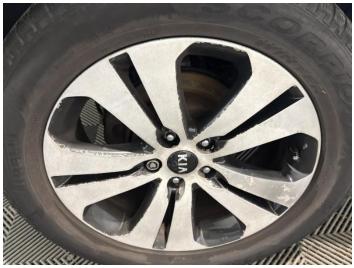
10: Wheel osr Scratched Over 50mm

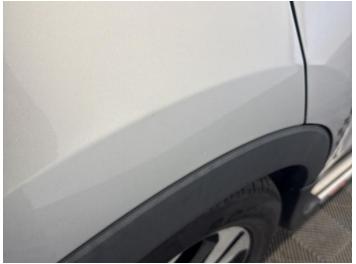
11: Qtr Panel osr Dented Between 10mm + 30mm

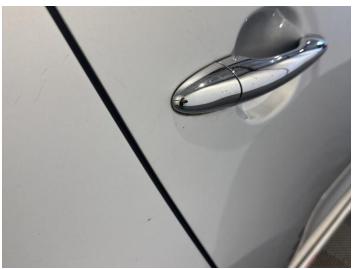
12: Door osr Scratched Over 25mm Thru Paint

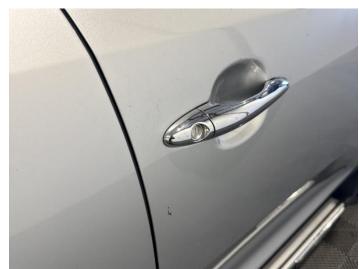
13: Door osf Scratched Over 25mm Thru Paint

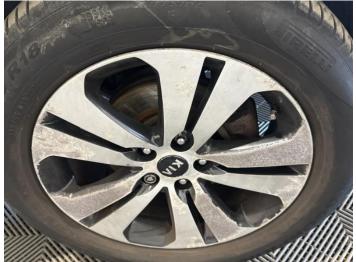
14: Wheel osf Scratched Over 50mm

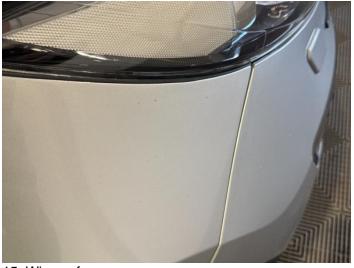
15: Wing osf Chipped 1 To 5

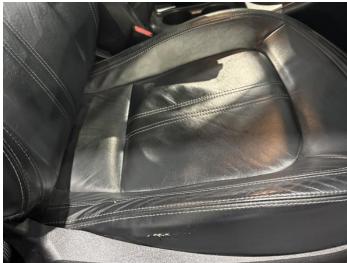
16: Seat Base Cover osf Scuffed Over 25mm
