# VEHICLE INSPECTION REPORT

**EA66GKX**

## DS Ds 3 1.6 THP Prestige 2dr

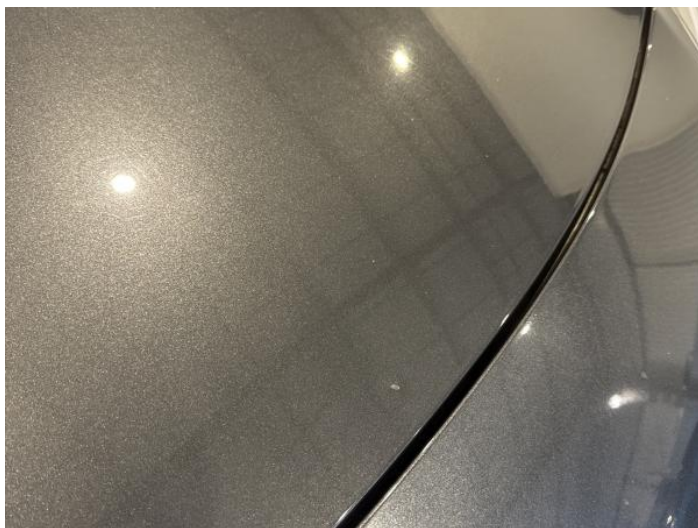
1: Bonnet  
Dented  
Between 10mm + 30mm

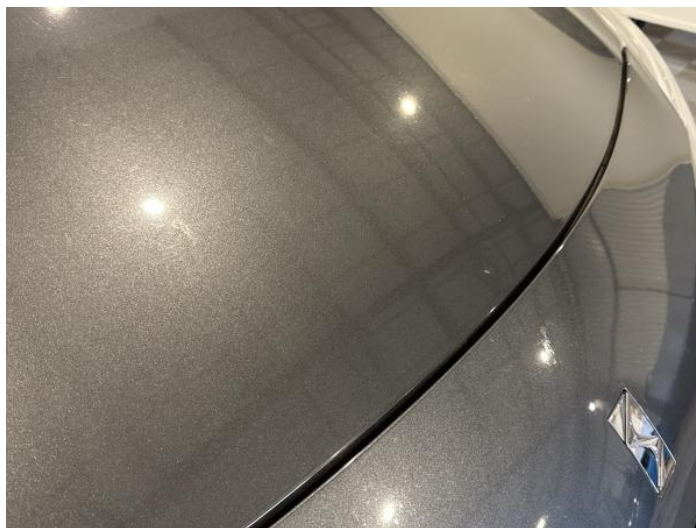
2: Bonnet  
Chipped  
1 To 5

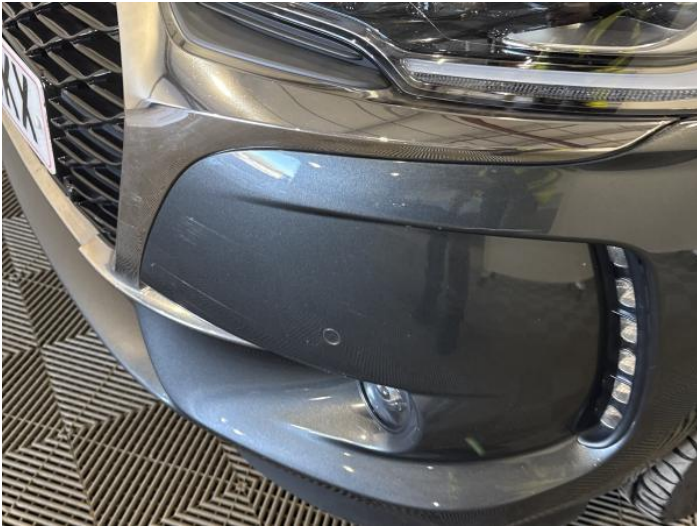
3: Bumper Front  
Scratched  
25 to 100mm Thru Paint

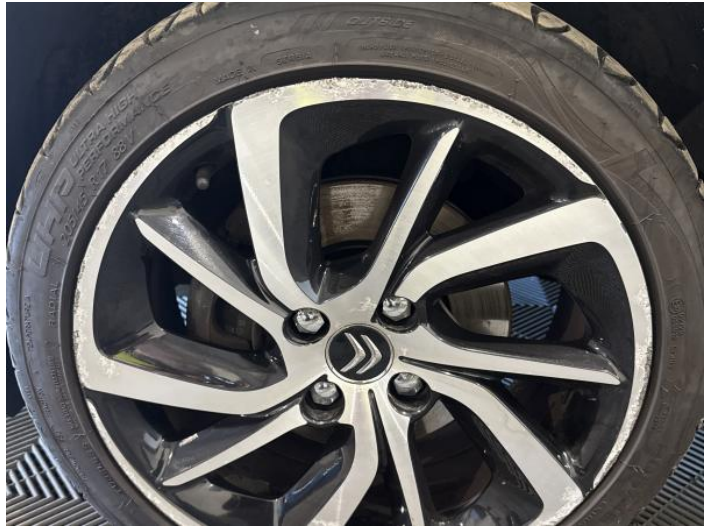
4: Wheel nsf  
Scratched  
Over 50mm

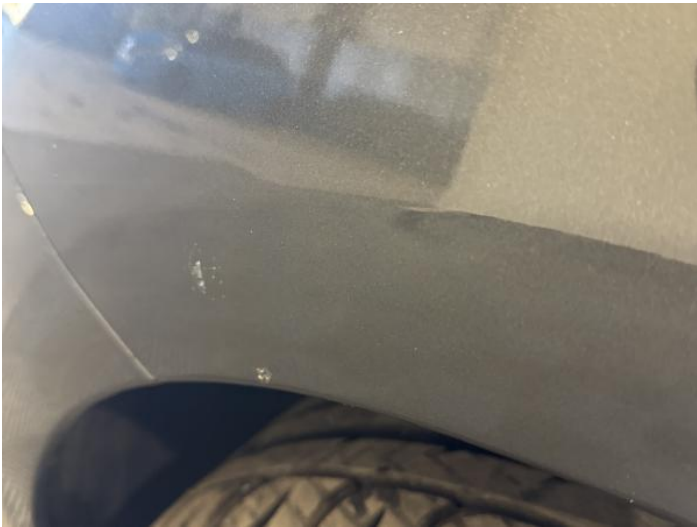
5: Wing nsf  
Scratched  
UpTo 25mm Thru Paint

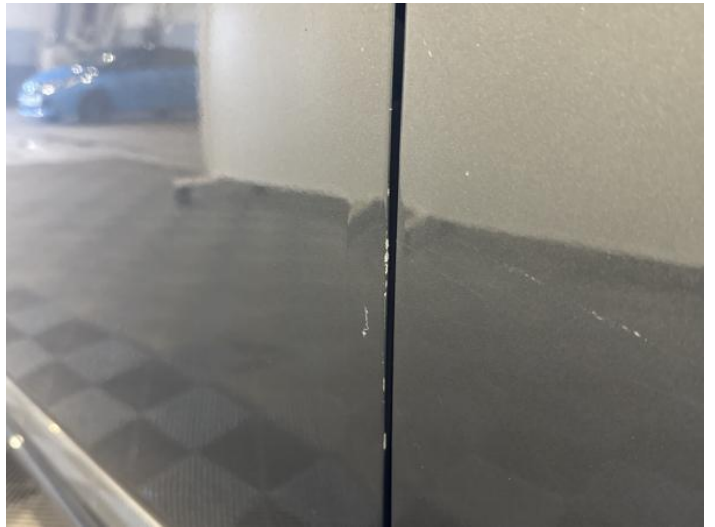
6: Door nsf  
Dented  
Over 30mm

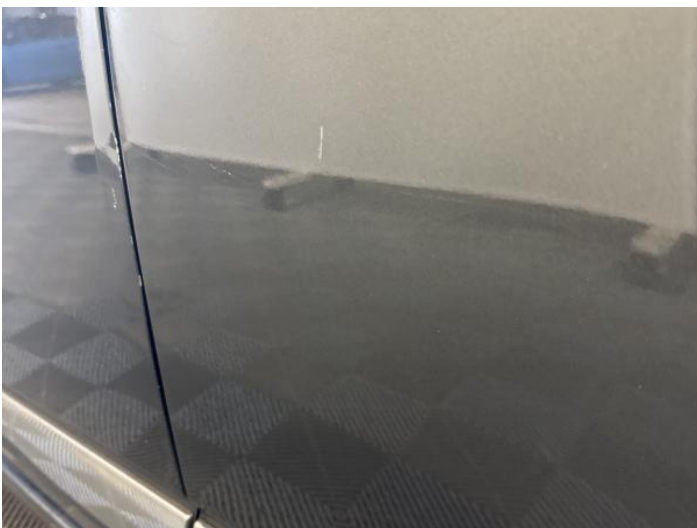
7: Qtr Panel nsr  
Scratched  
Over 25mm Thru Paint

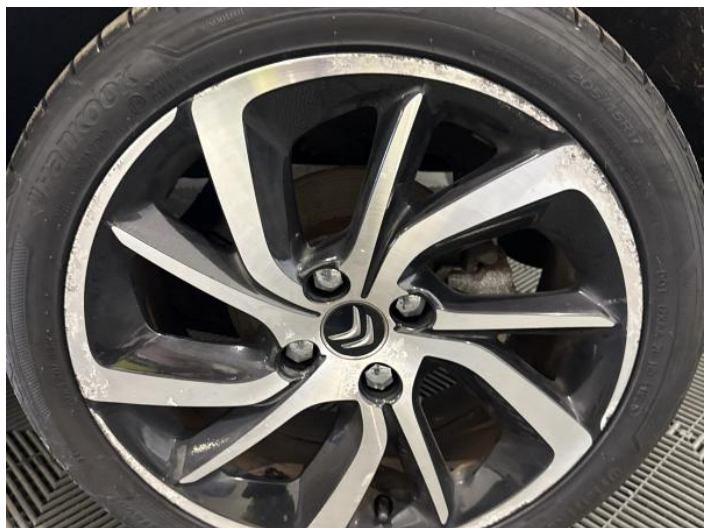
8: Wheel nsr  
Scratched  
Over 50mm

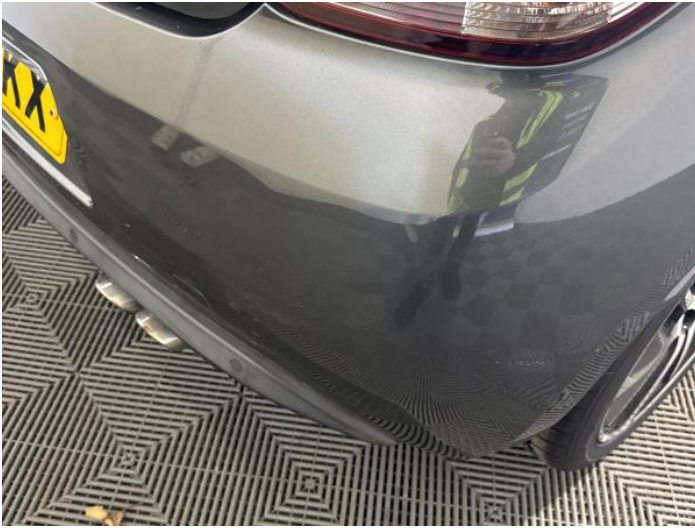
9: Bumper Rear  
Scratched  
25 to 100mm Thru Paint

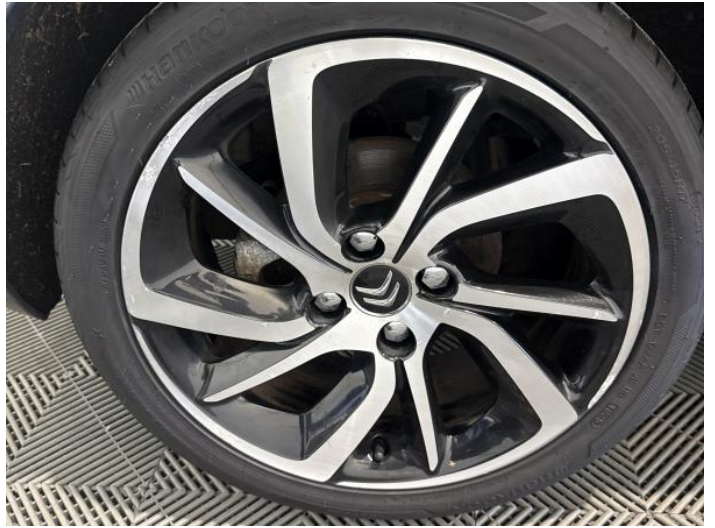
10: Wheel osr  
Scratched  
Over 50mm

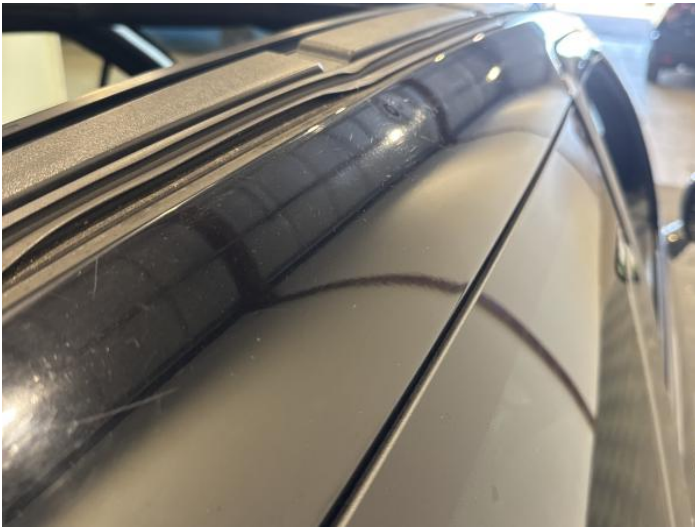
11: B Post os  
Dented  
Between 10mm + 30mm

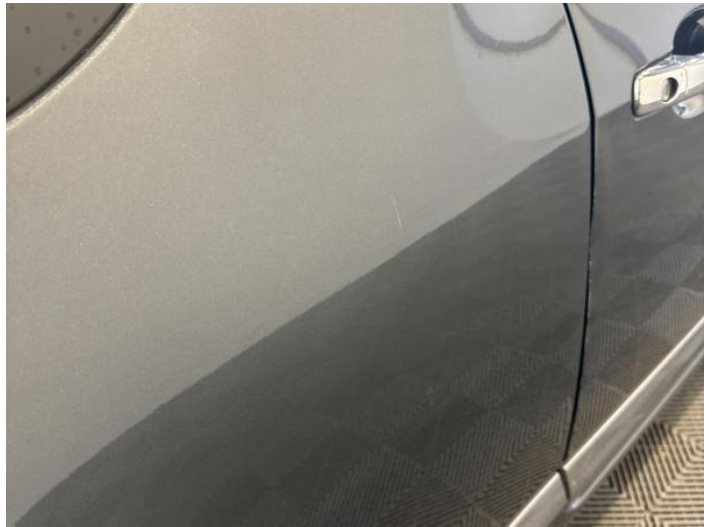
12: Qtr Panel osr  
Scratched  
Over 25mm Thru Paint

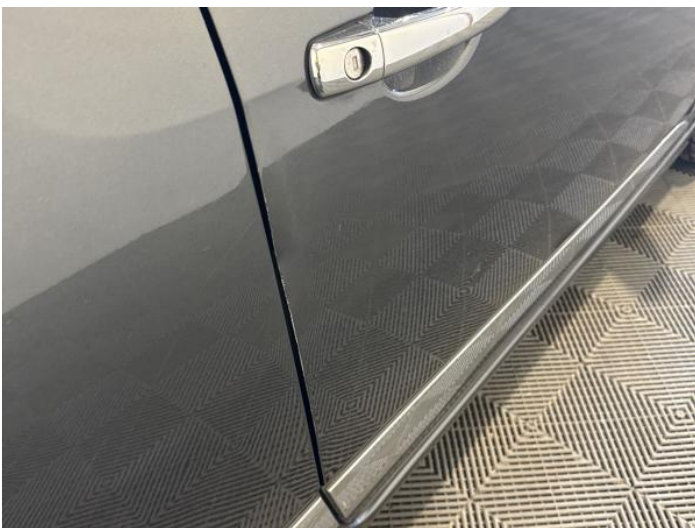
13: Door osf  
Dented  
Over 30mm

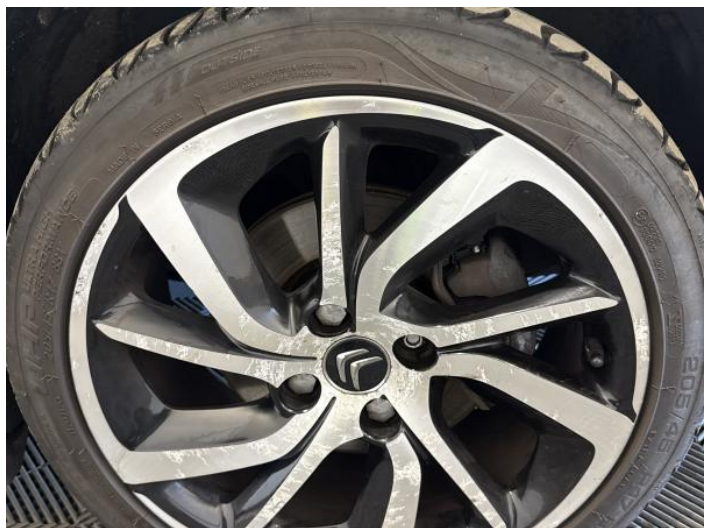
14: Wheel osf  
Scratched  
Over 50mm

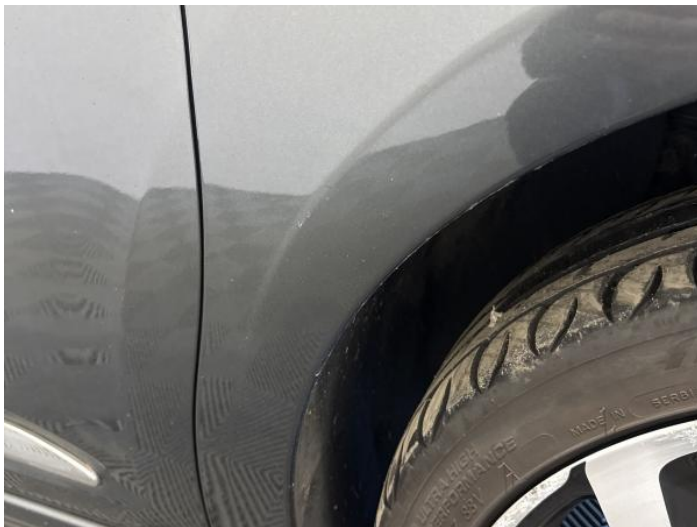
15: Wing osf  
Scratched  
UpTo 25mm Thru Paint

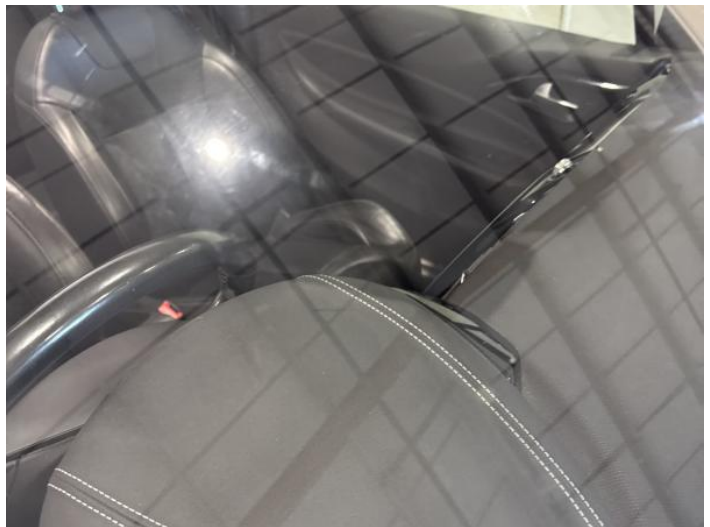
16: Screen Front  
Chipped  
UpTo 10mm
