VEHICLE INSPECTION REPORT

LC18VRY

Kia Sportage 1.6T GDi GT-Line 5dr DCT Auto [AWD]

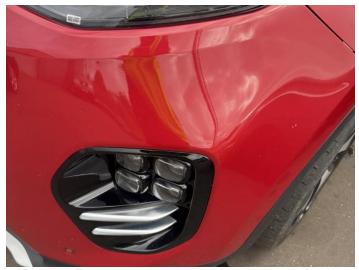
2: Bumper Front Poor Previous Repair Poor Paint

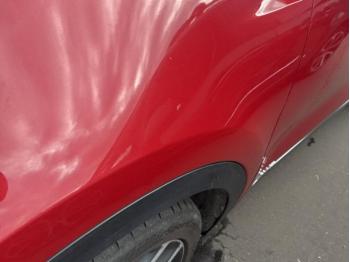
3: Wing nsf Chipped 1 To 5

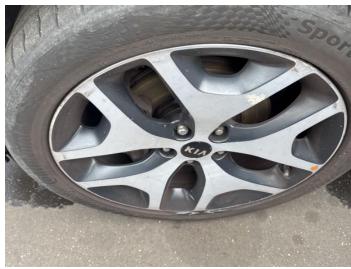
4: Wheel nsf Scratched Over 50mm

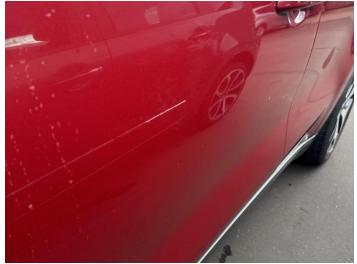
5: Door nsf Chipped 1 To 5

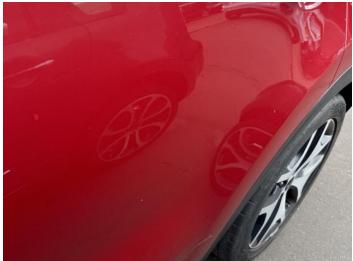
6: Door nsr Chipped 1 To 5

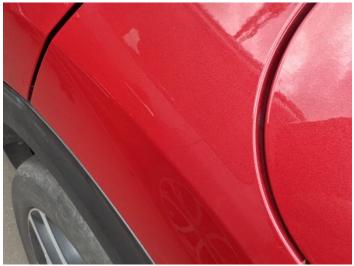
8: Qtr Panel nsr Scratched UpTo 25mm Thru Paint

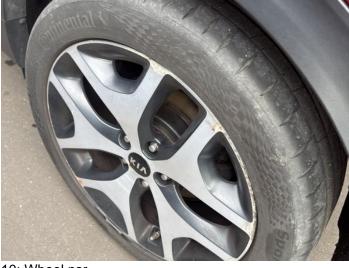
10: Wheel nsr Scratched Over 50mm

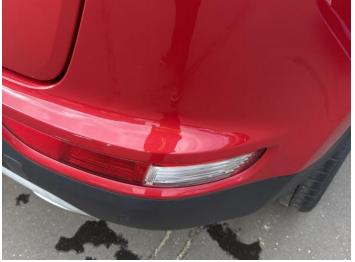
11: Bumper Rear Scratched 25 to 100mm Thru Paint

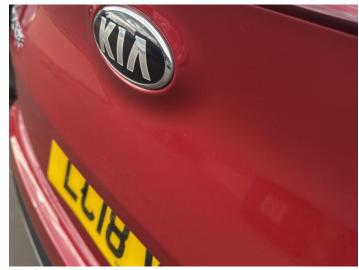
13: Boot Lid Chipped 1 To 5

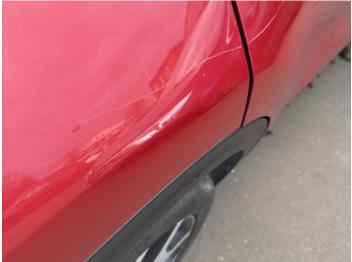
14: Qtr Panel osr Scratched Over 25mm Thru Paint

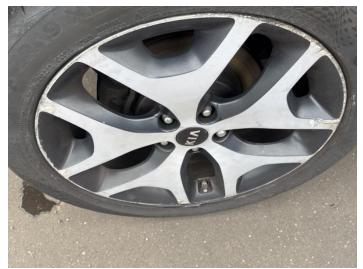
15: Wheel osr Scratched Over 50mm

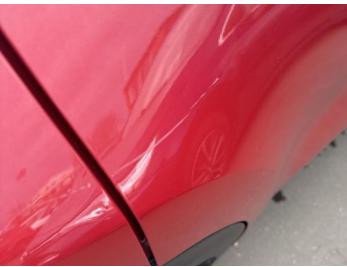
16: Door osr Scratched Over 25mm Thru Paint

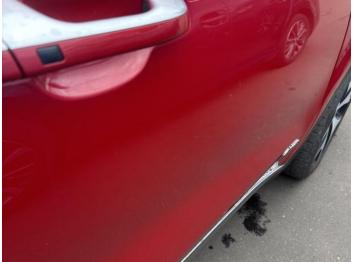
17: Door osf Chipped 1 To 5

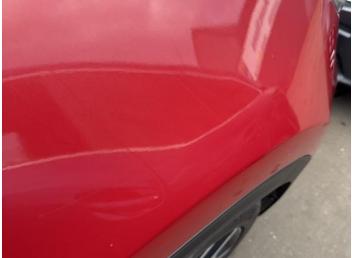
18: Wing osf Chipped 1 To 5
