VEHICLE INSPECTION REPORT

EJ20JVP

Ford Puma 1.0 EcoBoost Hybrid mHEV ST-Line X First Ed 5dr

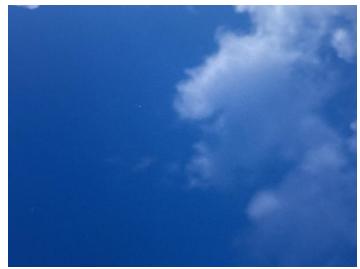
1: Bonnet Chipped Multiple Chips

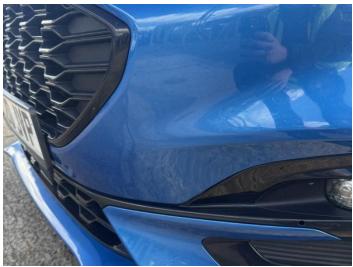
2: Bumper Front Scratched 25 to 100mm Thru Paint

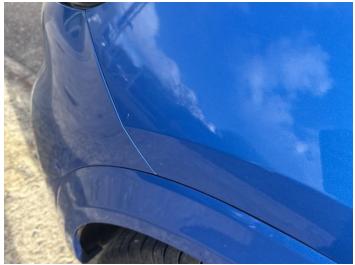
3: Wing nsf Chipped 1 To 5

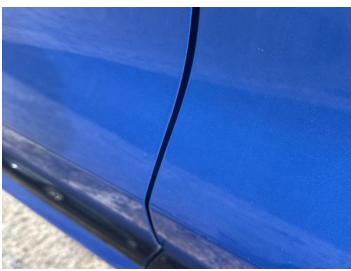
4: Door nsf Chipped Edge Chip

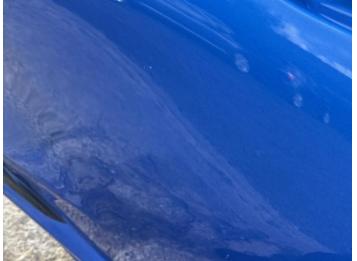
5: Door nsr Chipped 1 To 5

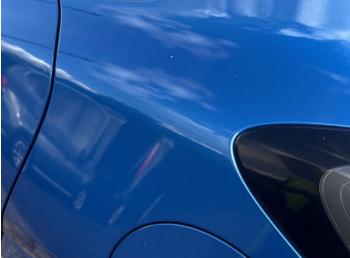
6: Qtr Panel nsr Chipped 1 To 5

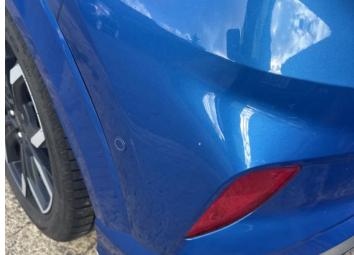
7: Bumper Rear Scratched 25 to 100mm Thru Paint

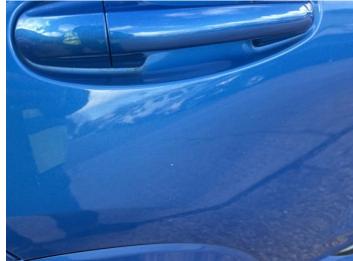
8: Door osr Chipped 1 To 5

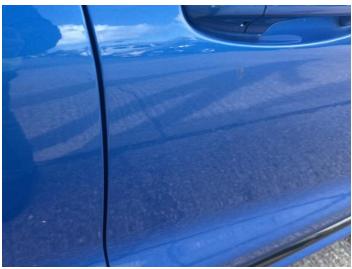
9: Door osf Chipped Edge Chip

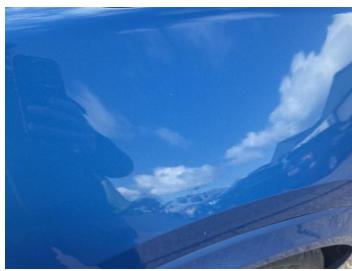
10: Wing osf Chipped 1 To 5
